**Report:**

**Environmental Impact Assessment  
(EIA) for the harbor construction at  
Black Rocks, Saba**

Final report

June, 2022

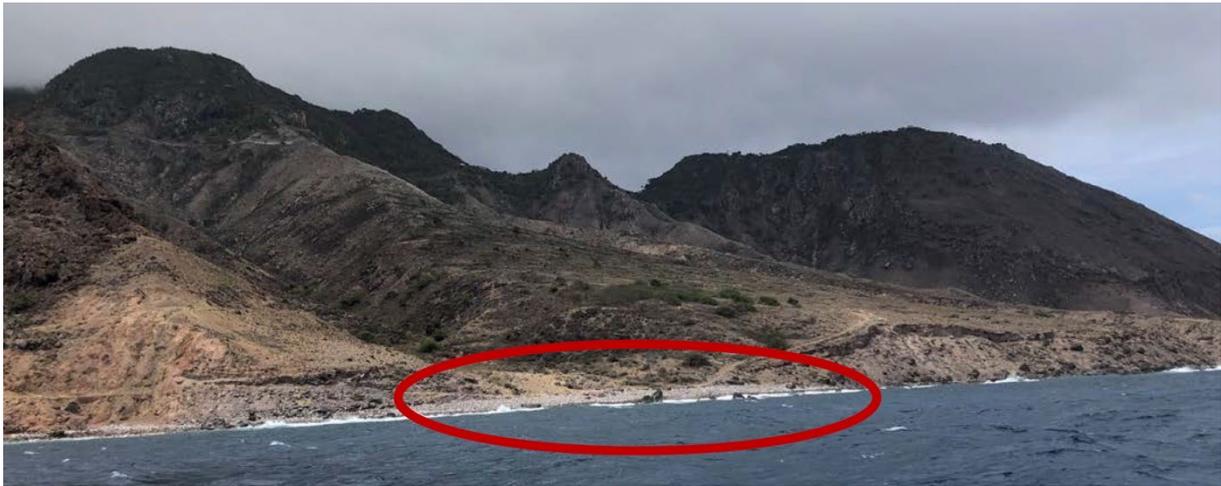
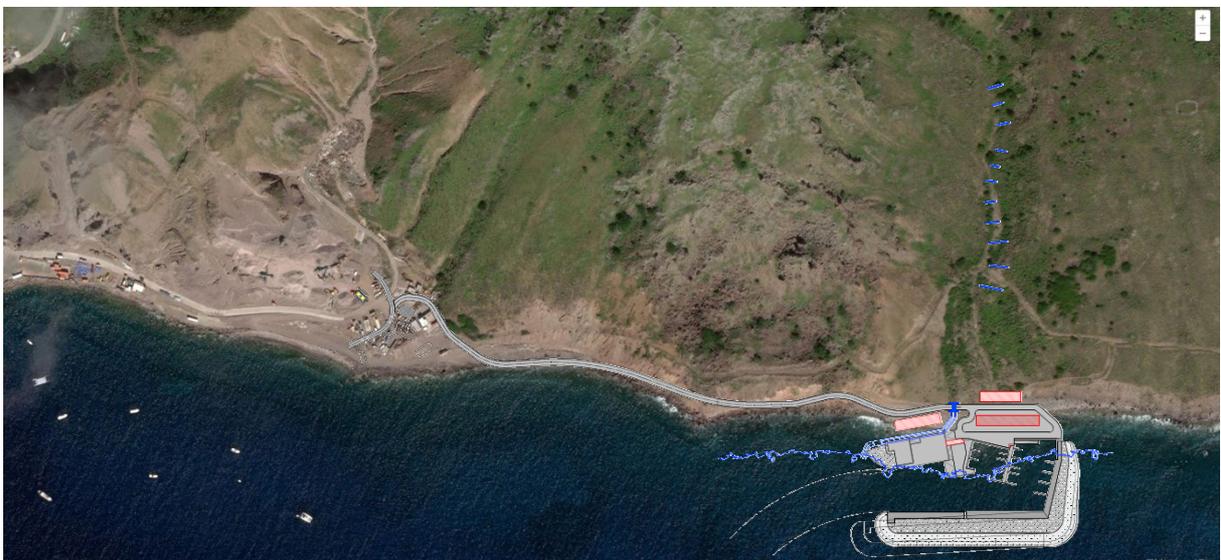
Figure 1.1 Black Rocks current situation (top) and proposed harbor with access road and gabions for water management (north of harbor).

Figure 1.1 shows the harbor in the new situation. In chapter 3 all project activities and project elements are described in more detail. In paragraph 1.4 and chapter 3 a number of alternatives are discussed.

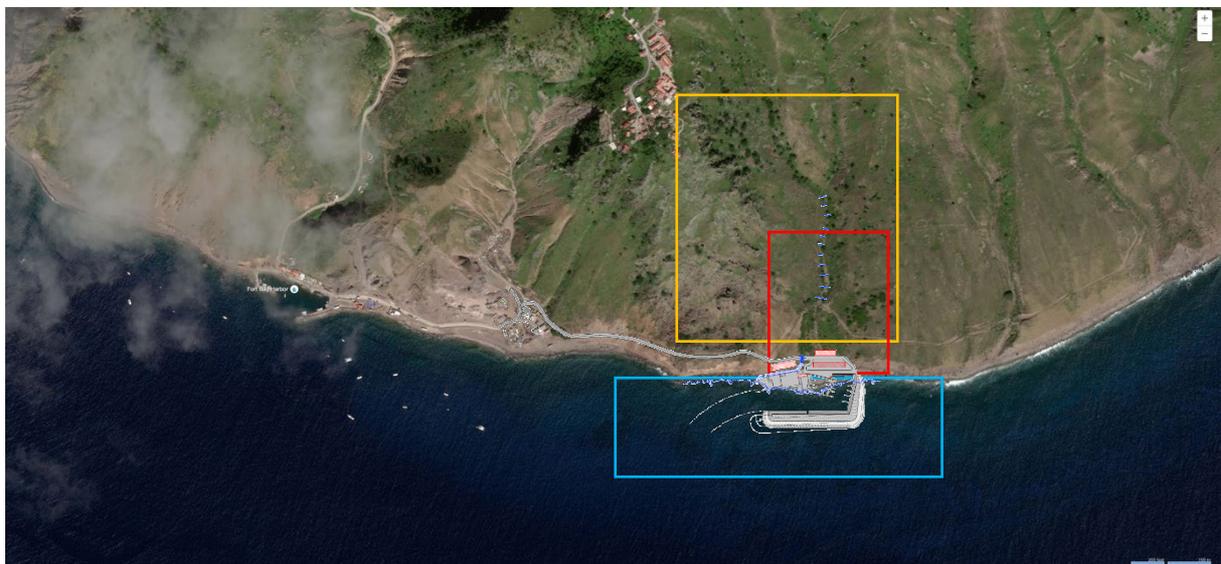
Figure 1.2: Main research areas: red (300x350m) vegetation survey; orange (650x500m) bird survey, blue (800x250m) marine survey

Figure 1.2 shows the main baseline research areas. The trajectory of the road is not indicated as an area, this area was observed as a line transect.

The vegetation survey by Saba Conservation Foundation was carried out in a rectangular area of approximately 300x350 meters, north of the beach where the harbor is projected (see figure 1.2). Table 4.3 shows the tree species found in the research area and the respective numbers observed. Figure 4.7 shows the locations of trees with a stem circumference at breast height (CBH) of 30-50 cm; figure 4.8 shows trees with a CBH of more than 50 cm. Annex 2a gives more detailed information on the recorded trees (including pictures).

The area for the bird survey is approximately 500x650 meters (see figure 1.2) and includes steep, inaccessible cliffs, particularly near the settlement of St. Johns, which are favored by nesting seabirds.

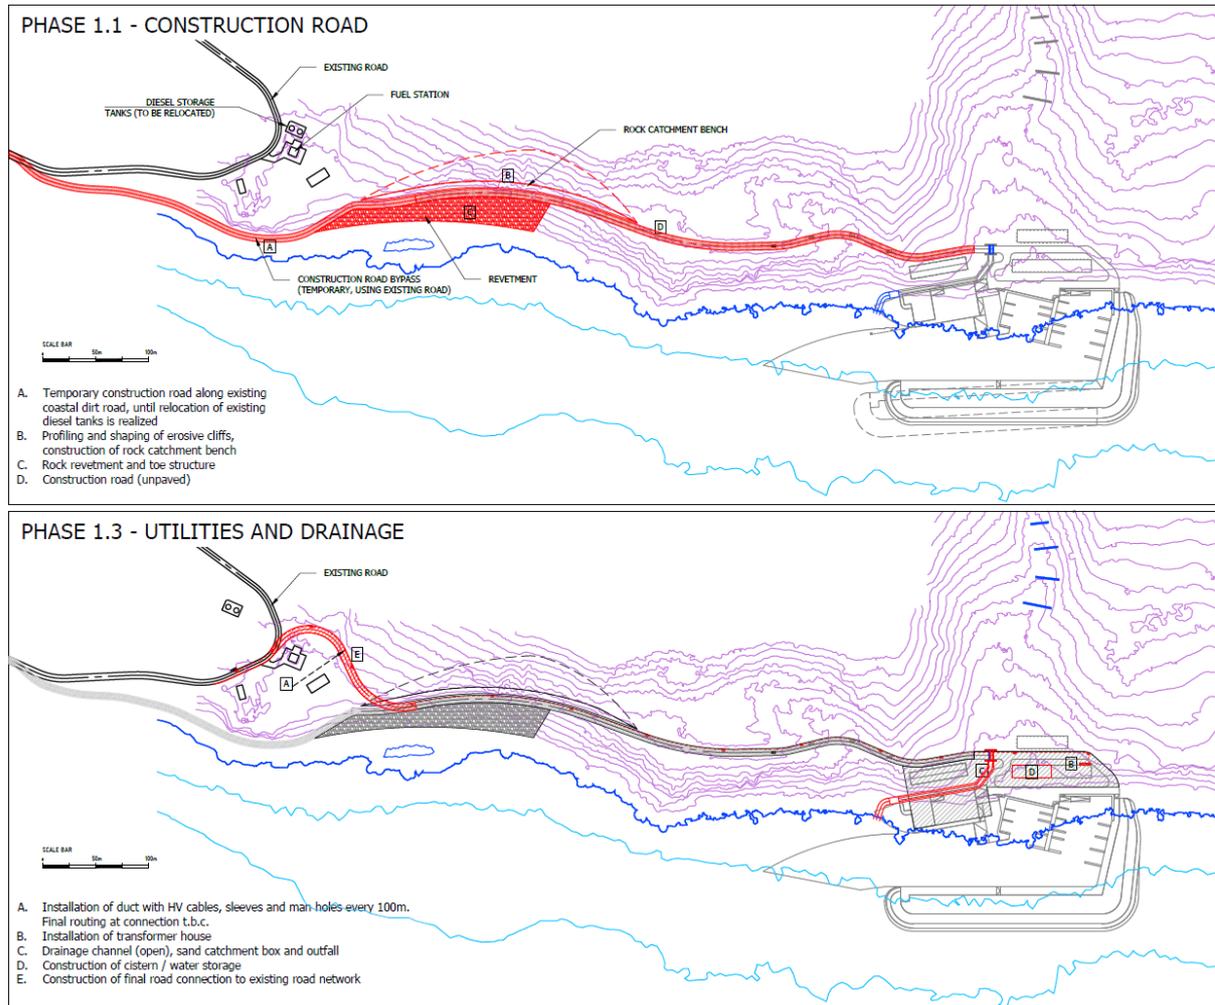
Figure 3.1: Two phases of road construction. Top: connection to harbor area by means of temporary road along the coast (currently unpaved road). Bottom: final road connection after relocation of fuel tanks.

- Levelling and widening in places of the entire road (approx. 800m length along the final route from existing road to the east side of the new harbor terrain), including road base compaction. The width of the construction road is approximately 7-8m.
- Benching and slope stabilization in a section of about 250m in the western part, including a revetment along the shore to protect the lowest section of the road against erosion by waves and run-off. The minimum elevation of the road is around +10m MSL (above Mean Sea Level).
- Creation of a temporary connection to the existing road along the shore (west side), until the existing fuel tanks along the final route have been relocated.

The road surface during construction phase consists of a typical sub-base material (e.g. 0/30mm) which is compacted. This is easy to maintain and level while being used by heavy construction traffic. After completion of the main construction activities (in approximately 18-24 months), the final road surfacing will be installed (concrete). The completion of the excavation works and compaction of the road is expected in Q3 2022.

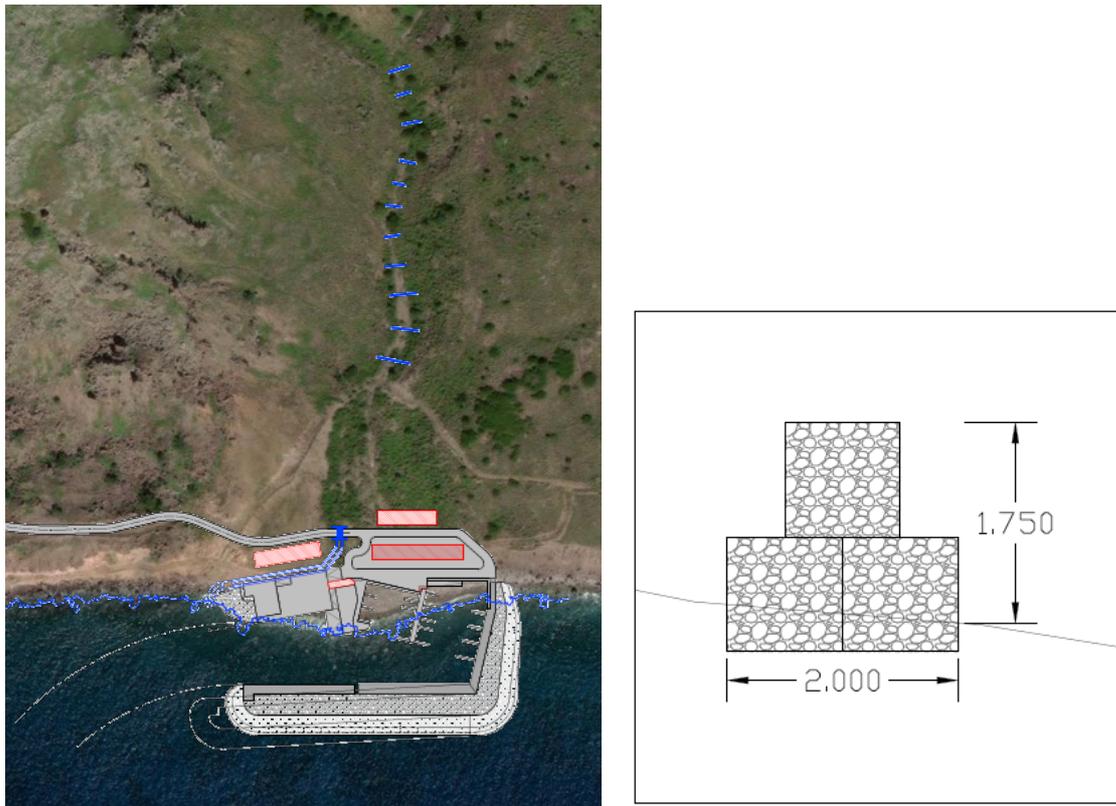
Figure 3.2: Positioning and design gabion weirs

The eleven gabion weirs will be positioned in the gut north of the harbor, see Figure 3.2. The eleven weirs will be placed between the 30m and 75m contour. Depending effectiveness during periods of

intense rainfall, an additional seven weirs may be required downstream. The weirs have a length of 10-30m and a height of 2m relative to the lowest point in the gut. The weirs have a stepped shape, see section in Figure 3.2.

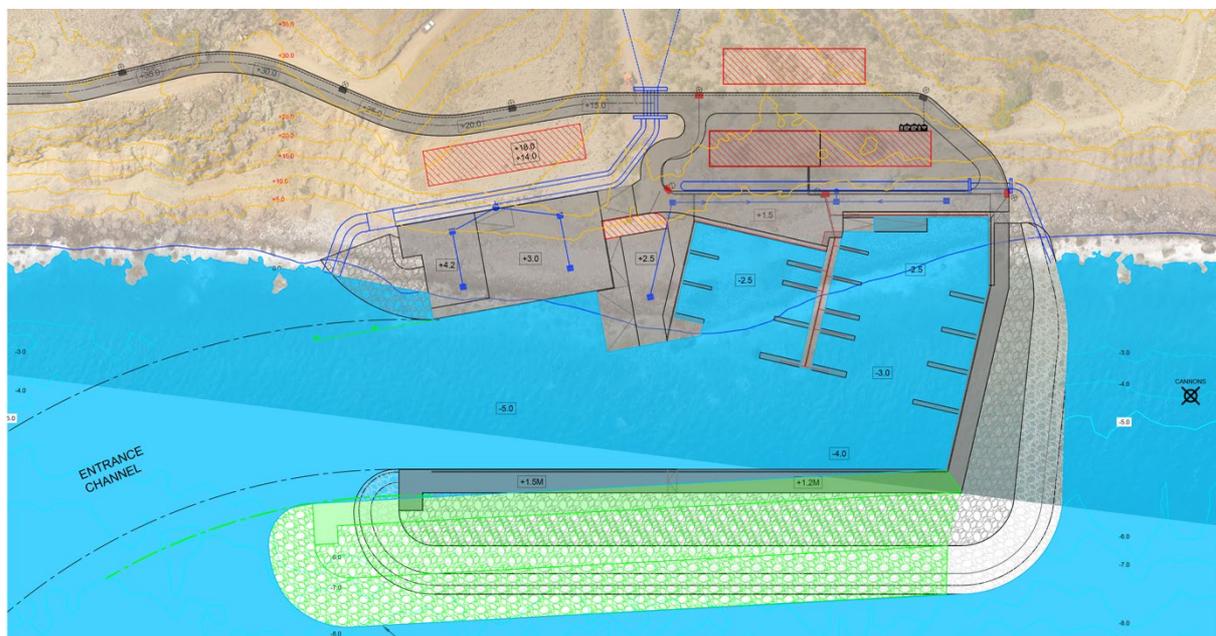
BLACK ROCKS HARBOUR - HARBOUR LAYOUT  
OPTION FOR LARGER RO-RO QUAY AND BREAKWATER SHOWN IN GREEN

At this stage, the final orientation and length of the main breakwater is not decided yet but depends on the final go-ahead for an improved design to make the harbor suitable for future, larger (90m LOA), RoRo vessels. The base-case layout (breakwater with 180m length) and the improved layout (breakwater 210m length) are shown below<sup>1</sup>. In this EIA we assume the realization of the larger structure for all environmental impacts. The width of the breakwater depends on the construction method chosen (with the rubble mound breakwater being the widest with 40 meters).

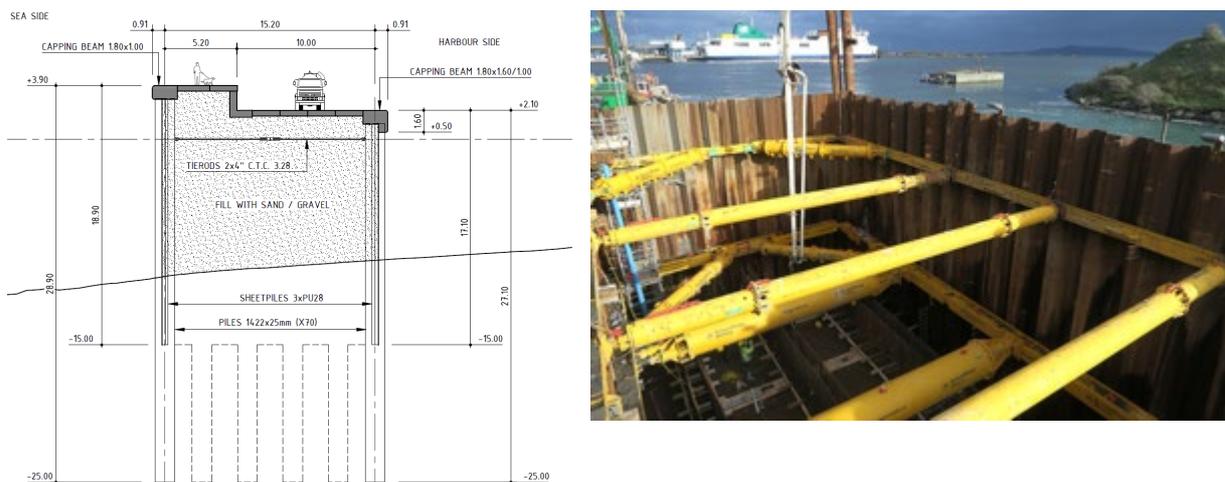
Figure 3.4: Example of typical cofferdam structure (schematic, left) and under construction (right)

A cofferdam breakwater/quay consists of two 'combi-walls' placed about 10-15m apart (width depending on final design), connected with tie rods and backfilled with suitable material. A combi wall is a combination of main piles at regular intervals (e.g. 2-3m center to centre) and thinner sheetpiles in between. A principle section and picture are shown in Figure 3.4.

If rocky substrates are encountered beneath this level, these could be broken first by means of a heavy steel H-profile driven into the substrate, or drilled out, or removed by other means (grab, etc). The resulting two separate combi-walls are connected by tie rods (horizontal steel rods as shown in the figure below and backfilled with suitable rock/gravel/sand material. A concrete beam is cast on top of the main piles to provide a solid coping for the quay (on the harbor side) and a hard edge for the pavement.

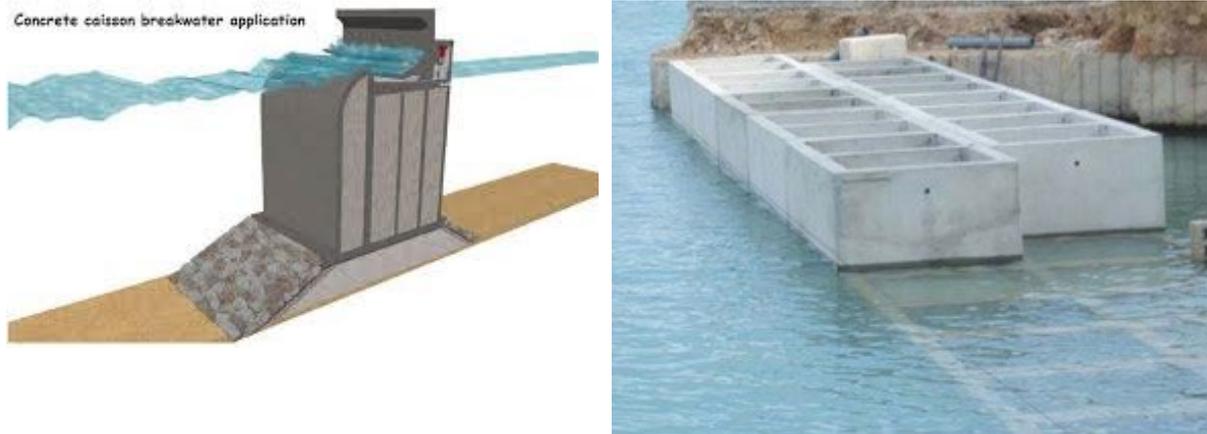
Figure 3.5: Example of typical caisson structure (left) and modular caisson (right)

An alternative for the main breakwater and quay structure is a caisson. Figure 3.5 shows an example of a typical deep-sea caisson (left) and a modular caisson (right). The caisson structure is a suitable alternative in waters of medium depth<sup>2</sup>.

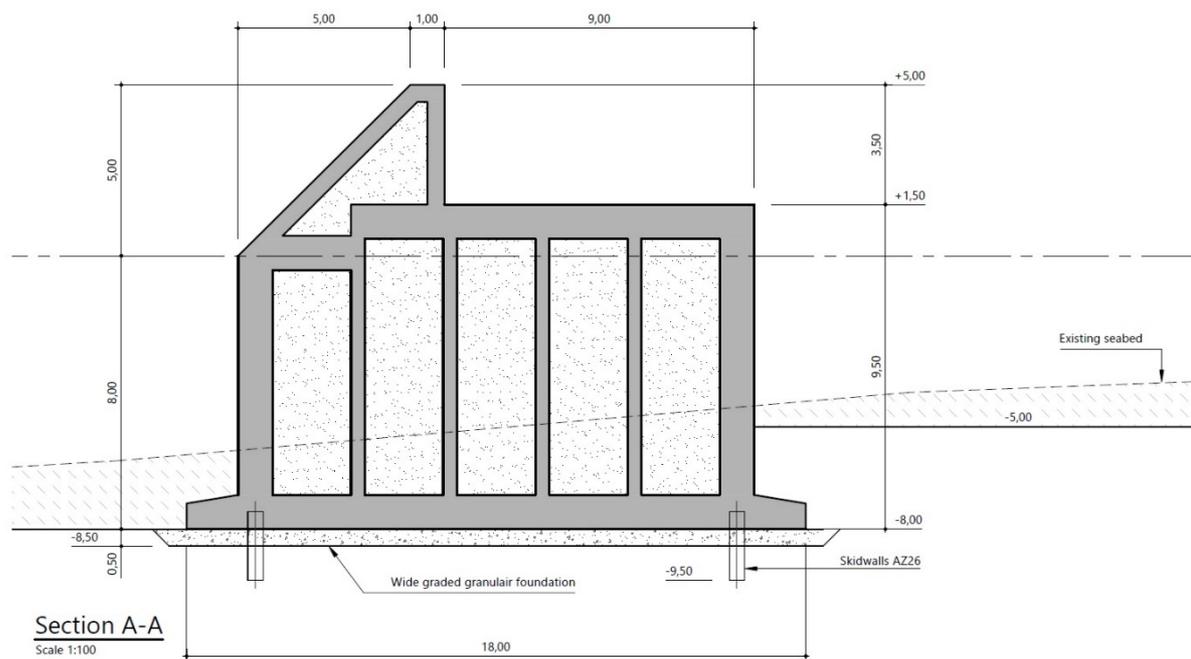
Figure 3.6: Reference design for a caisson breakwater).

A reference design has been made yet for the caisson breakwater, see Figure 3.6.

Before the placement of the caissons on the seafloor, the seafloor needs to be prepared (levelled). This includes removal of rocks currently present on the seafloor. This work will be executed with a barge and an excavator. A second step in the levelling of the seafloor is the application of a 30-50 cm layer of foundation material, which typically is crushed granular material.

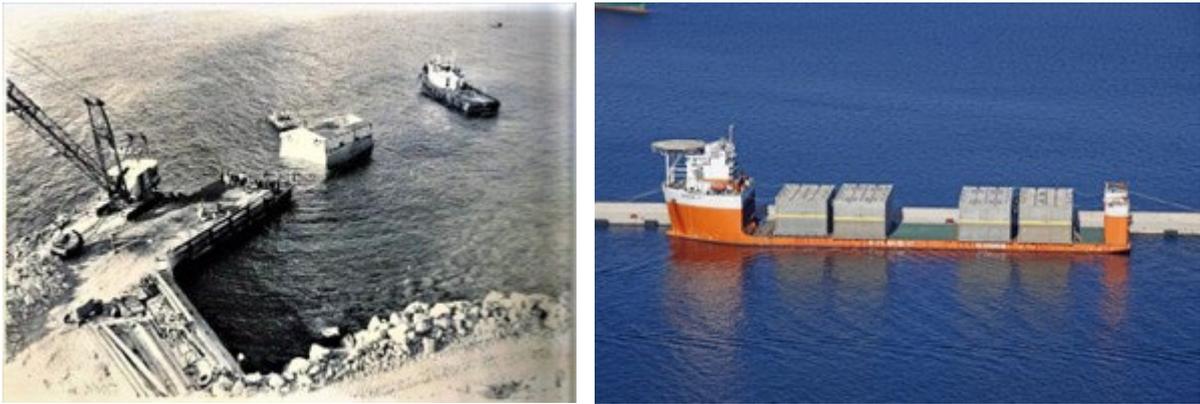
Figure 3.7: Example of caisson transportation by tugs (left; this is a 1970 picture of the construction of the Fort Bay main breakwater), and by semi-submersible vessel (right).

The caissons may be constructed in a dry dock (floating or fixed), on land adjacent to a slipway, or on a special pontoon which sinks as construction progresses. Given the limited space on Saba, it is considered to construct the caissons off-island, and transport these to Saba. This transportation can either be done by floating the caissons and towing these to Saba with tug boats, or by using special transport vessels like semi-submersible vessels. Examples of caisson transportation are shown in Figure 3.7 below.

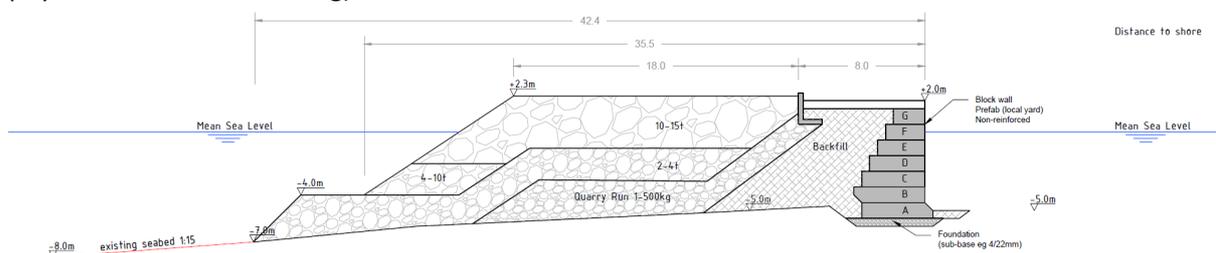
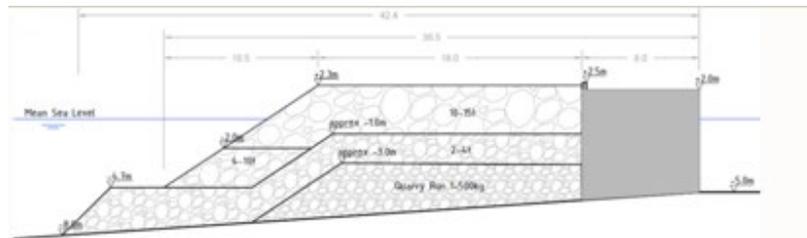
Figure 3.8: Top: section view of berm breakwater (base case). Design with block-wall at quay side (A-G)  
 Bottom: technical option with caisson at quay side (no backfilling of quay)

If the choice is made for a berm breakwater, it is recommended to use a caisson structure at the quay side of the breakwater. This will result in the use of 35% less backfill material and will considerably lower turbidity and sedimentation.

As an alternative, a so-called 'berm breakwater' is designed. The cross section (yet to be validated in physical scale model testing) is shown below.

The berm breakwater design is based on creating a wider breakwater (approximately 40m wide, see figure 3.8), but with smaller rocks on the outside. During a storm some movement and reshaping of the rocks is allowed, according to the principle below.

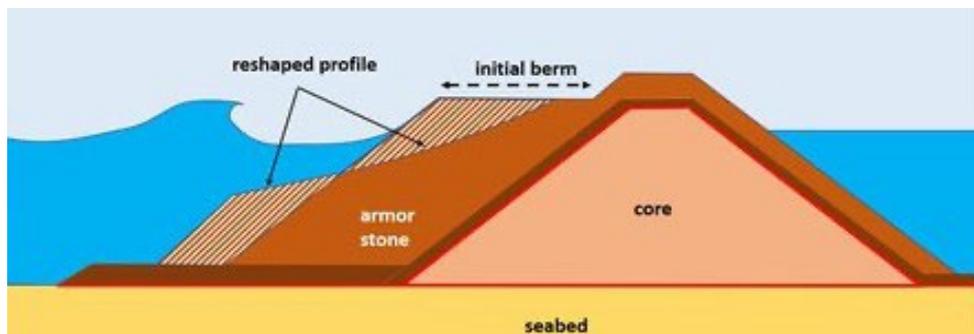
Figure 3.9: Movement and reshaping of berm breakwater

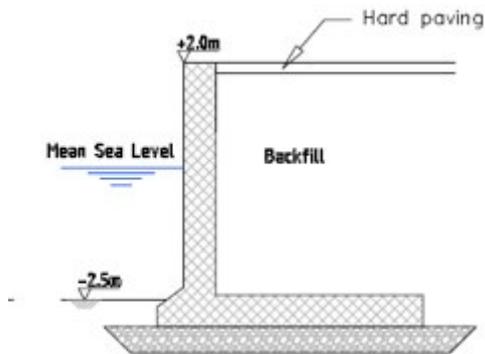
Figure 3.10: L-shaped wall (top level should be +1.5m)

The landside quay wall is a relatively low retaining structure, with a landside of about +1.5m MSL and a depth of about -2.5m (east basin) to -3.0m MSL (west basin). A typical cross section, based on a concrete L-wall, is shown below.

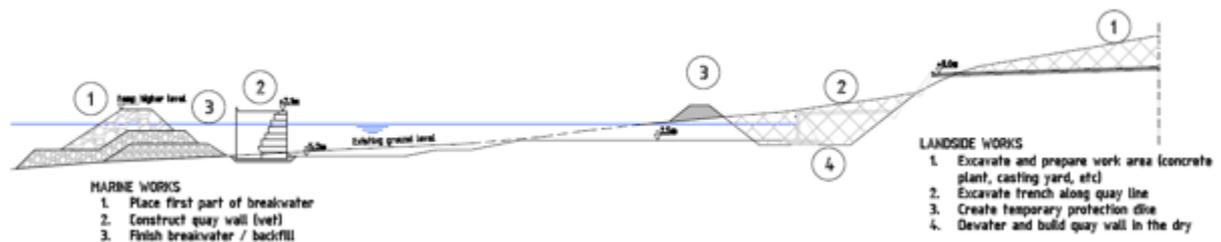
Figure 3.11: Sequence of works (marine works and landside works)

The location of the landside quay walls makes it possible to consider a dry, land-based, construction method. In this method, a small protection dike is constructed on the seaside, above seawater level, after which the construction pit is excavated and dewatered. The method prevents any exchange of sediments and seawater. After levelling, the foundation layer (gravel) can be placed. The structure type depends on the final selected solution but can be in the form of a L-shaped wall. This wall can be cast in-situ. After hardening, suitable back fill (sand/gravel) is placed and compacted in layers. The general sequencing is shown below.

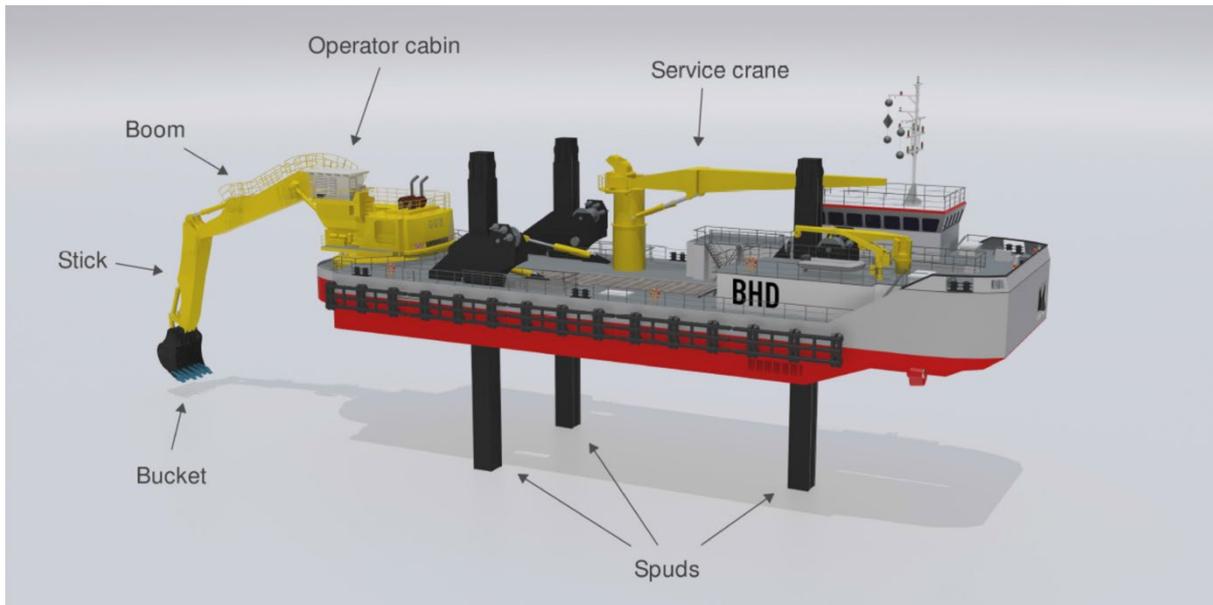
Figure 3.12 Example of barge with excavator

Dredging will be done partially from land, using “backhoe” or long boom excavators. The excavator can create its own dry construction platform into deeper water (approximately -3m MSL), working its way back to the shore. The material is then transported to land and used in the core of the berm breakwater, as ballast material in the caissons, or as infill for the cofferdam. Material is also required for the reclamation of the RoRo quay. Alternatively dredging can be performed with marine equipment, using a barge with excavator. This is likely the selected method for the deeper parts of the harbor basin. Sediments from the harbor will be re-used and placed securely in the reclamation area. If these materials cannot be used in the project (e.g. because of excess material in the mass balance) this material may be deposited in the open sea.

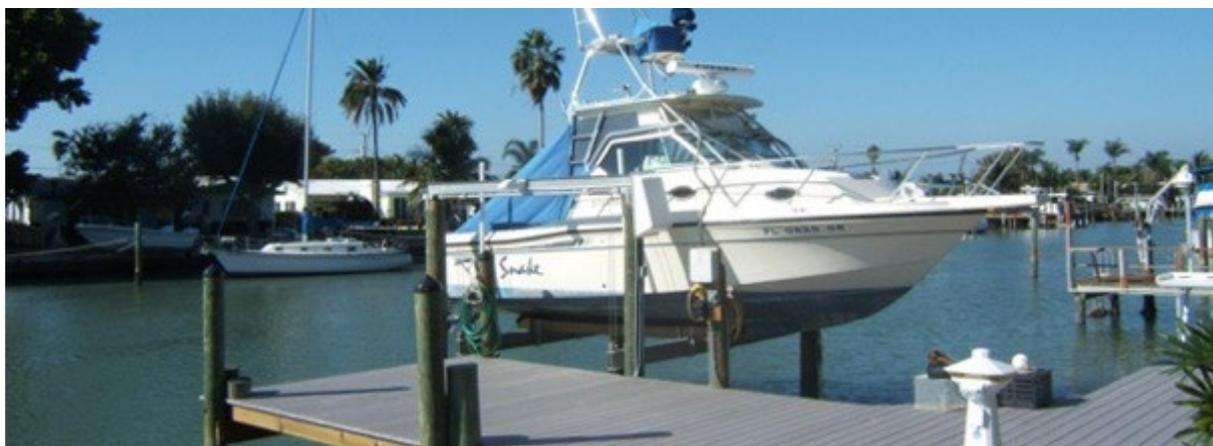
Figure 3.13: Example of a boat lift and fixed jetty structure.

In this phase also, the west basin quay wall is constructed. Perpendicular to the quay wall, finger piers are to be installed. These finger piers are currently planned as piled structures, with a robust (concrete) deck on top. A few finger piers will be fitted with boat lifts (see picture below). The total length of the west basin quay wall is about 90m, consisting of the north wall, west wall and the wingwalls.

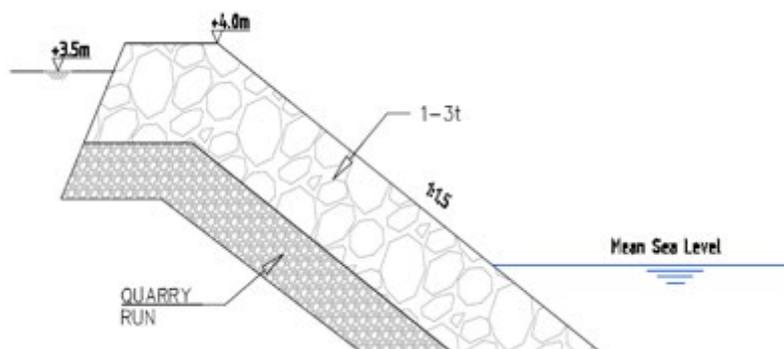
Figure 3.14: Principle cross section RoRo area revetment (geotextile between quarry run and armor rock).

The harbor area and reclamation directly adjacent to the RoRo quay have a total surface area of about 2,200m<sup>2</sup>. At the west side of the RoRo quay, a revetment is constructed to retain the reclaimed land and to provide a stable shore protection. The material for the reclamation originates from the land excavation and from dredged material from the harbor basin. Most of the material is coarse sand and gravel, although a part may contain finer material. A suitable filter will be installed between the reclamation material and the outer armor. This filter may be a wide graded granular filter ('quarry run') or alternatively a geotextile. A principle cross section is shown below.

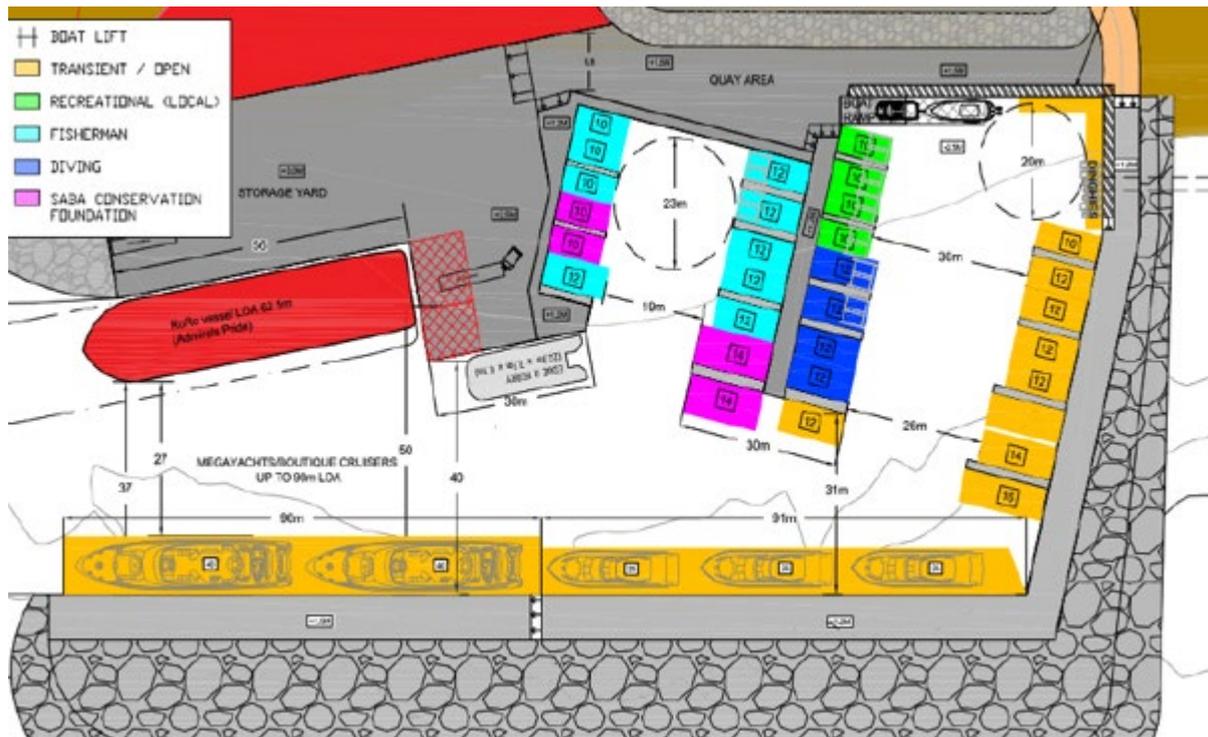
Figure 3.15 Harbor user groups

After completion of the main marine works, the so-called ‘marina’ elements can be installed. In total some 35 slips will be provided in the new harbor. This excludes the ferry dock, the mega-yacht berths, and the smaller boat/dinghy dock in the north-east basin. See picture below.

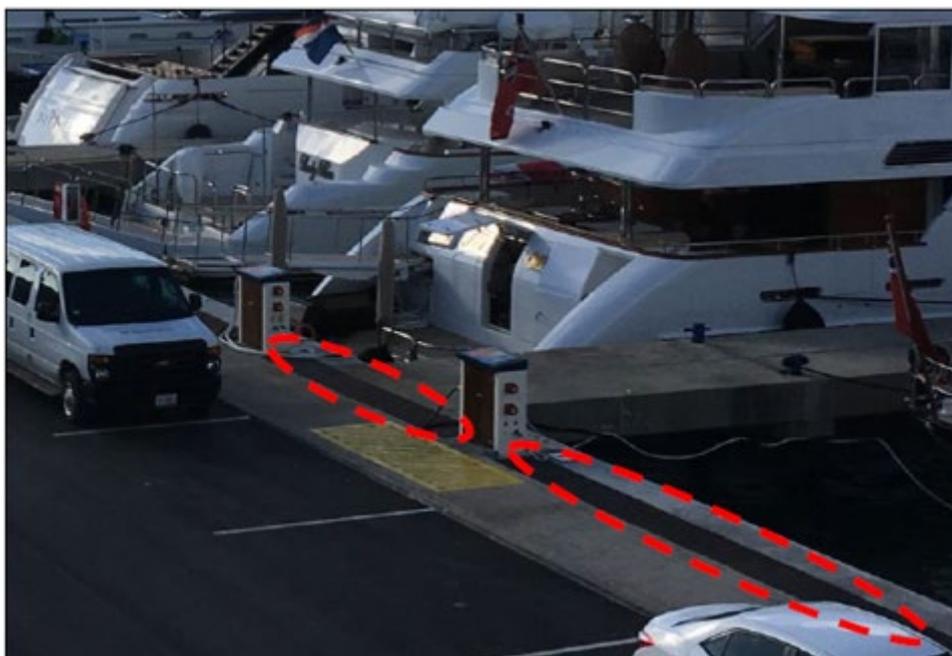
Figure 3.16: Pre-installed ducts and pedestals for water and electricity

All the slips will be serviced with water and electricity. These utilities will be placed in pre-installed ducts in the quay structures and are accessible for the harbor users via pedestals. An example of a mega yacht power pedestal is shown below.

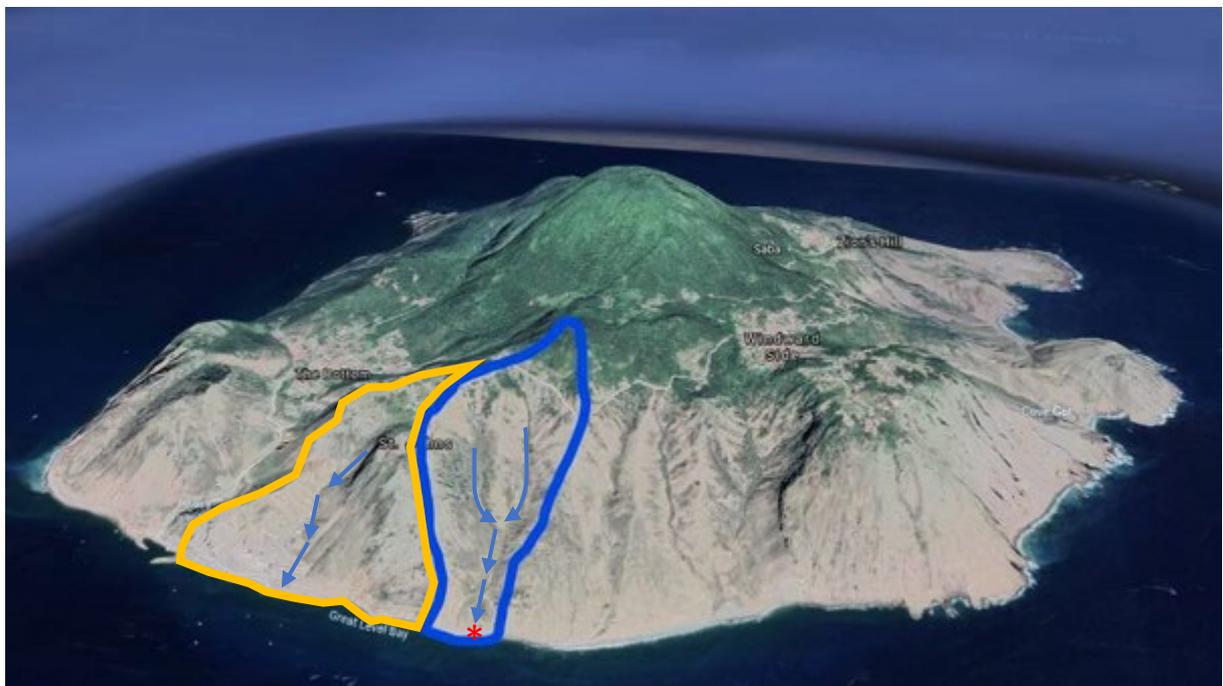
Figure 4.1: Two main watershed areas with approximate locations of main gutters (adapted from CCM Engineering, 2020 and Carmabi, 2014). Asterisk: location of proposed harbor

Figure 4.1 shows the watershed area in which the proposed harbor is located, east of St. Johns. The area is 55 ha large. Two gutters join near the center of the watershed area and from there the main gutter runs southward.

The proposed location of the harbor is exactly where the main gutter enters the sea.

The watershed west of St. Johns, approximately 50 ha large, drains to sea near the gas station.

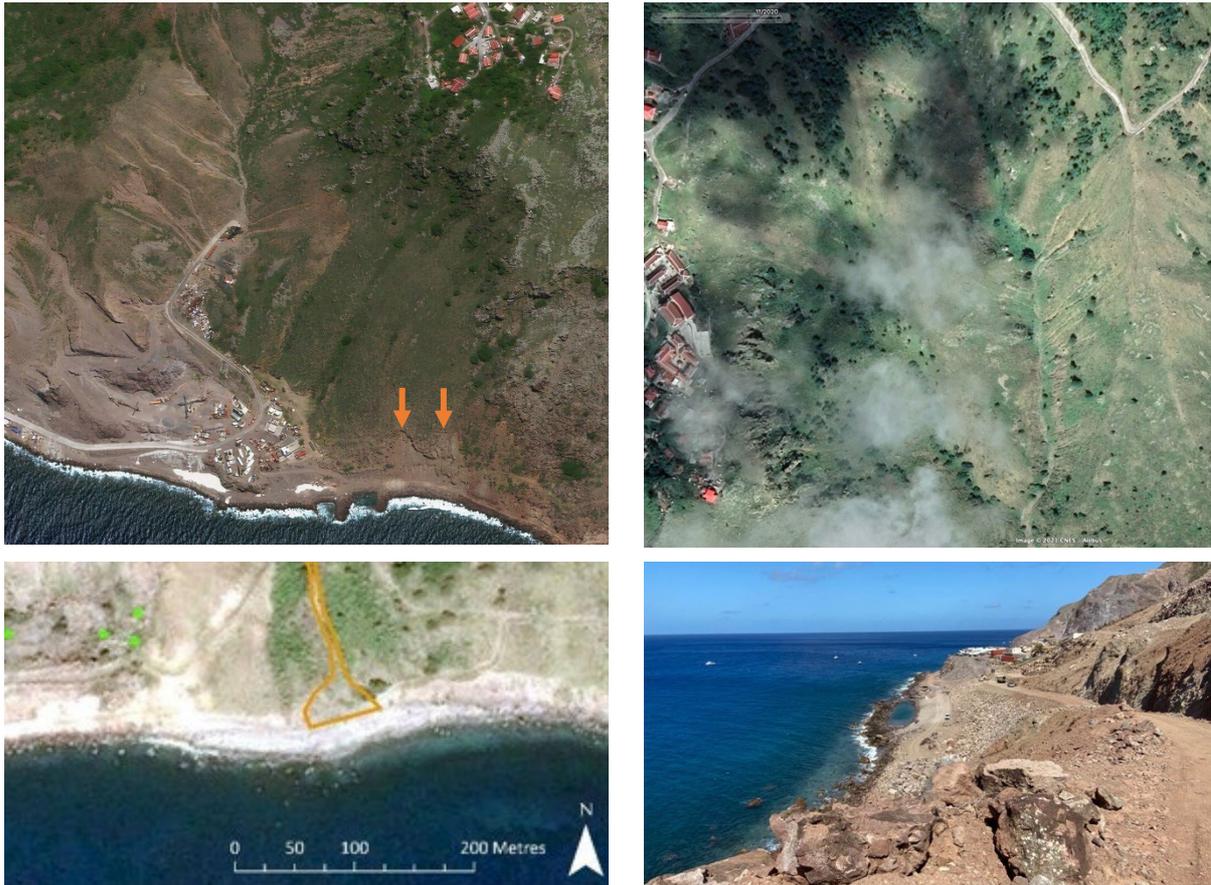
Figure 4.2: Top left: Erosion channels in watershed] west of St. John's. Arrows: landslides north of unpaved road. Top right: Erosion channels in watersheds east of St. John's. Bottom left: Trajectory of south part of gutter, with small delta near sea. Bottom right: location of proposed access road (foreground) and temporary road (background, north of Gary's Pond), which are unpaved roads at present.

The watershed area of Black Rocks, is relatively intact, except for some distinct erosion channels in the higher parts of the watershed area. Discharge of storm water to sea is through a small "delta" (see figure 4.2, bottom left), where discharge velocities are significantly lower and where sediments deposit.

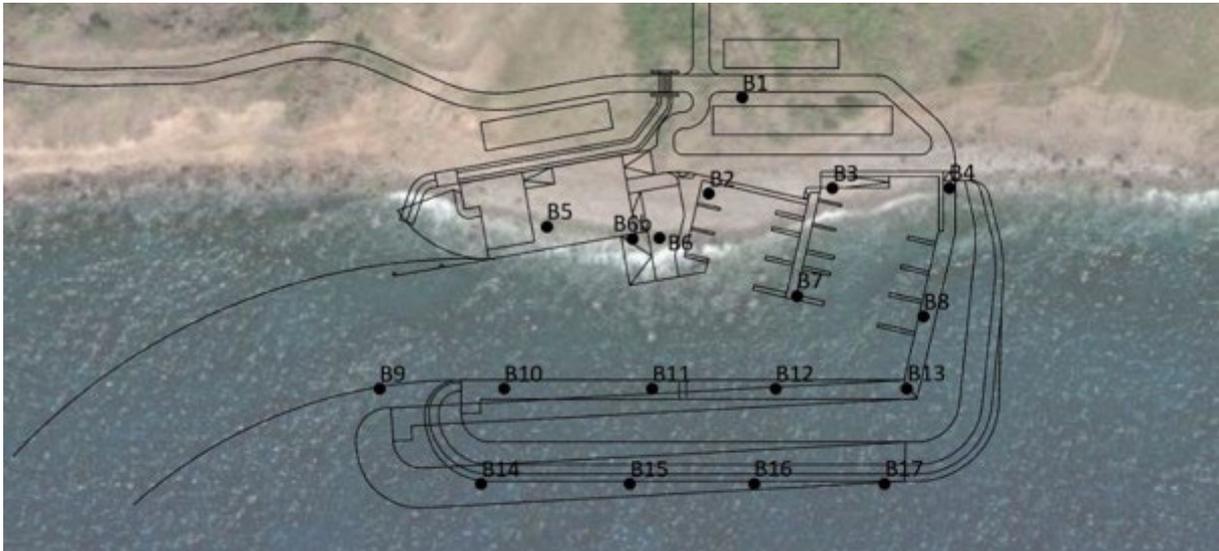
Figure 4.3 Sample locations

In November 2020 sediments were sampled by Geotron at the seafloor and on land (see figure 4.3). Samples were sent to the Dutch laboratory EuroFins Analytico for chemical analysis. Samples for chemical analysis were named as follows:

During the course of 2020, samples have been taken from the seafloor in the Black Rocks area for physical analysis (densities, particle size distribution etc.). See figure 4.3 for locations (B1-17) and annex 3b for a list of parameters analyzed.

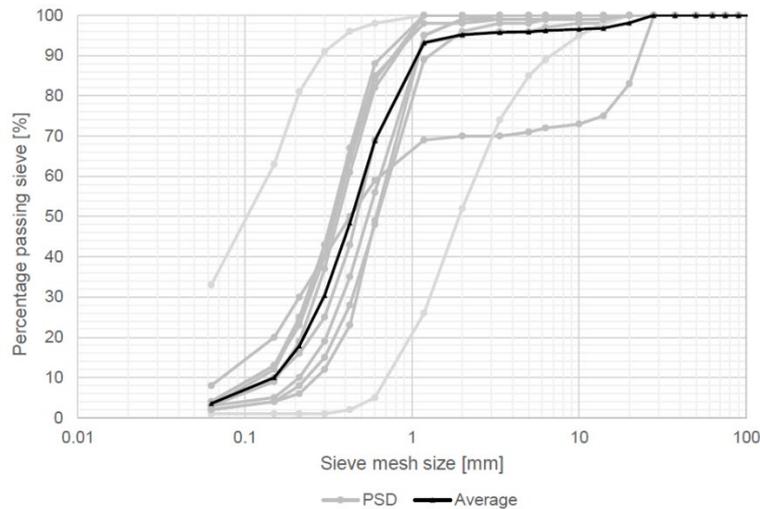
Figure 4.4 Summary of PSD results (black line indicating average values)

The specific gravity of the gravelly sand, with locally shell fragments, equals on average 2.76 Mg/m<sup>3</sup>. Figure 4.4 shows the results from particle size distribution (PSD) as well as the average PSD based on all results, except the two outliers shown in the graph (far left and far right). The fines content (silt + clay, defined as material <63 µm) equals 4%, sand 91% and gravel 4% on average (Geotron 2020, annex 4).

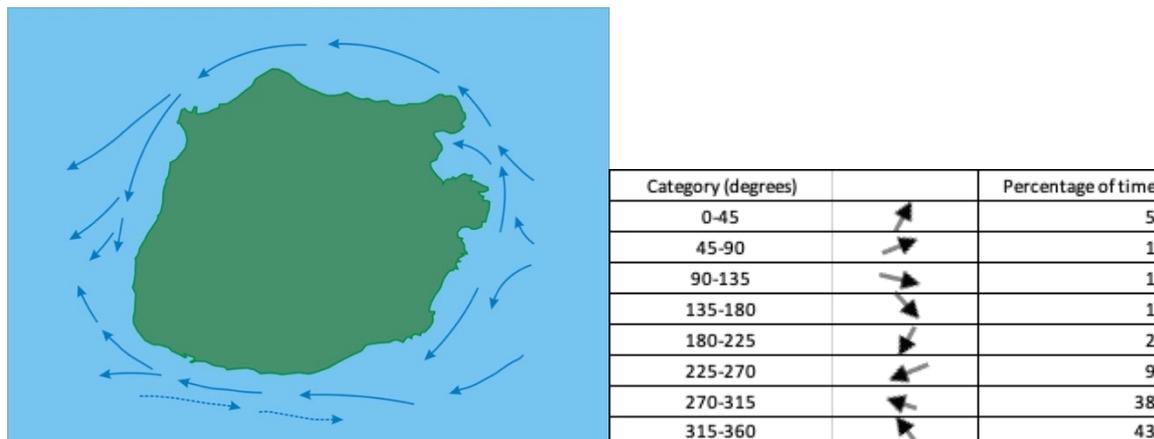
Figure 4.5: Current patterns around the island of Saba. Dashed line in picture left side: current reversal (information from US Navy Hycom model, and Dr. J. Rahn, Geographer). Right: Direction of currents as percentage of time (nearest point of Hycom database, 3000m SE of Saba)

Prevailing currents are from east to west (see figure 4.5). The table in the figure presents an analysis of the data from the US Navy Hycom database<sup>2</sup> with respect to direction of currents as percentage of total time. These are data from the closest modelling point near Saba, 2 km east of Saba (17.6N; 62.2W).

At the nearest data point of the HYCOM database, the average current velocity is 0.24 m/s (surface layer), and velocities are below 0.4 m/s 93% of the time. With the prevailing currents from east to west, seawater moves away from the island in the area just north of Tent Reef (see figure 4.5).

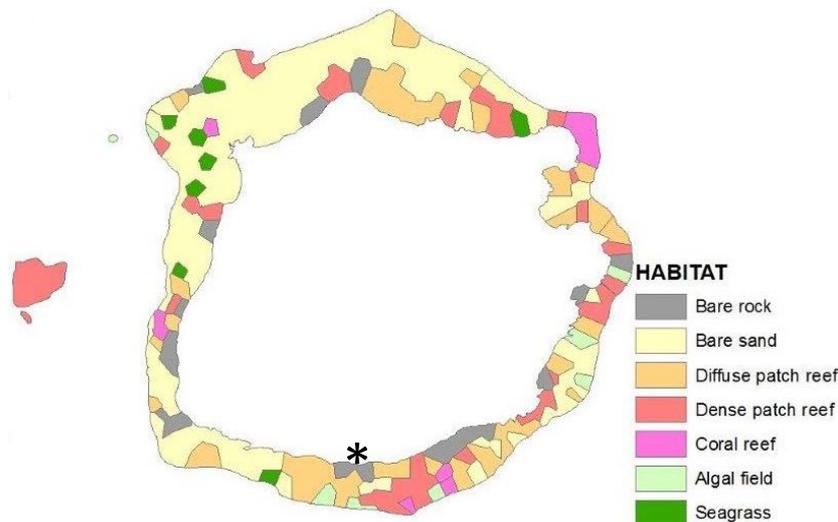
Figure 4.9: Characterization of sea floor (Kuramae et al., 2013). Proposed harbor location indicated by asterisk.

On Saba, five types of reef structures can be distinguished: 1) seamounts or pinnacles, 2) deep patch reefs, 3) encrusted boulders, 4) walls, and 5) true reefs (Van't Hof, 1991). Kuramae and Rouendal (2013) presented a classification of true reefs and patch reefs (dense and diffuse, see figure 4.9). True reefs are only found at a few locations within the Marine Park (e.g. Tent Reef, East of Giles Quarter). The vast majority of coral structures can be categorized as “coral encrusted boulders”. These boulders are volcanic in origin and generally originate from the hillsides along the coast. Both hard and soft corals and sponges cover these boulders.

From the benthic seascape map of Saba (Kuramae et al., 2013, figure 4.9), it can be concluded that in the direct vicinity of the Black Rocks location, the seafloor consists of bare rock and diffuse patch reefs. Important marine values are present in the area east of the Black Rocks area: dense patch reefs and true coral reefs, approximately 250m – 750m eastward of the proposed harbor.

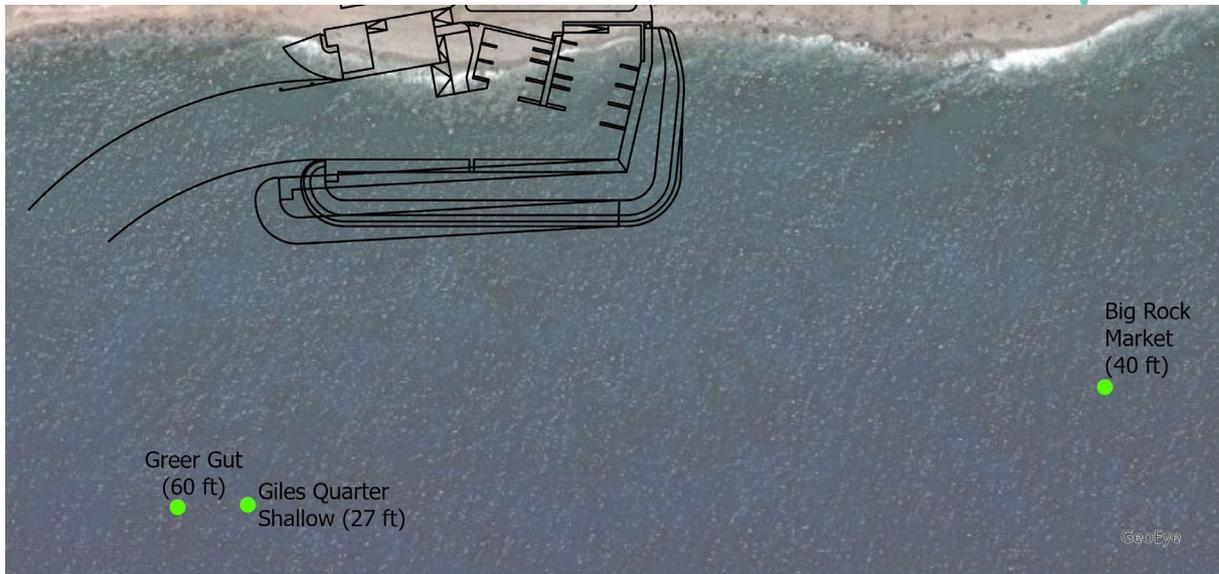
Figure 4.10: Dive sites near the proposed harbor location, studied determination of Reef Health Index

In the direct vicinity of Black Rocks, 3 dive sites have been studied for marine benthos and occurrence of fish. These sites are (see also figure 4.10):

The dive sites Greer Gut, Big Rock Market and Giles Quarter Shallow (see figure 4.10) have been studied for occurrence of fish (Van der Vlugt, 2016, Hildebrand, 2017). Presence of key herbivorous fish was “good” at Giles Quarter Shallow (3353 g/100m<sup>2</sup>), at the two other reefs it was “poor” (1586 g/100m<sup>2</sup> at Greer Gut and 1423 g/100m<sup>2</sup> at Big Rock Market).

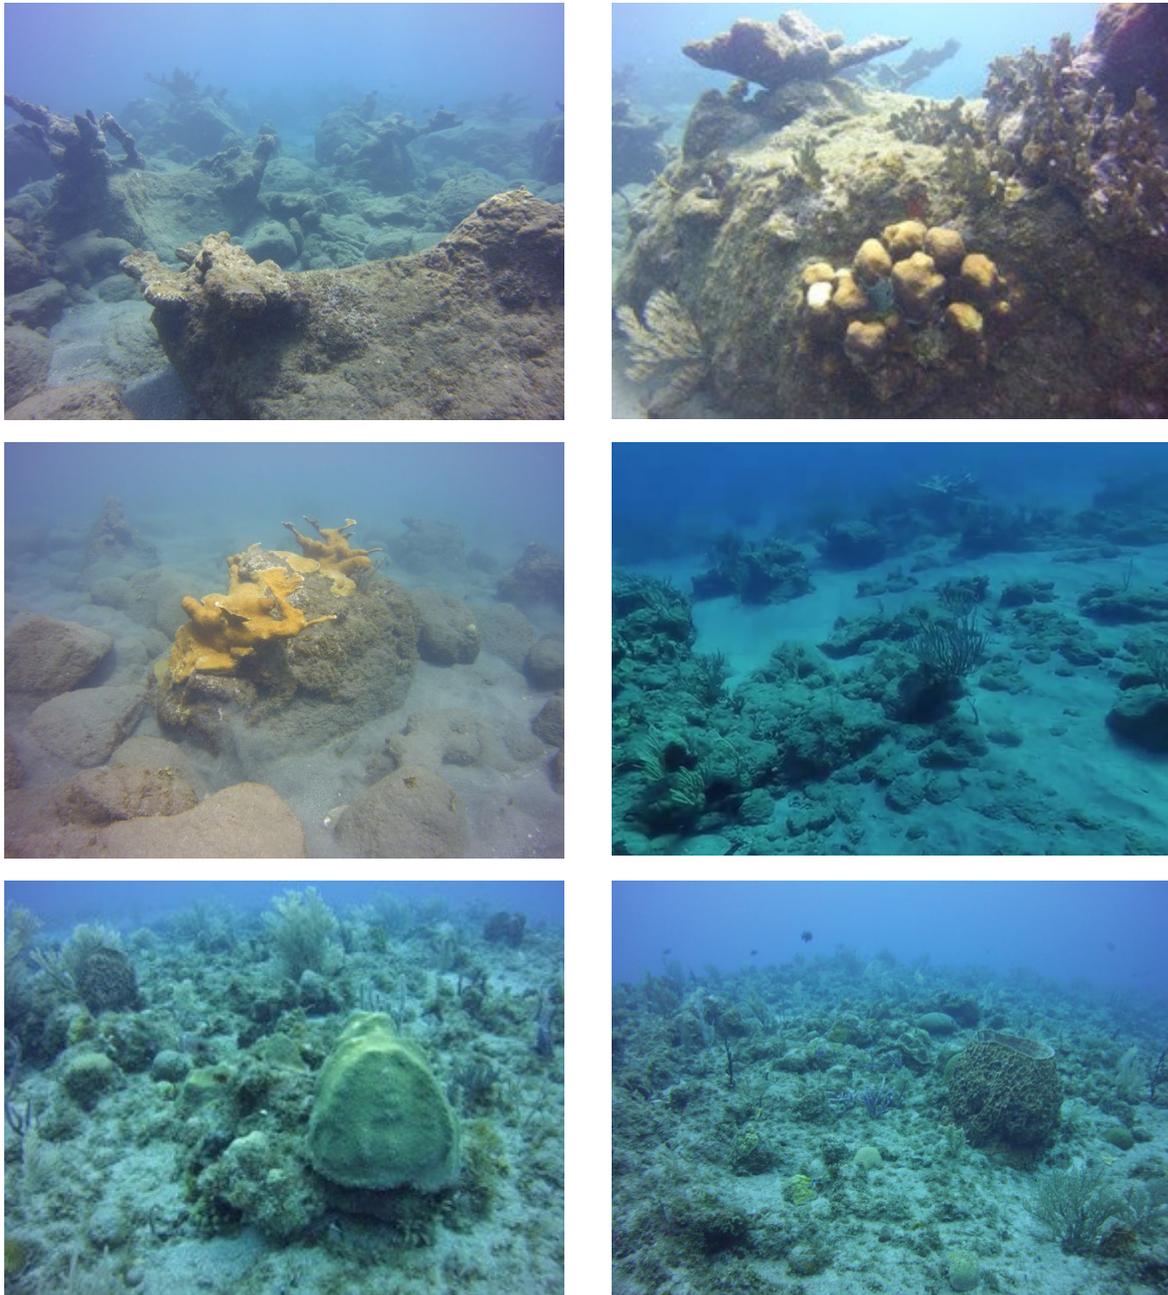
Figure 4.11 Top photos and mid-left: shallow area covered with boulders (0-7 m). Mid-right: area of patch reef covered with boulders. Bottom: deeper area with patch reef (10m+)

The seafloor in the area consists of sand, boulders, sand with boulders interspersed, patch reefs and patch reefs covered with boulders (see figure 4.11 for photographs). Figure 4.12 shows the spatial distribution of the different seafloor-types.
