**Report:**

**Environmental Impact Assessment  
(EIA) for the harbor construction at  
Black Rocks, Saba**

Final report

June, 2022

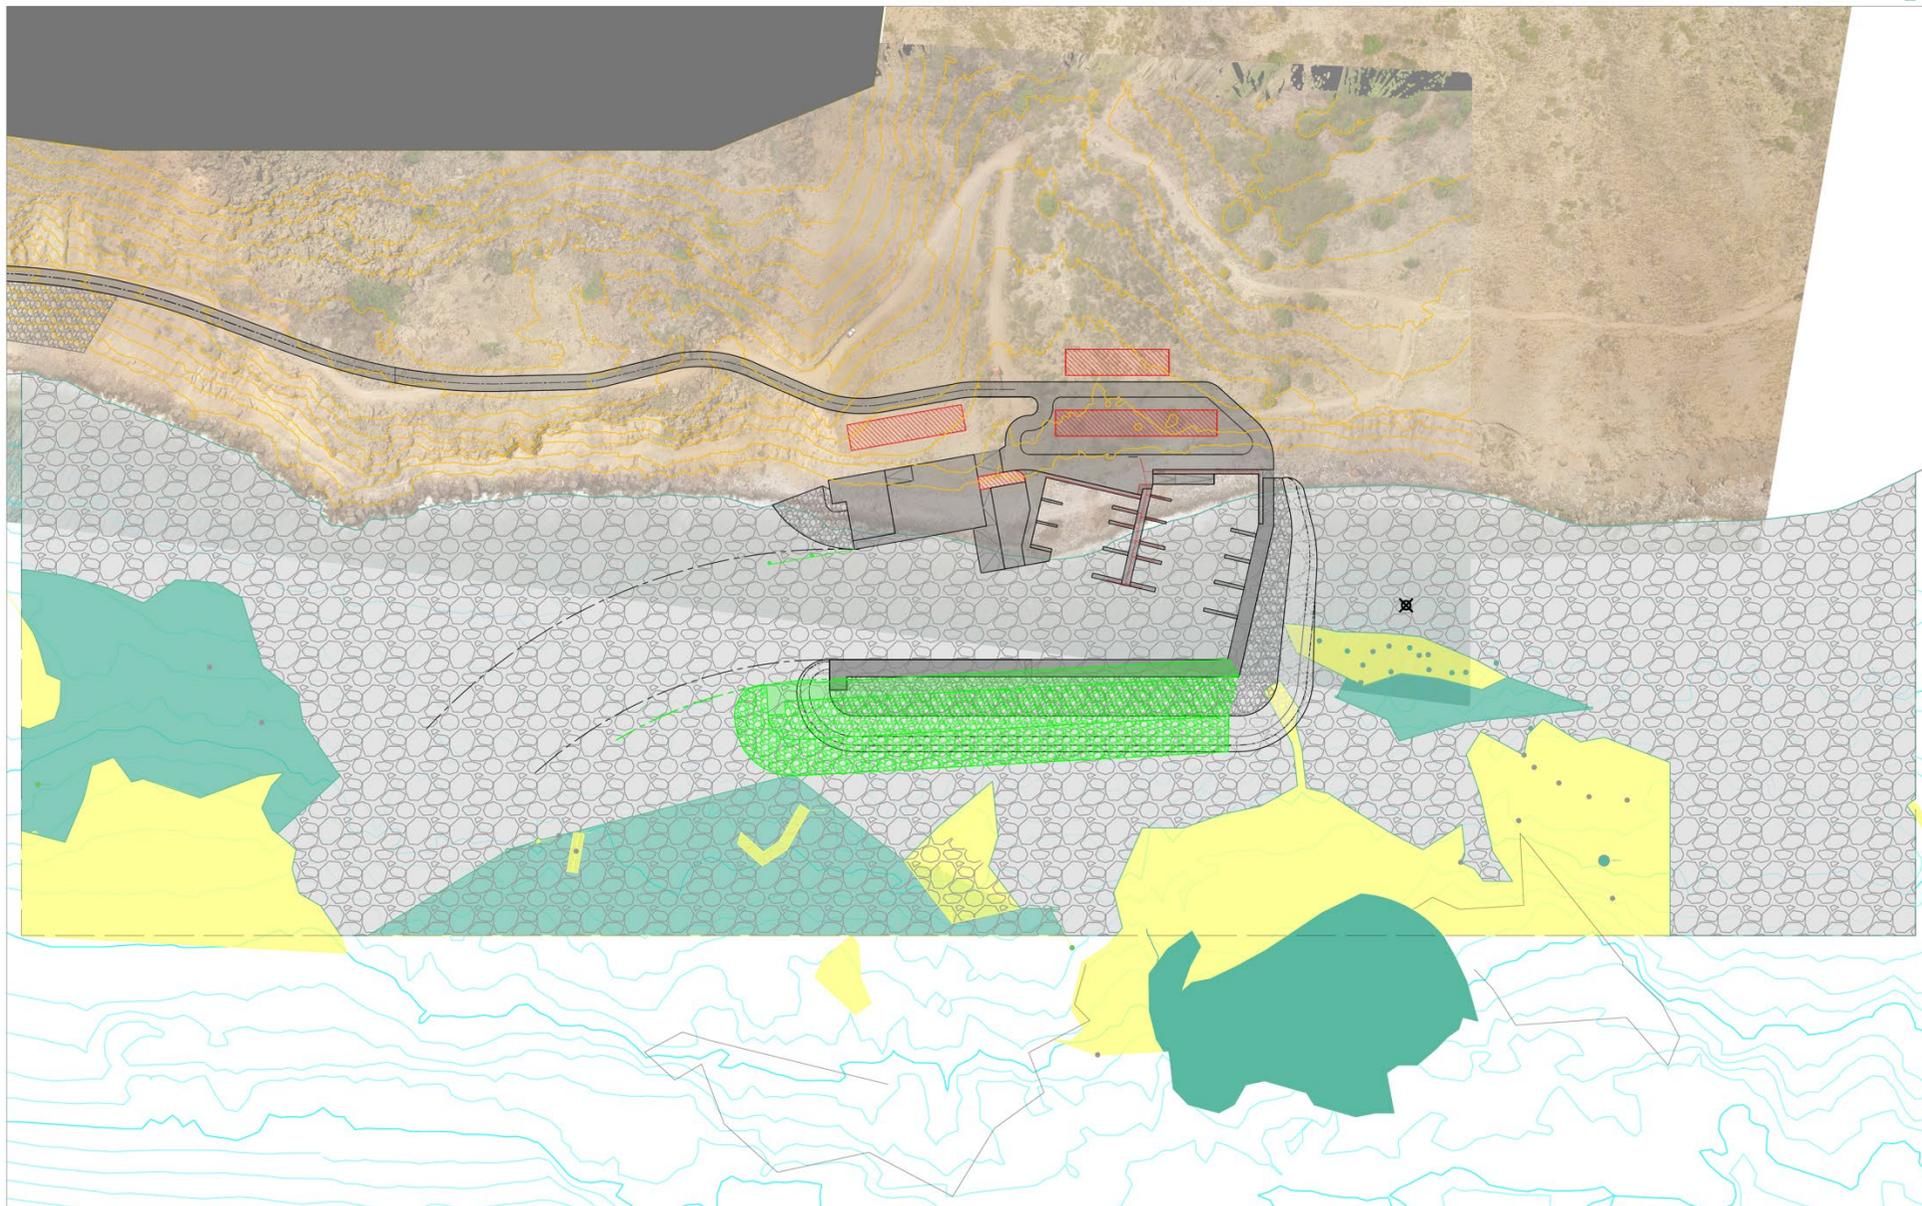
Figure 4.12: Seabed characterization and coral survey by SCF, February 2020  
 EIA Harbor construction Black Rocks, Saba

The seafloor in the area consists of sand, boulders, sand with boulders interspersed, patch reefs and patch reefs covered with boulders (see figure 4.11 for photographs). Figure 4.12 shows the spatial distribution of the different seafloor-types.

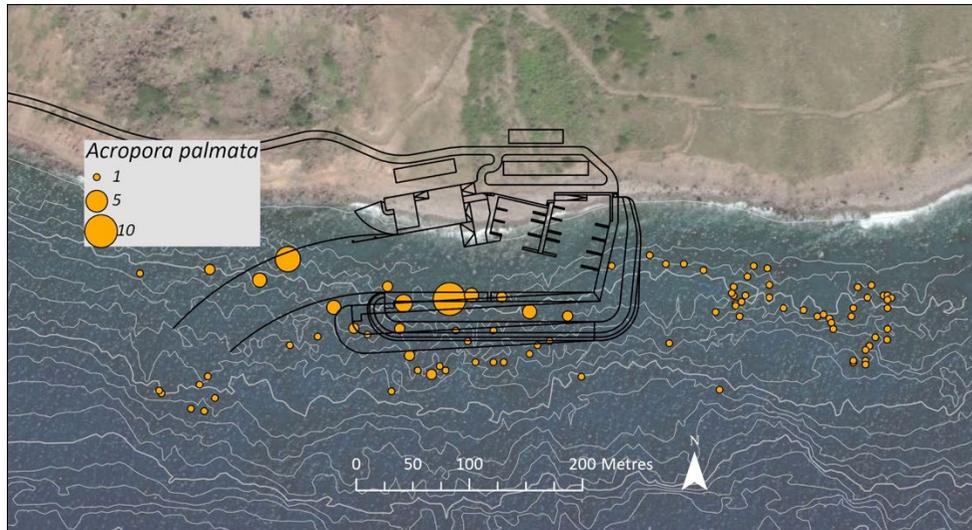
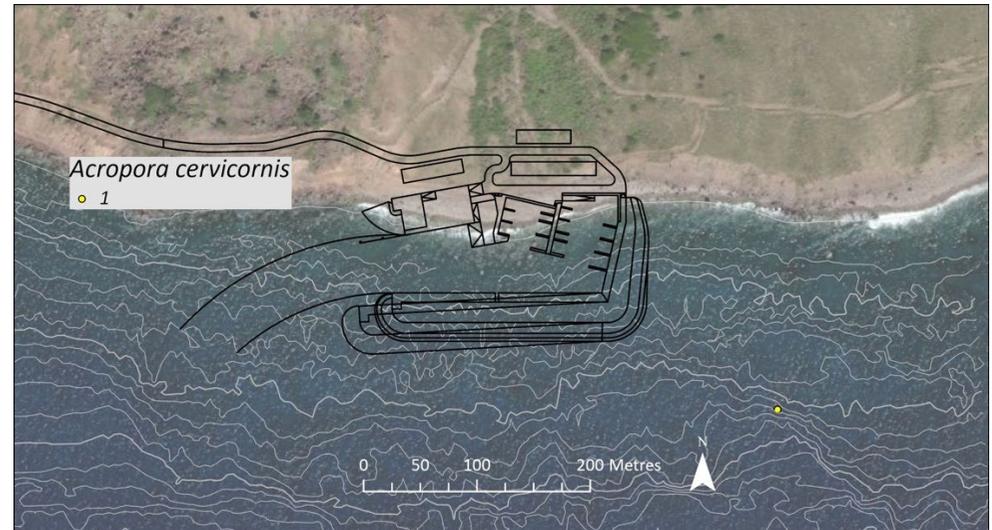
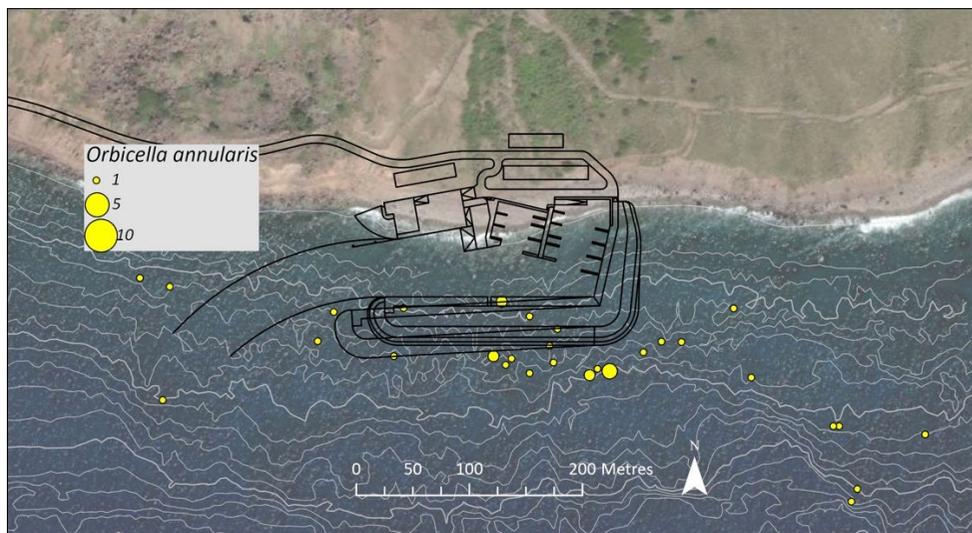
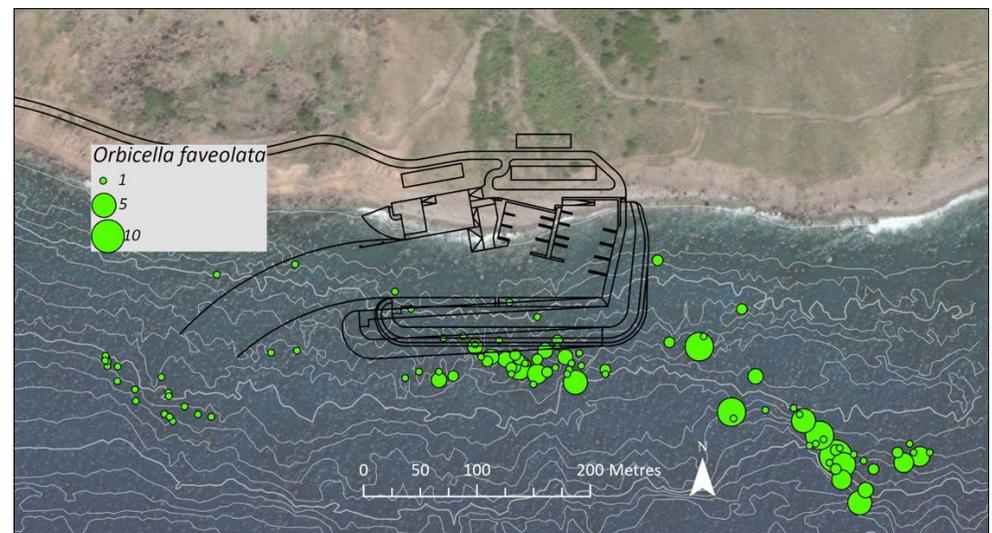
Figure 4.13 Distribution of colonies of protected species (dots give indication of numbers). SCF, February 2020

In figure 4.13 the locations of the colonies of these 4 species are mapped. The dimensions of the observed colonies (in cm x cm) and the coordinates of the colonies are summarized in annex 2b. As can be concluded from the annex and figure 4.13, a concentration of *A. palmata* is present in the footprint of the breakwater and the harbor approach channel. In this area also the largest specimens of *A. palmata* have been found. A second concentration of colonies of *A. palmata* is present just east of the projected breakwater.

In total 118 colonies of *Acropora palmata* have been counted in the 800x250m area. *A. cervicornis* is almost absent (1 colony southeast of the projected breakwater).

*M. annularis* (34 counted) is present in a small concentration in the footprint area, and a more significant concentration just south of the projected breakwater, while the distribution of *M. faveolata* (187 counted) is mainly in deeper waters (between 10 and 15m), south and southeast of the projected breakwater. *M. cavernosa* (not protected, vulnerable, 17 counted) is present in small concentrations in and near the footprint area and west of the projected breakwater. *D. cylindrus* (14 counted) is present near the projected approach channel and southeast of the breakwater. The latter 2 species are not indicated on the map in figure 4.13.

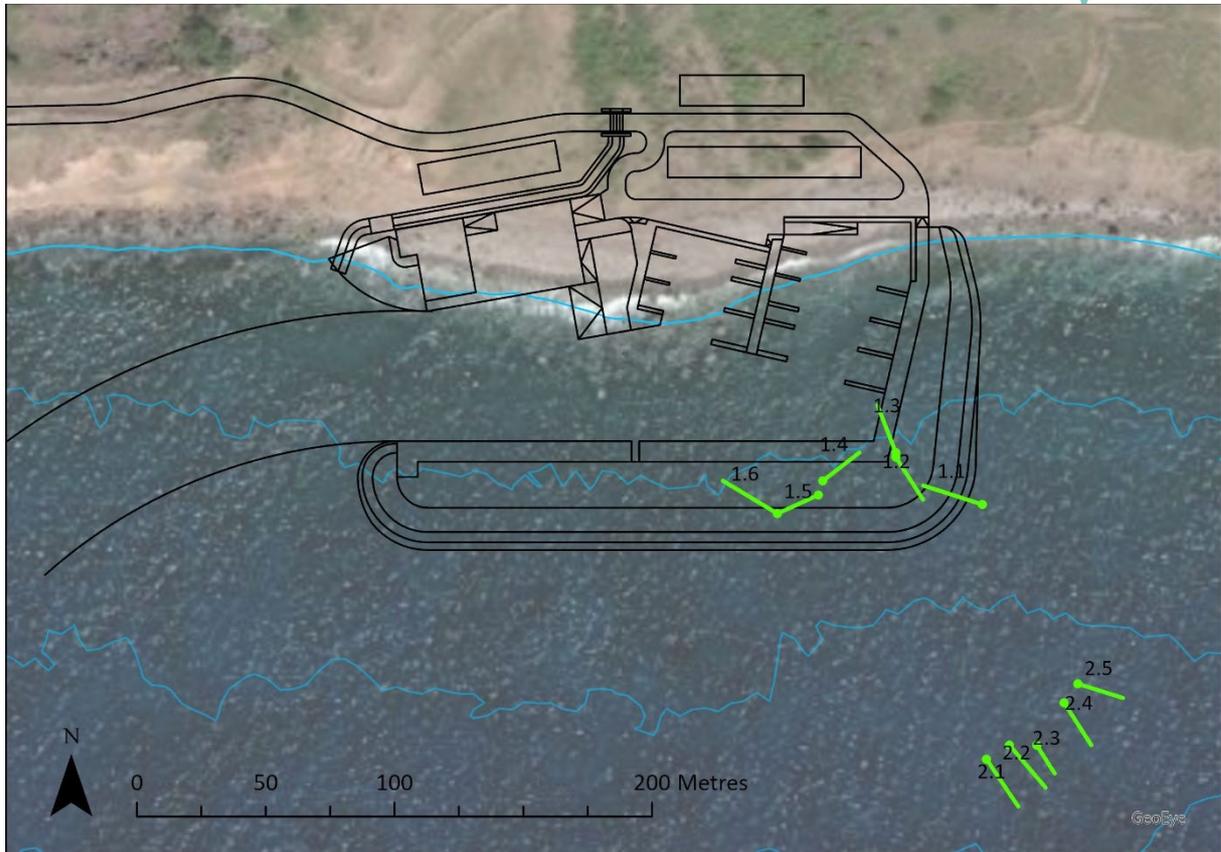
Figure 4.14: Location of transects (5 transects have been photographed in the area of 1.1-1.5 and 10 transects have been photographed in the area of 2.1-2.5)

Coral cover and occurrence of coral species were assessed by taking photoquadrats on 6 shallow water transects (4-7 meters, footprint of proposed breakwater) and 10 deeper water transects (10-15 meters, a nearby patch reef). In figure 4.14 the locations are mapped. The photographic output was analyzed with CPCe using 40 random points per photoquadrat.

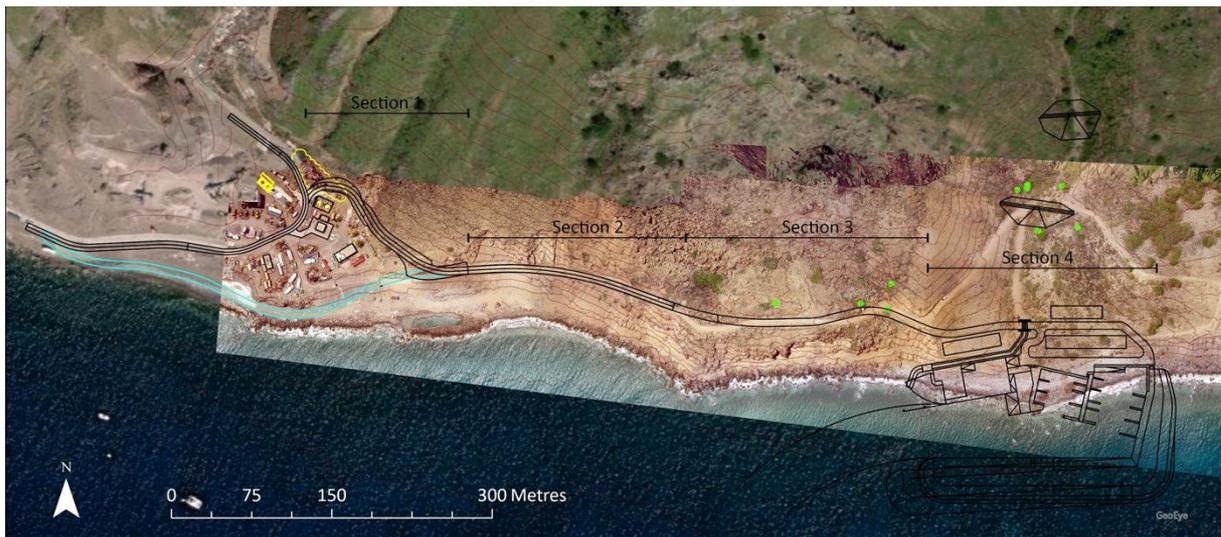
Figure 5.1: Sections 1-4 of new road. Road indicated in blue is the temporary road. Green dots: mature trees.

The access road to the proposed harbor will have a length of approximately 800 meters and a width of 7-8 meters. For a large part, approximately 500 meters (section 2 and 3), the construction of the access road takes place by renovation of an old unpaved road, which was partly collapsed. This part of the existing road is located in a heavily eroded area (section 2) and an area where a low growing vegetation is present, consisting of grass, low shrubs and a few trees (section 3 and 4).

The first section of the new access road of approximately 150 meters (near the gas station) and the last 150 meters (near the harbor area, section 4) are to be constructed as new, partly in the natural landscape. A stretch of approximately 350 meters along the coast serves as a temporary road, needed for construction (see chapter 3).

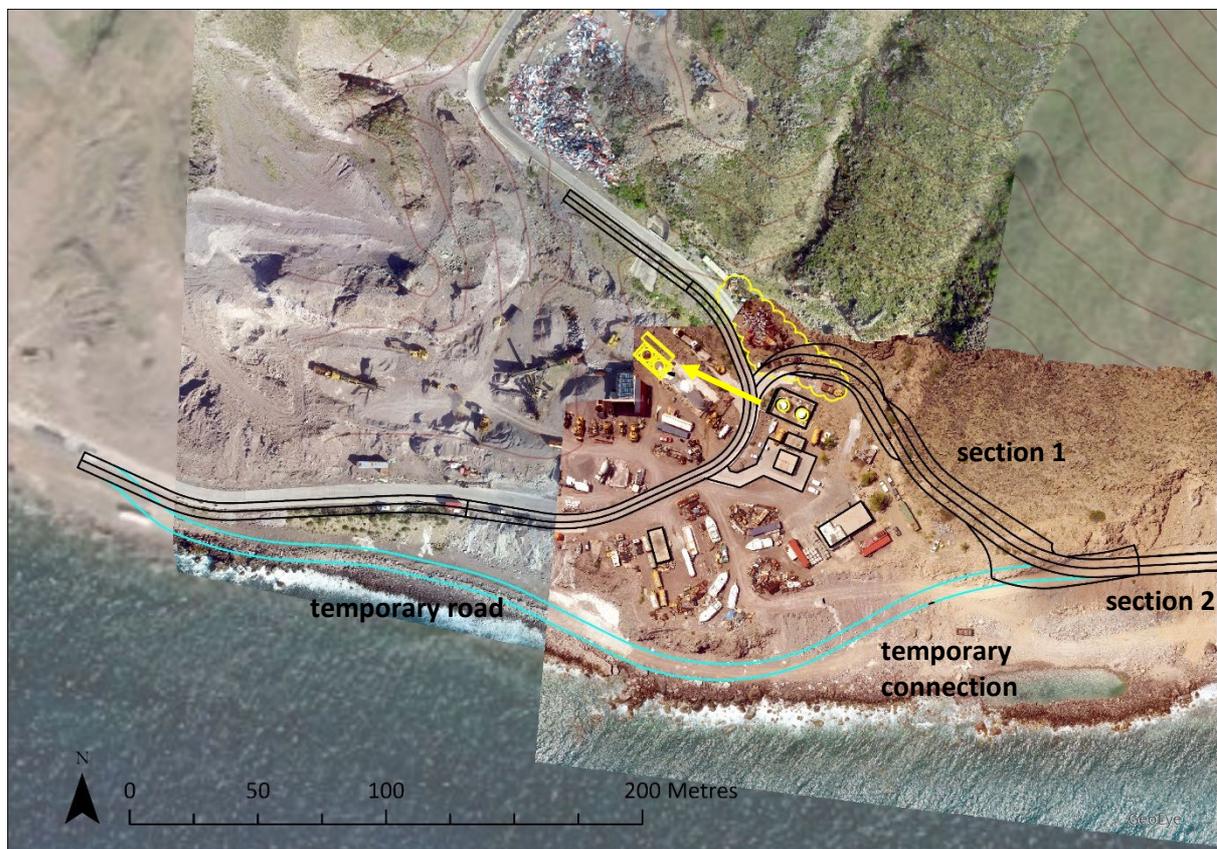
Figure 5.2: Temporary road with connection, in blue color. Main road (section 1 and 2). Yellow arrow: relocation of gasoline and diesel tanks before construction of section. Yellow area: scrap yard.

The temporary connection between the current harbour road and the main road to the Black Rocks area is a 350 meters section, projected in the direct vicinity of the coastline, which is mostly flat land. For the large part, this section follows an existing, unpaved road of 3m wide (see figure 5.2 and 5.3),

The final connection between the current harbour road to the Black Rocks area, which is an entirely new section of 150 meters, passes just north of the gas station (figure 5.2). As stated in chapter 3, the fuel tanks of the gas station need to be relocated to realize this connection. The environmental impact of this relocation is not in the scope of this EIA.

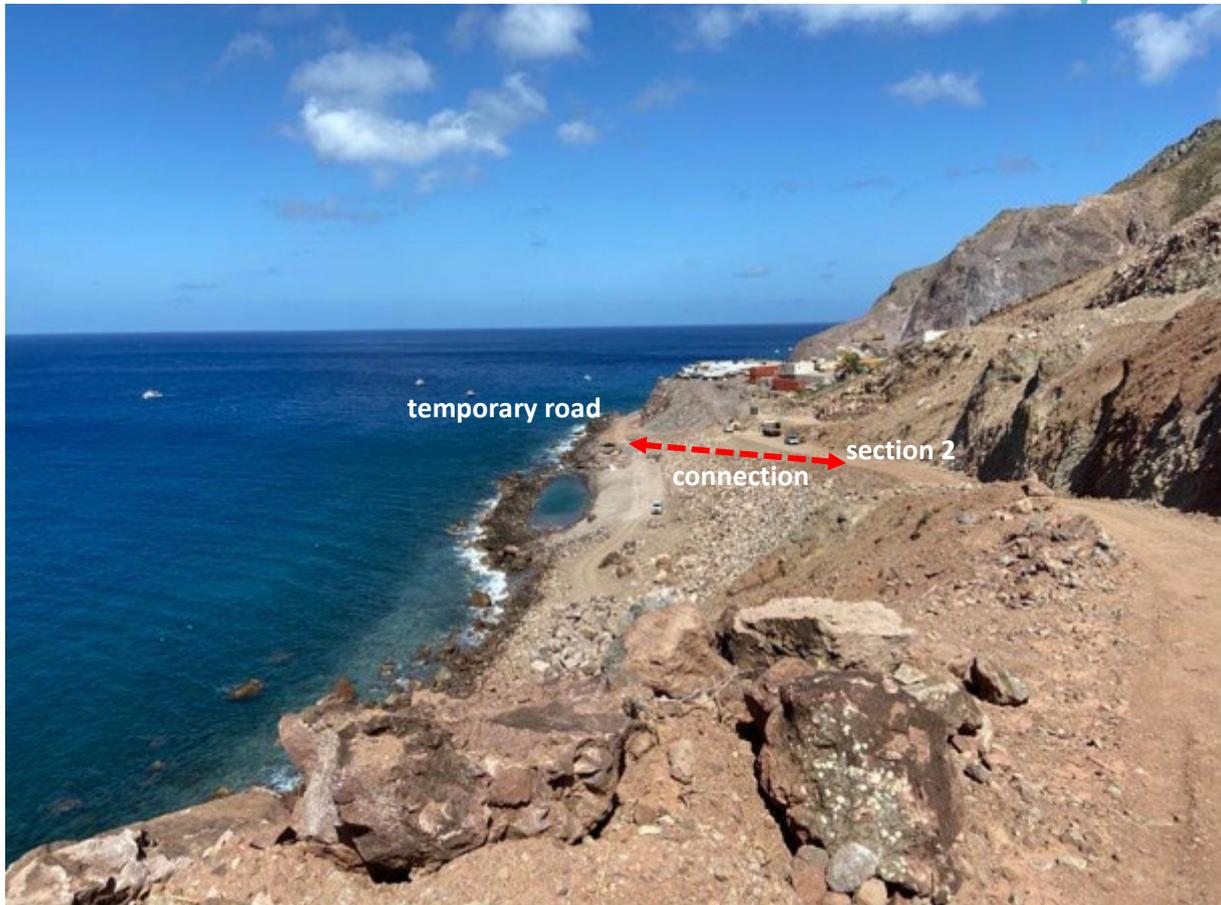
Figure 5.3: Temporary road, main road (section 2) and temporary connection

which needs to be widened to approximately 4 meters. In the east part of this section, a connection will be made between the temporary road and the main road. At this point, the hillside is severely degraded, there are several locations where rocks have been dumped (see figure 5.3). In this steeper area, profiling of the hillside is necessary to create space for the road-connection (approximately 5 meters on both sides of the road for 50 meters). The footprint is entirely in bare rock, ecologically important elements were not observed in this part of the footprint.

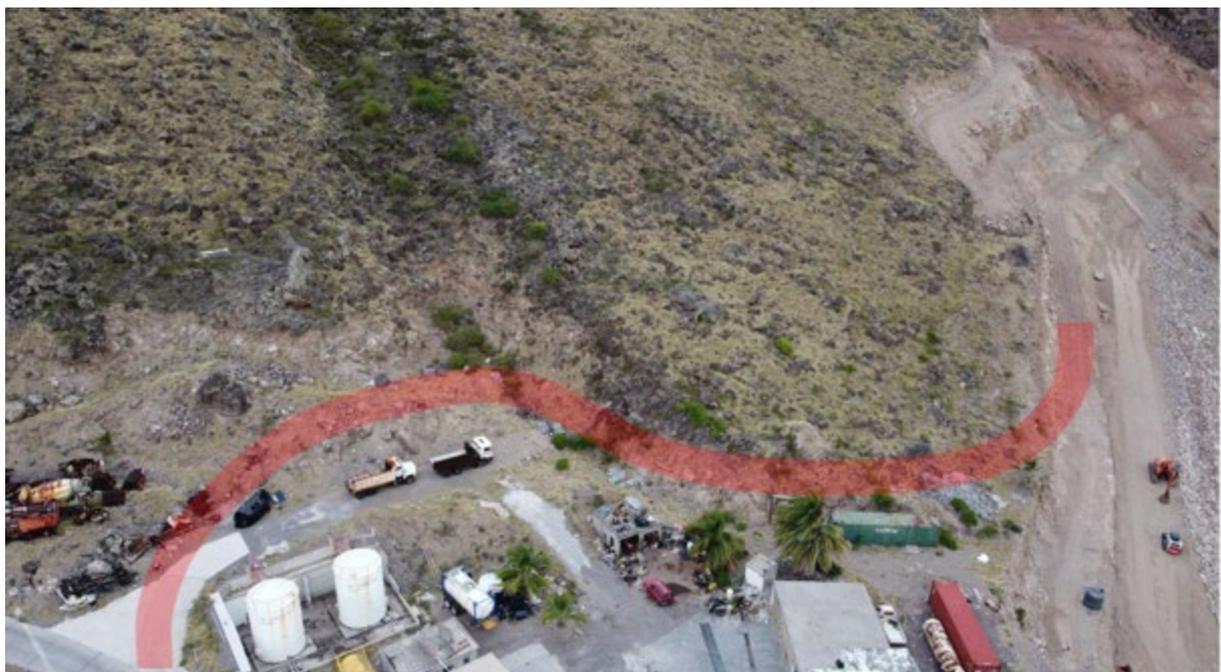
Figure 5.4: Main road section 1, partly through scrap yard and partly through hill vegetation

The road connection partly runs through a current scrap yard, that will be removed and partly through an intact part of the hillside (see figure 5.4 and 5.5). The road will have a width of 7-8 meters. About 4 meters on north-east side and virtually zero on the other side are needed for profiling of the hillside (total width of footprint: 18m). The hill in the east part of section 1 can best be characterized as grass land (main species: *Aristida adscensionis* and *Bothriochloa pertusa*) with few flowering species (mainly *Pentalinon luteum*, hammock viper's tail) interspersed. Ecologically important elements such as high trees have not been observed in the footprint.

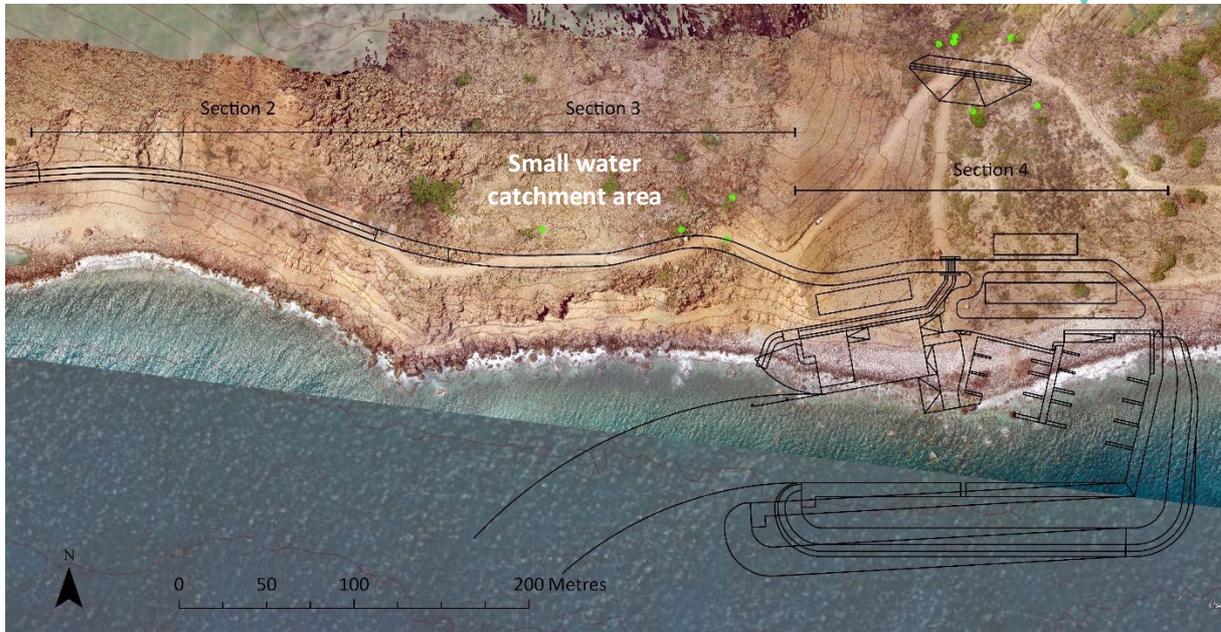
Figure 5.6: Main road to Black Rocks area (sections 2, 3 and 4). Green dots are mature trees

Just north of the projected road, a natural depression in the landscape occurs. This area has both ecological importance and hydrological importance. It functions as a (small) catchment area for storm water and several large mature trees are present (see figure 5.6). This area should be excluded from the footprint and kept intact as much as possible.

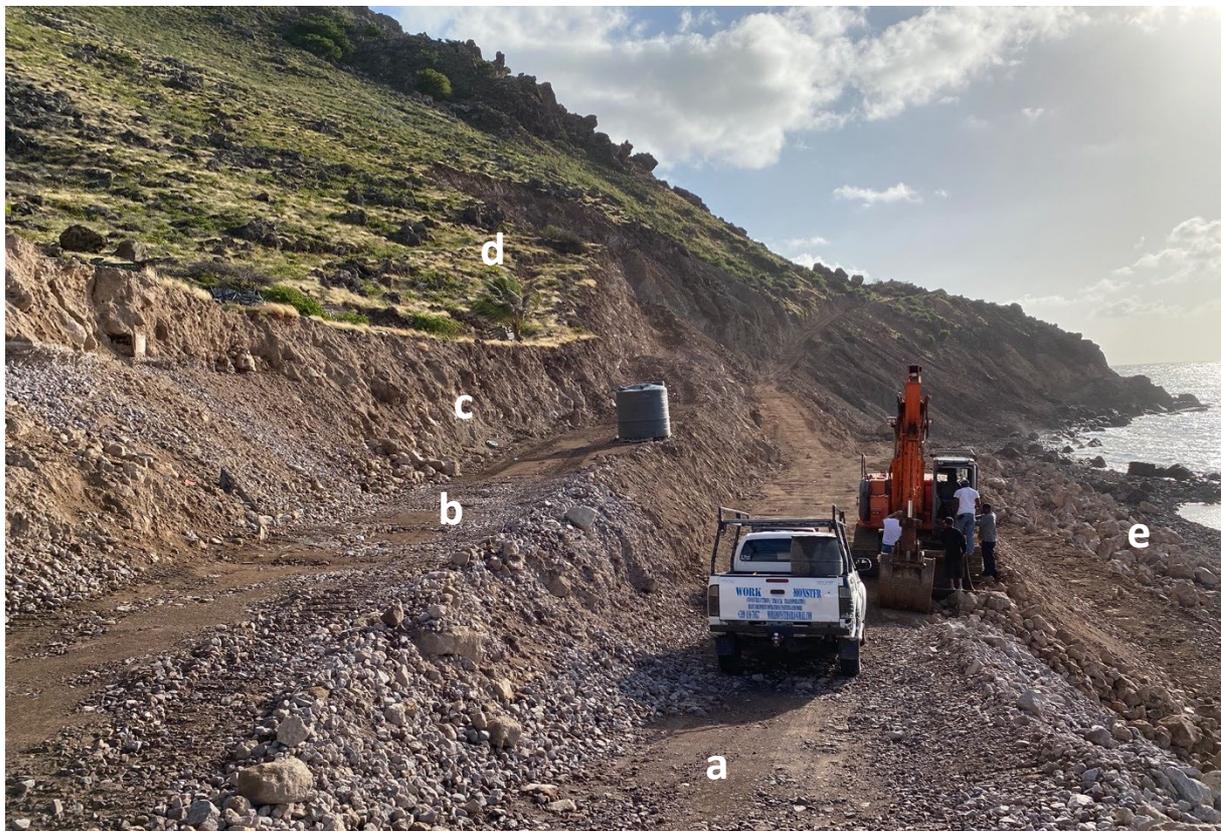
Figure 5.7: Section 2: Existing unpaved road (a), safety bench (b), hillside profiling (c). (d): part of the vegetation that still needs to be cleared. In the right part of the picture, near the shore line, the construction of the rock revetment is visible (e).

Section 2 (225 meters long) is the section where the road crosses the steepest part of the hillside (steepness of road 13-16%). In this area most benching and slope-profiling need to take place. Figure 5.8 (cross section) shows that the total footprint of the road and slope profiling in this part is approximately 30-50 meters wide (horizontally), which includes a safety bench of 6-8 meters wide. This part of the footprint is in a heavily eroded environment. South of the road vegetation is virtually absent. North of the road a secondary grass and shrub vegetation is present. Part of this vegetation was already removed in earlier construction activities, part of this vegetation still needs to be cleared for profiling of the slope of the hill (see figure 5.7). As can be seen in figure 5.7 construction in this section already started.

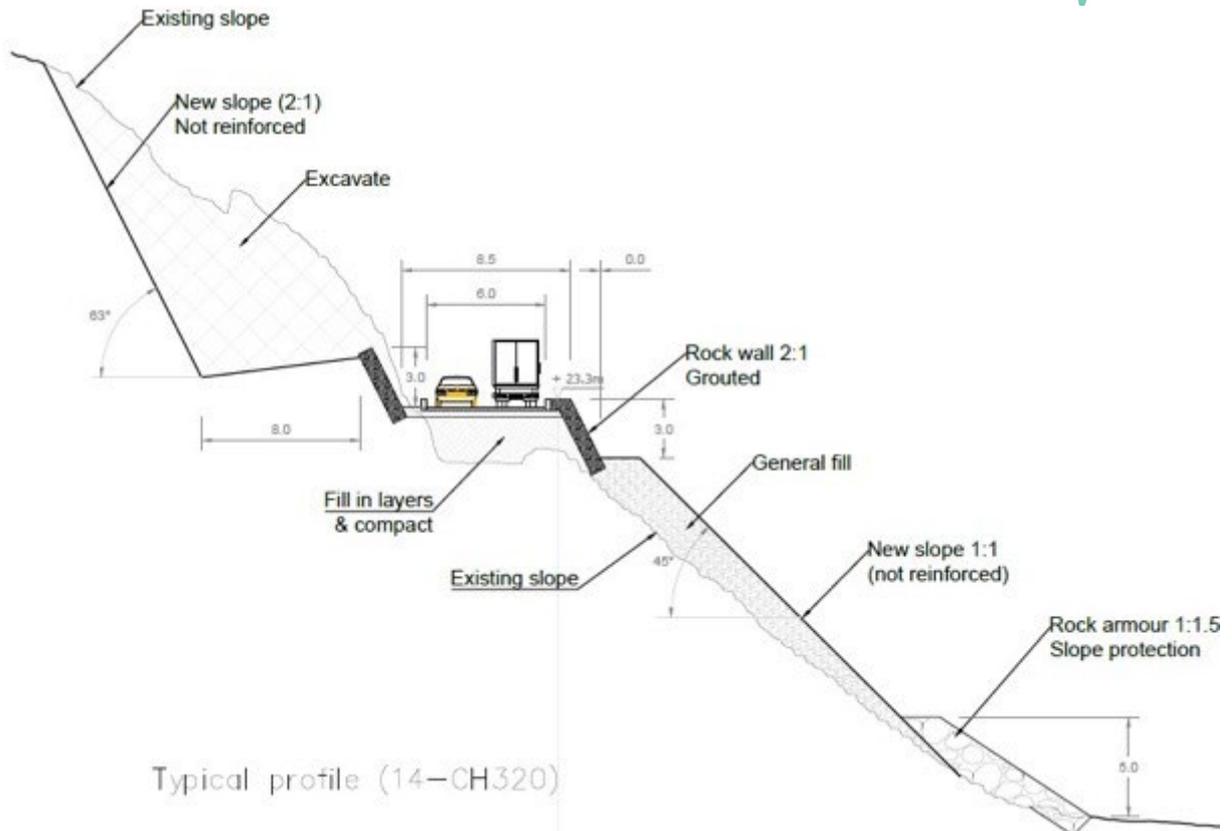
Figure 5.8: Section 2, cross section

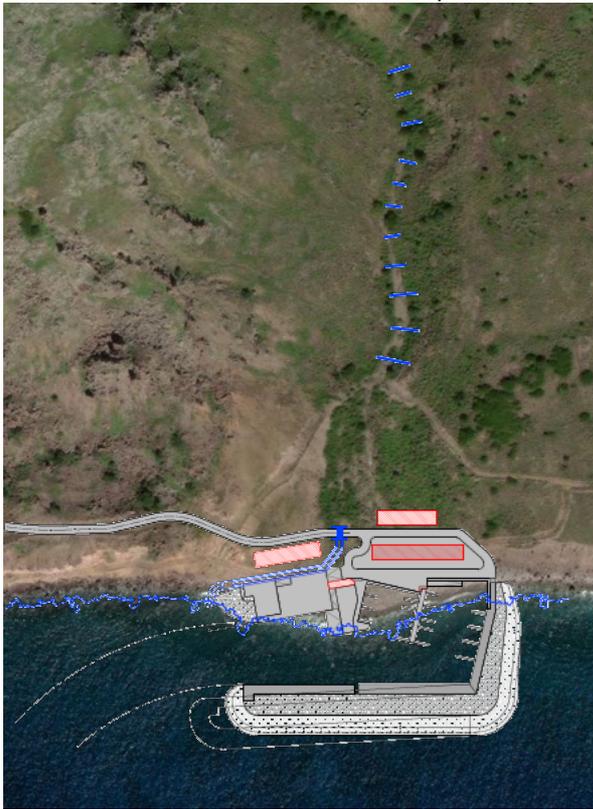
Figure 5.13: Footprint of landside part of harbor and weirs for storm water management

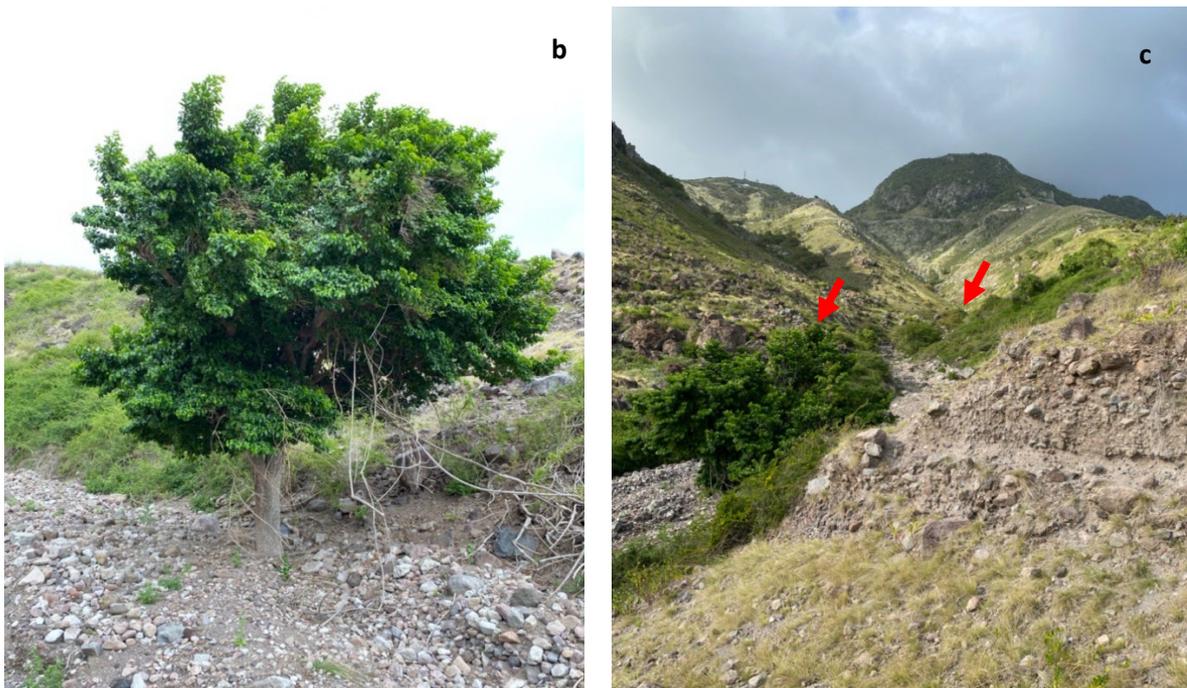
Figure 5.14: a. Dense vegetation in Compagnie's Gutter; b. tree that needs to be worked around (species unidentified); c. Trees that need to be worked around (left arrow) and shrub vegetation with small trees in the gut (right arrow)

Figure 5.14 presents pictures of some nature elements, mainly trees, which are in the area where the weirs will be built. The weirs will be positioned in such a way that no trees need to be removed.

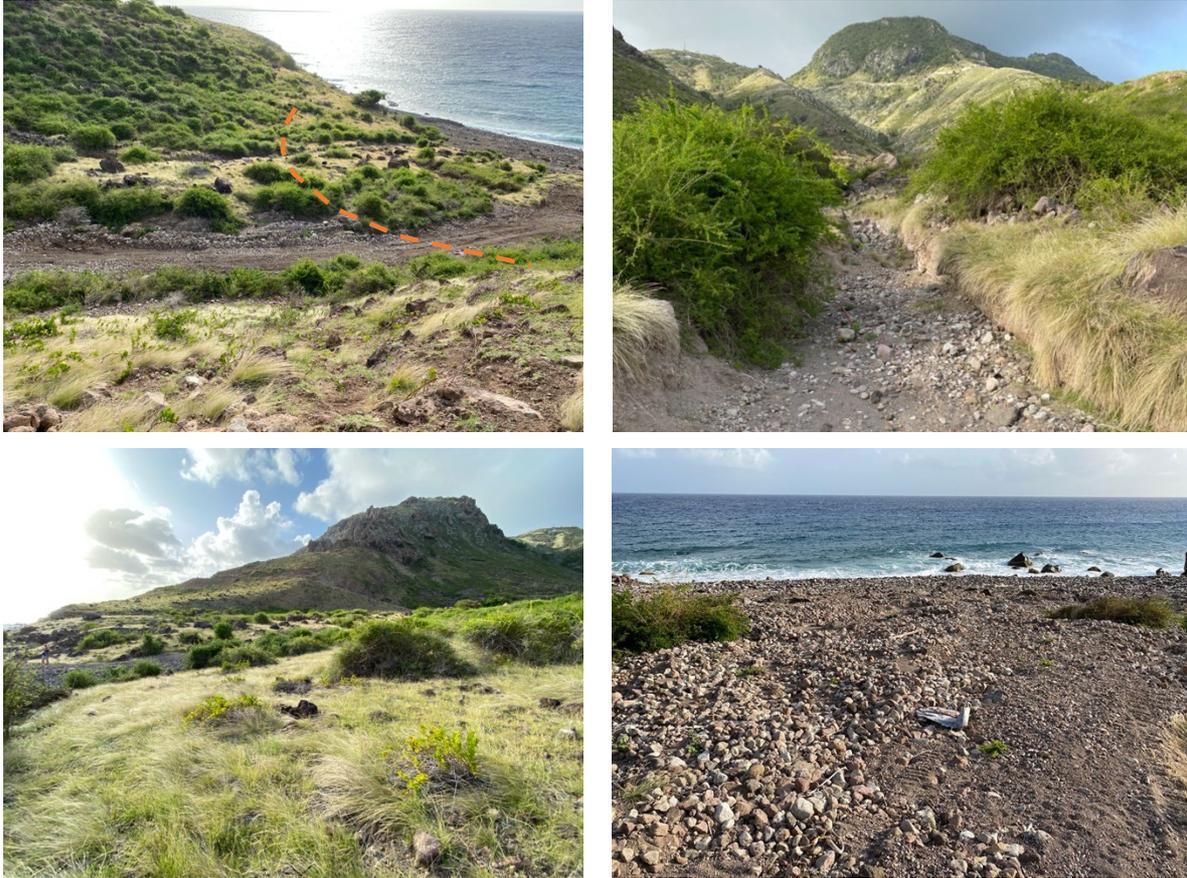
Figure 5.15: Current situation in footprint future harbor Top left: view from west side, with indication of footprint of harbor area. Top right: Lower parts of gutter, which will lose its hydrological function in the future. Bottom left: view from east side (in footprint). Bottom right: natural cobble beach

Figure 5.15 gives an overview of the nature elements present in the footprint of the harbor area, that will be impacted or need to be removed.

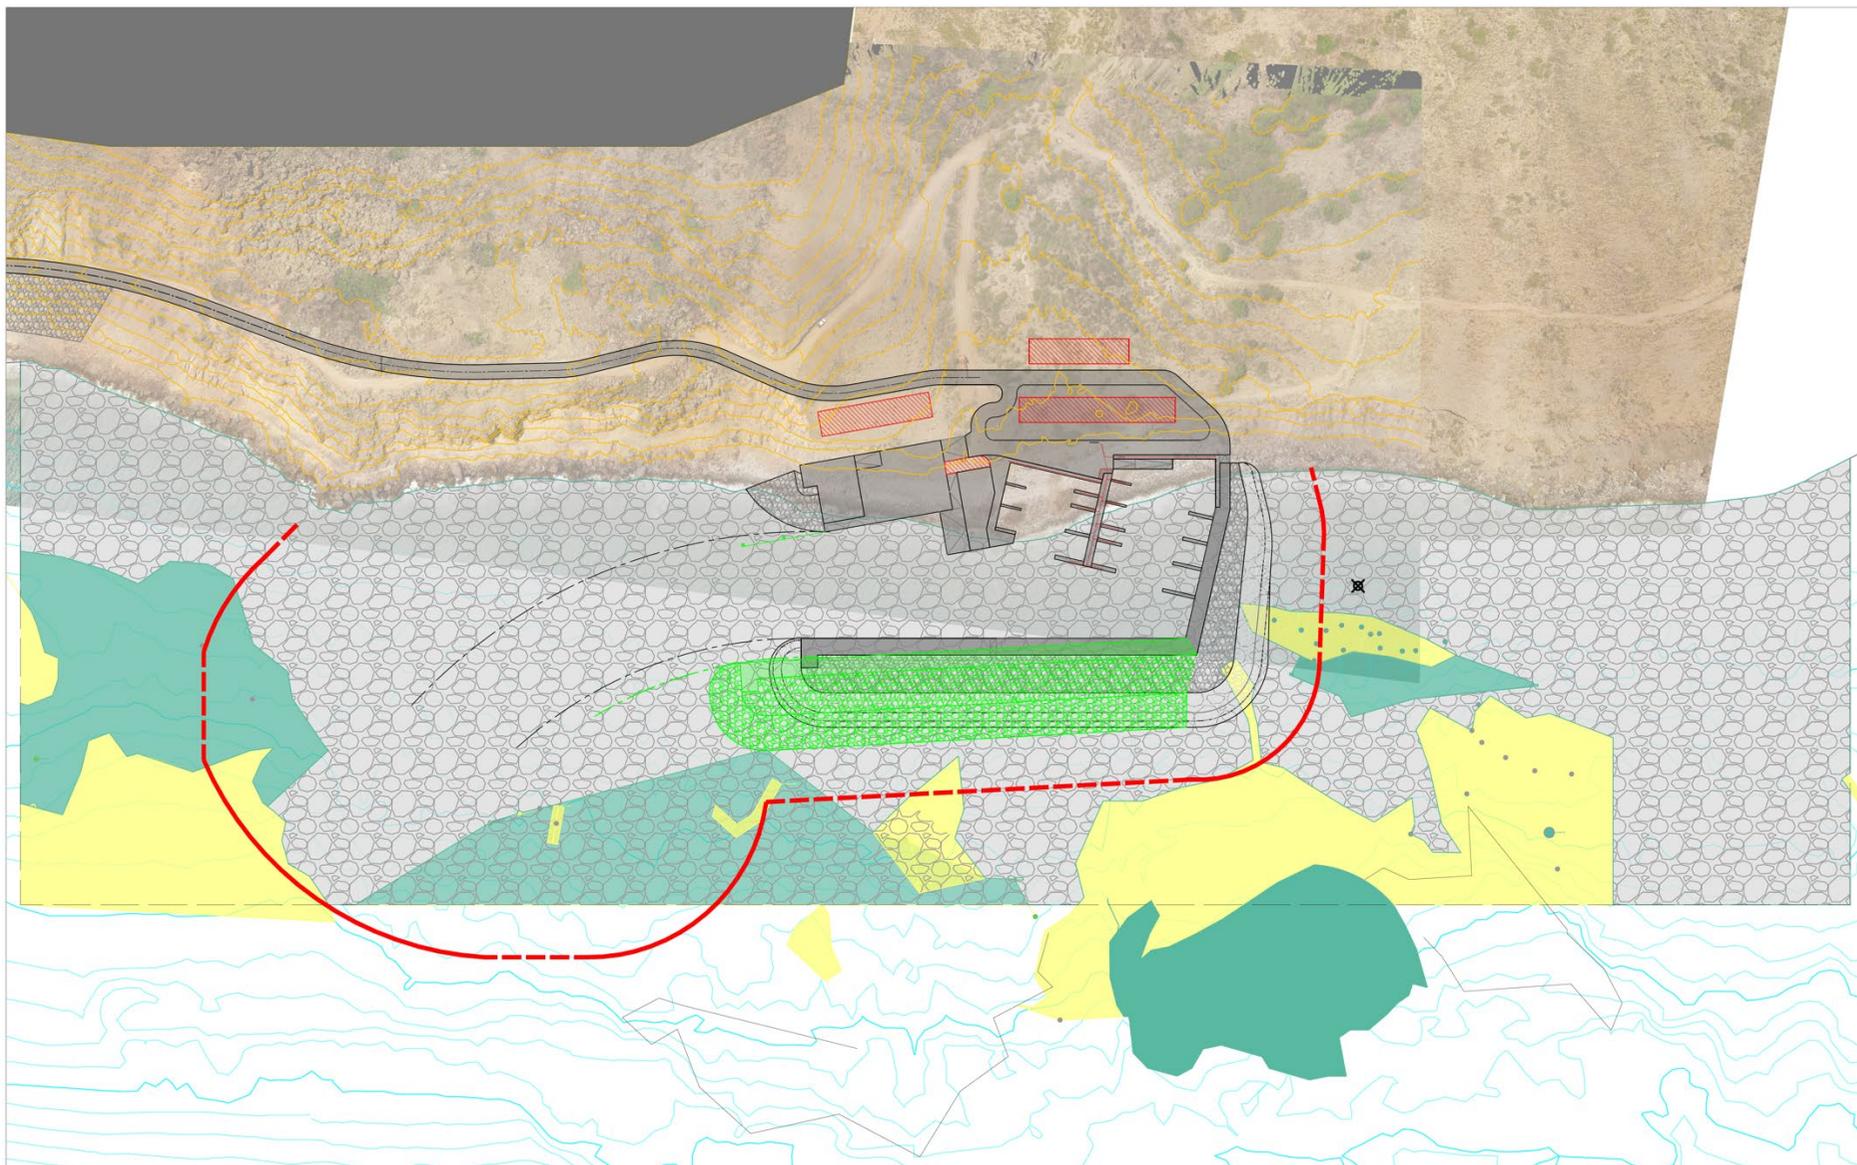
Figure 5.16: Footprint including high-risk zone of harbor in relationship to seafloor cover and patch reefs

Corals impacted by reduced current velocity and wave action are located in the area of the footprint and high-risk zone for a large part (see also figures 5.16 and 5.17). Protected corals of the *Orbicella* and *Acropora* genera will be removed from this zone to a safer area.

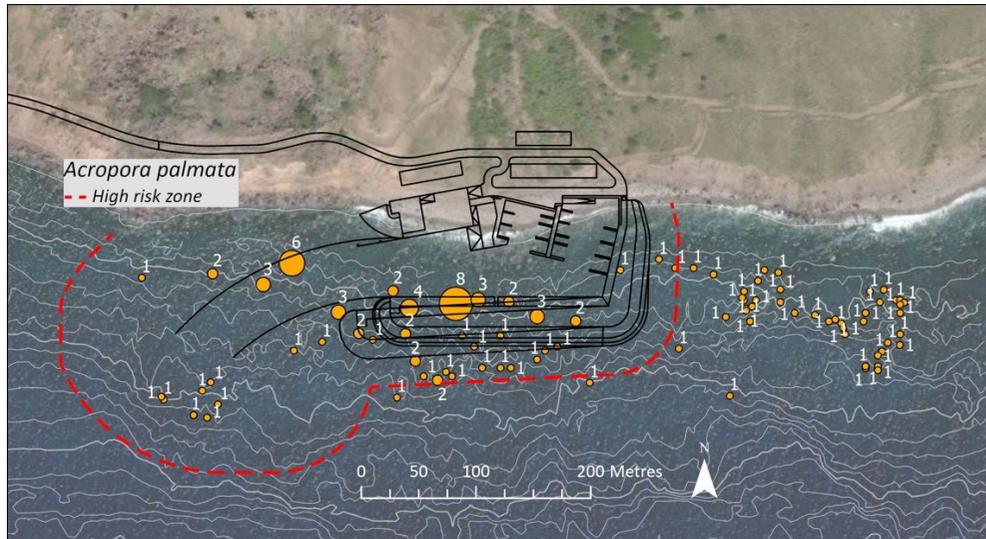
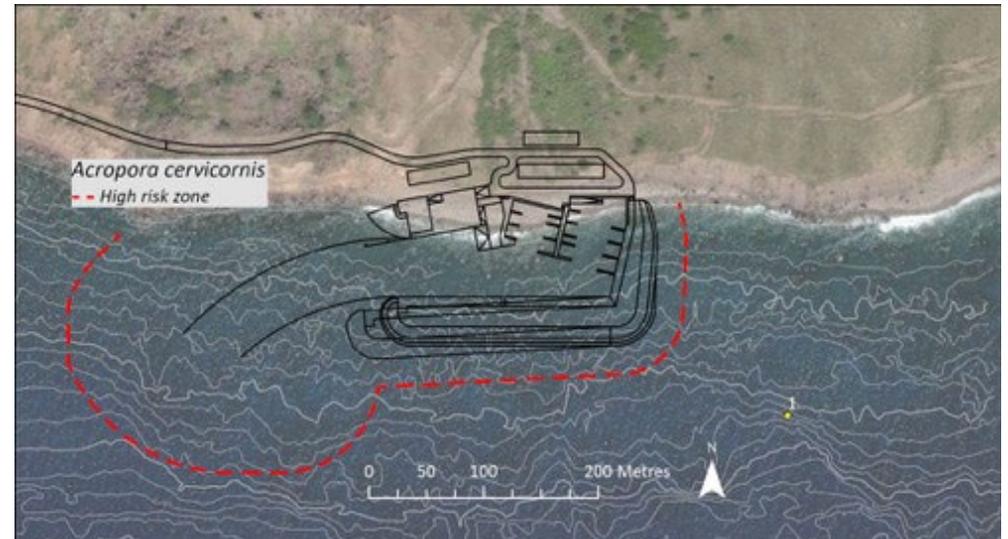
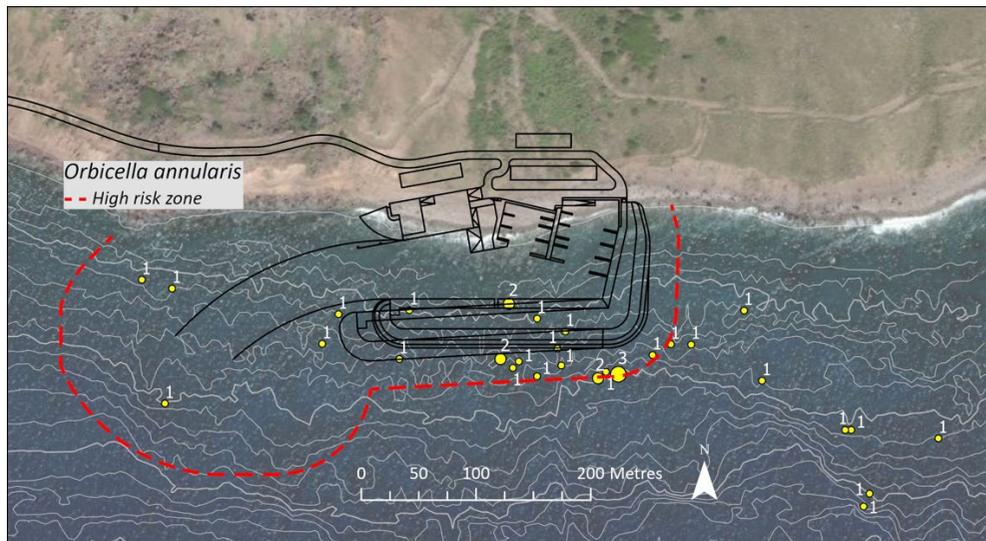
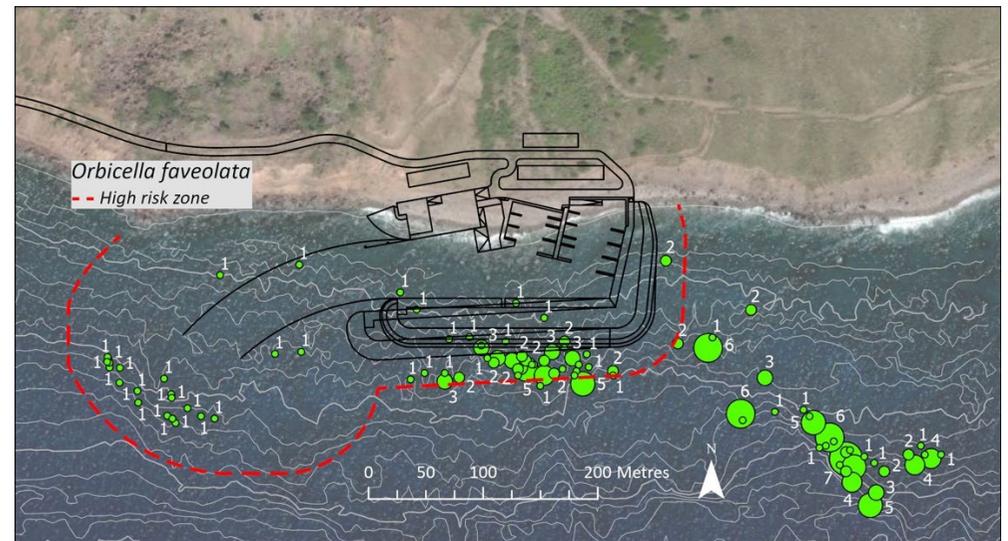
Figure 5.17 Distribution of protected and important (vulnerable) coral colonies

Figure 5.17 shows the protected corals (colonies) that are within the footprint including the high-risk zone. In this area 72 colonies of *Acropora palmata* were found, 26 colonies of *Montastraea annularis*, and 100 colonies of *Montastraea faveolata* (see also table 5.4 and annex 2b). *Acropora cervicornis* was not observed in the high-risk zone. These numbers correspond to the worst-case situation (choice of a berm breakwater). If the cofferdam structure would be chosen instead of the berm breakwater, the footprint would be significantly narrower leading to the loss of less colonies, especially of the *Orbicella* and *Acropora* genus. In that case, 102 less colonies of protected species will be lost in the footprint and high-risk area and need to be removed to another location (see table 5.4). In case of the caisson structure this will be 46 less corals in the footprint that need to be removed.

The area just west of the breakwater, which is currently the habitat of a cluster of *A. palmata* (see figure 5.17) will be unsuitable for this species in the future, because of the combination of a new sediment source (outlet from weirs), reduced current and reduced wave-action.

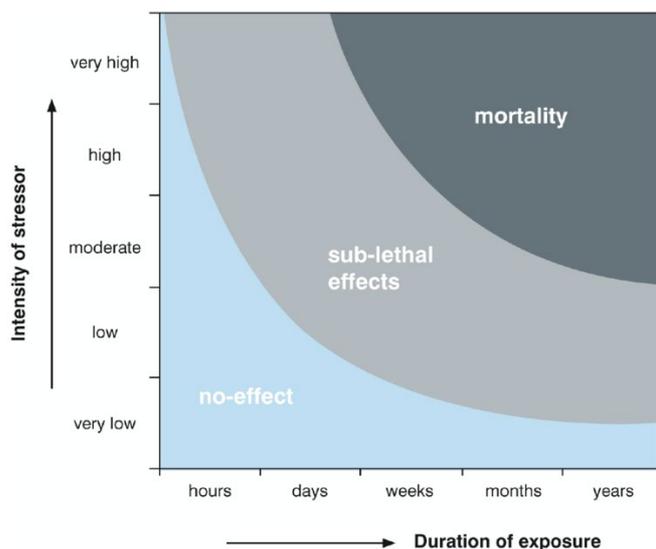
Figure 6.1: General relationship between the magnitude of an increase in turbidity or sedimentation above background levels (vertical axis), how long it lasts (horizontal axis) and the onset of (sub)lethal effects on corals. Actual thresholds will vary by location, sediment properties (e.g. grain-size) and the sensitivity of the coral species (from: Erftemeijer et al, 2012).

Figure 6.1 indicates the general relationship between the intensity and duration of a stress event (such as turbidity, light reduction and sedimentation) and the risk of sublethal and lethal effects on corals. Sublethal effects can include reduced growth, lower calcification rates, reduced productivity, bleaching, increased susceptibility to diseases, physical damage to coral tissue and reef structures (breaking, abrasion), and reduced regeneration from tissue damage (Erftemeijer, 2012).
