**Report:**

**Environmental Impact Assessment  
(EIA) for the harbor construction at  
Black Rocks, Saba**

Final report

June, 2022

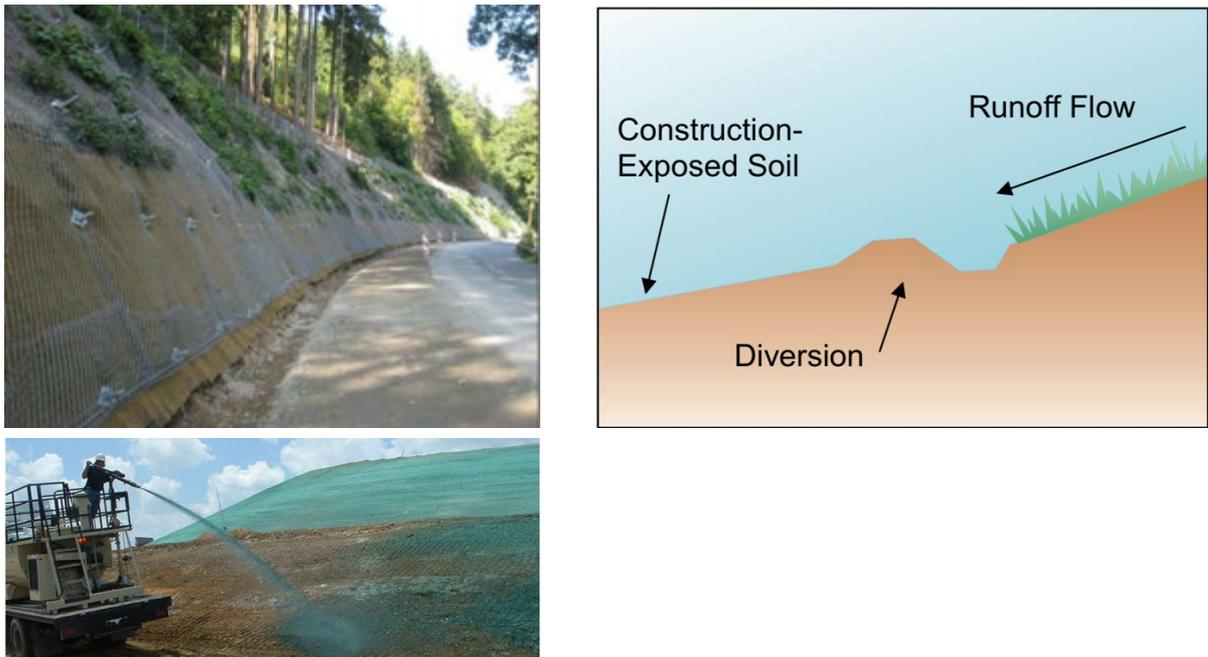
Figure 6.2: Left: example of anchored mesh system with netting of organic materials. Top right: example drainage interceptor ditch. Bottom: example of hydroseeding with wood mulch.

**Slope stabilization** can take place by means of rock anchors, wire mesh and netting (see figure 6.2, left). Rock anchors will be installed in a 2m x 2m grid (length of bolts: 50cm). These anchors will support a steel mesh and netting, preferably a biodegradable netting or blankets such as jute or coir. Installation of anchors will be done by drilling into the rock and filling the drilling hole with the anchor bolt and with grout for solid attachment. While reducing runoff velocity and keeping loose soil and rocks in place, the mesh and netting structure also optimize microclimate (mainly temperatures and moisture) for germination. In extremely steep areas (steeper than 1:1 H:V), confinement methods such as wire mesh confinement of cellular confinement may be considered. These methods also allow for the retainment of some soil.

When the slopes are steep as in the case of the flanks of St. Johns Hill, it is recommended to apply active seeding not as a single process, but in combination with slope stabilization. Figure 6.2 (bottom) shows an example of hydroseeding.

**Drainage:** Storm water will be diverted from the scarred part of the slope, by means of a drainage interceptor ditches along the contours of the hillside. For a graphical principle sketch of a drainage interceptor ditch, see figure 6.2, top right. In case of forecasted heavy rains during the construction works, the use of silt barriers (e.g. silt fences or straw bales) is advised.

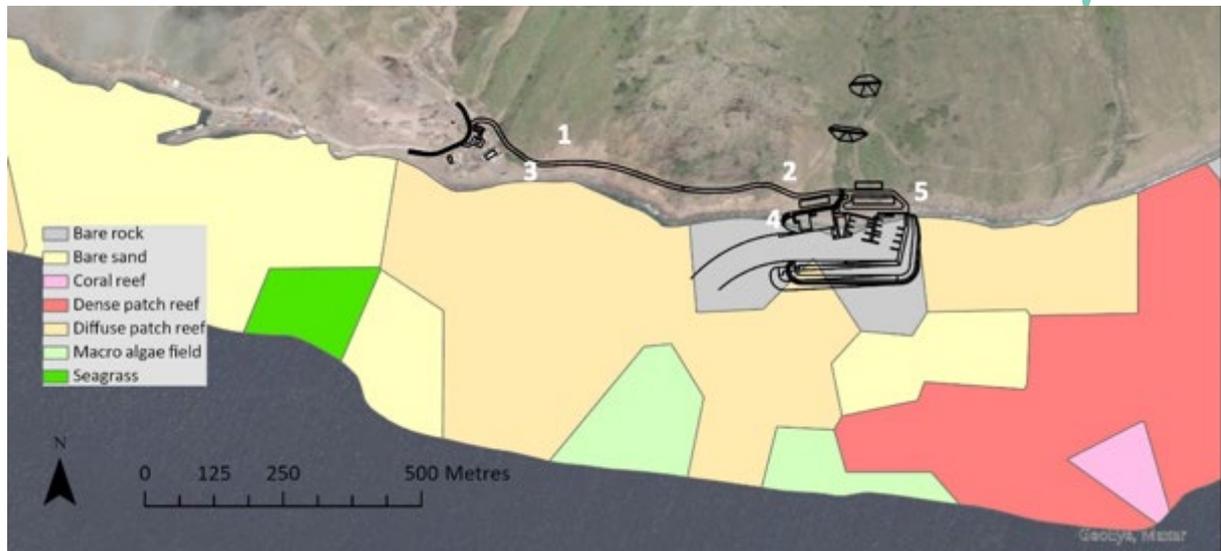
Figure 6.3: Marine nature values near critical construction sites with respect to erosion and sedimentation: 1: section 2 of access road; (2) section 4 of access road; (3) rock revetment; (4) outfall from gabion weirs; (5) landside of harbour area. Source base map: Kuramae et al, 2013

Water management in this figure is based on an earlier design with dams instead of gabion weirs.

The area's most prone to erosion are section 2 and section 4 of the access road, where slopes are particularly steep (see figures 5.1 and 5.11). In this area a rock-revetment to the south side of the road was installed to prevent further erosion by wave action. The marine area with highest expected impact is the area just south of this area, which is an area where relatively valuable "diffuse patch reefs" occur (see figure 6.3). A small seagrass bed in this area (see figure 6.3) will also be impacted by terrestrial sediments.

Separate analysis (not presented in tables 6.16 and 6.17) points out that the dense patch reefs, present east and southeast of reef 4 (see figure 6.3 in paragraph 6.3), are not impacted in any significant way by dredging, because of their presence at greater distance from the source (more than 200 meters south and eastward).

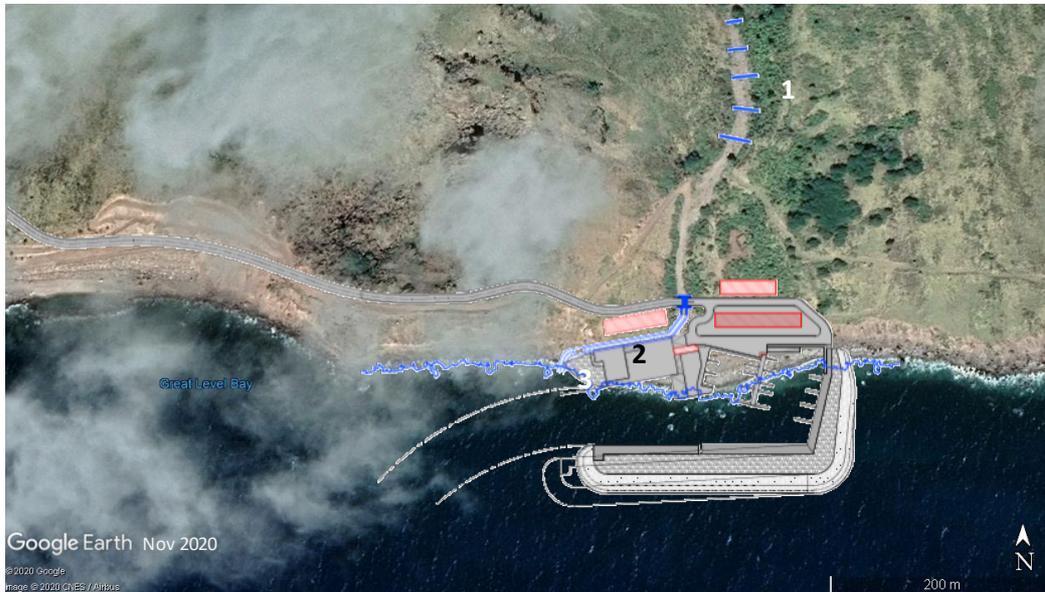
Figure 6.4: Discharge of runoff from weirs: 1. weirs; 2. discharge channel (run-off); 3. Outlet

Run-off from the weirs will enter the sea just west of the breakwater (see figure 6.4), in an area protected from the main currents and waves by the breakwater. In this area circulation of seawater will be considerably less than in the current situation without a breakwater (see also chapter 7). The impacted area can be characterized as an area covered with bare rock and relatively low coral cover (1,6%, see chapter 4), but the area is rich in protected elkhorn coral (*Acropora palmata*, see figure 5.17). Since these colonies are in the high-risk zone, they will be removed from the area before construction of the harbor.

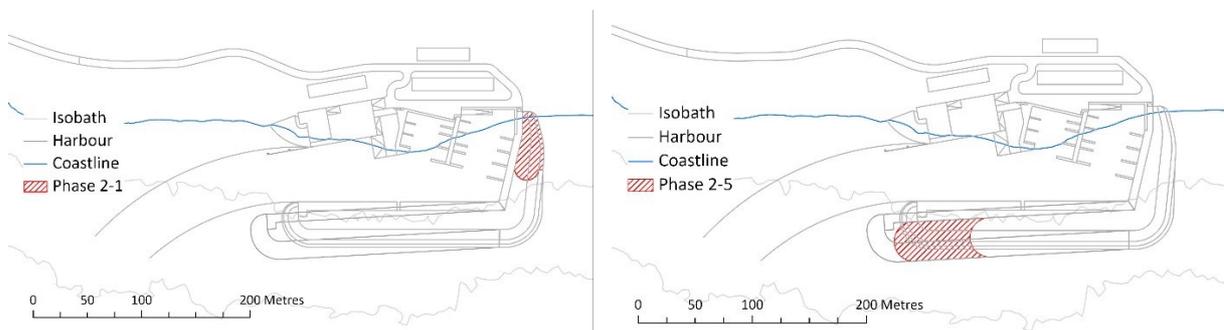
Figure 6.5 Two critical phases of construction used for quantitative impact assessment (phase 2.1 to the left and 2.5 to the right, indicated by hatched part of the breakwater)

- Phase 2.1. Beginning of construction of breakwater (core material, quarry run); no breakwater structure (yet) in place. Placement of aggregates in open, shallow water by means of excavators. Several patch reefs nearby, especially patch reef nr. 4 (see figures 6.5 and 6.6). The duration of phase 2.1 is 2,5 weeks (net construction time, hydraulically modelled) to 10 weeks (gross construction time, not modelled).
- Phase 2.5. Final parts of construction. Placement of core material (quarry run) for breakwater and backfilling for main quay. Breakwater structure largely in place with hydraulic impact on currents and dispersion. Several patch reefs nearby (especially patch reef 2, see figures 6.5 and 6.6). The duration of phase 2.5 is 2,5 weeks (net construction time, modelled) to 10 weeks (gross construction time, not modelled).

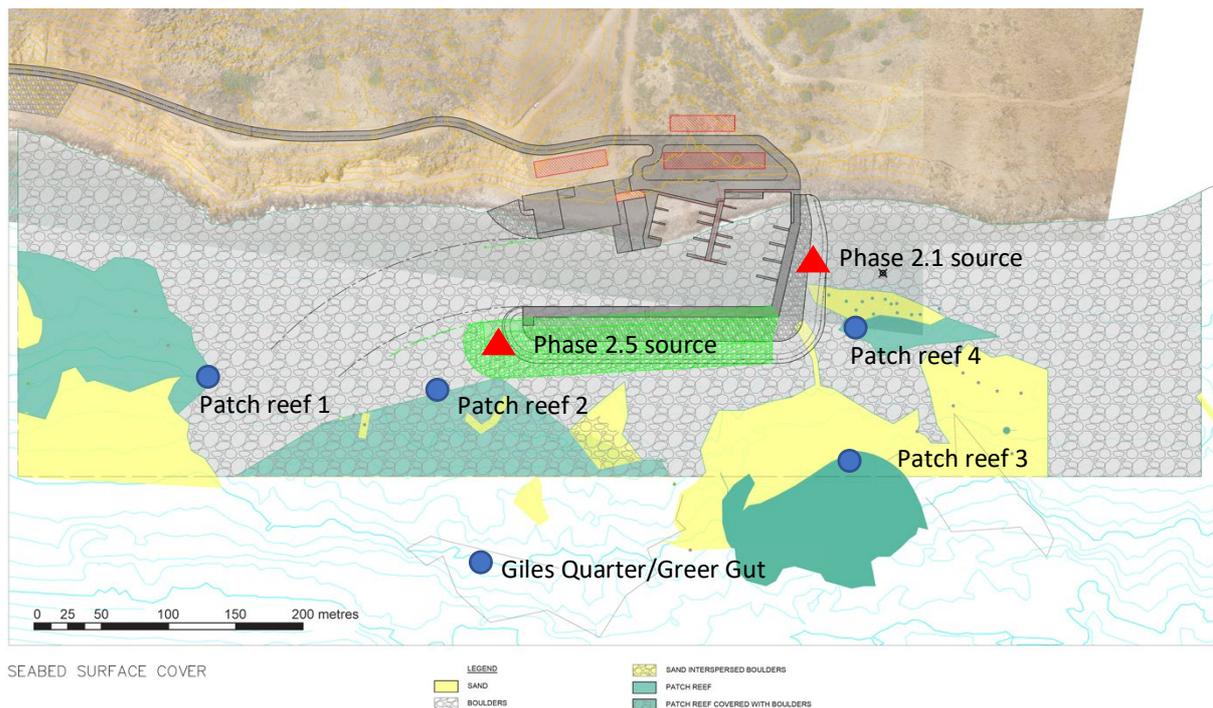
Figure 6.6: Modelled locations of placement of aggregates and calculation points for the 4 patch reefs and the Giles Quarter/Greer Gut dive site.

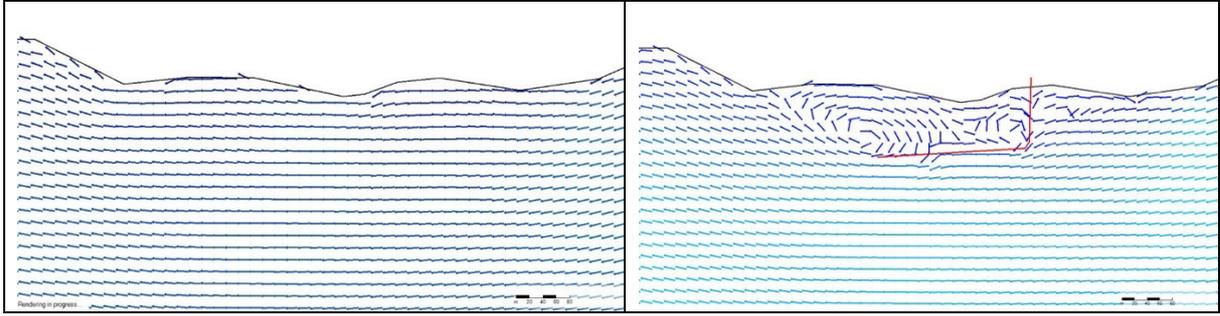
Figure 6.7 Current pattern (predominant) without the breakwater structure (phase 2.1) and with the breakwater structure in place (phase 2.5)

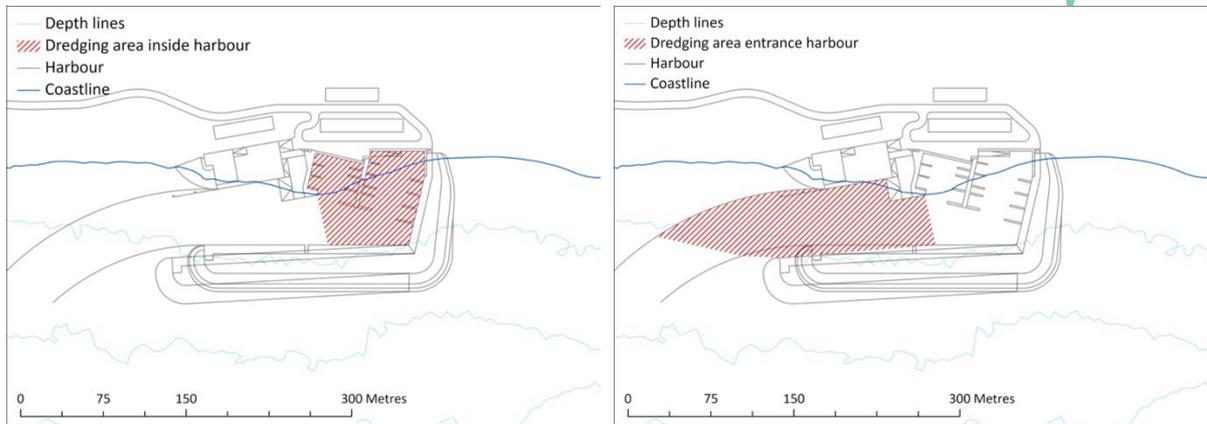
Figure 6.8 Dredging area east part of harbor (phase 1, left) and west part of harbor including approach channel (phase 2, right)

Another reason for the low values at reef 1 (during phase 2.5 of construction) may be that the breakwater - in this stage almost completed - creates a vortex-like counter current just west of the breakwater, causing the plume to bend in a northward direction (see figure 6.8).

- Phase 1: Dredging of east basin (see figure 6.8). Dredged volume: 20.000 m<sup>3</sup>. The breakwater structure is fully in place. Sample BH3 is representative for the sediment characteristics (annex 3 and 4). Dredged material contains a maximum of 33% of fines (<63µm, see annex 4). Dredging is modelled with and without silt screen. Duration of dredging in phase 1 is 8 weeks. Since dredging starts when the breakwater structure is fully in place, patch reefs 1 and 2 are most near to the source of sediments (see figures 6.9 and 6.10).

- Phase 2: Dredging of western parts of harbor basin and approach channel (see figure 6.9). Dredged volume: 10.000 m<sup>3</sup>. Sediments of B3, B7 and B9 (figure 4.3 of this report and annex 4) are representative for the dredged material (and assumed to contribute to suspended fines equally). Dredged material contains 13% of fines (<63µm). Dredging takes place without a silt screen; conditions for using a silt screen are not adequate, because of waves and currents in the area. The duration of phase 2 is 4 weeks. Patch reefs 1 and 2 are the reefs most near to the source of sediments (see figures 6.8 and 6.9).

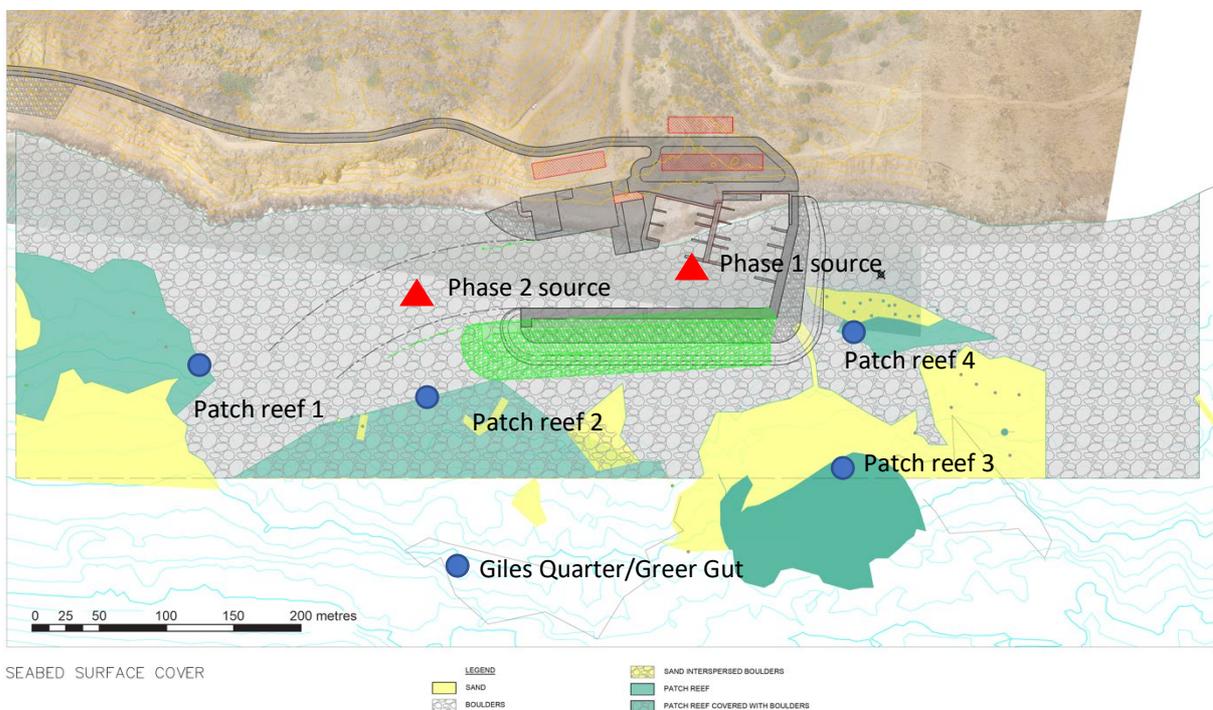
Figure 6.9: Modelled source locations of dredging and calculation points for the 4 patch reefs and Giles Quarter/Greer Gut

important (see mitigating measures). This is especially true for the situation with respect to reef 1 and 2 during dredging of the approach channel (see also figure 6.9).

The official dive sites of Giles Quarter and Greer Gut, located approximately 150m to the south of the breakwater (figure 6.9), are not considered to be in the critical zone with respect to deposition of fine sediments and SSCs during dredging.

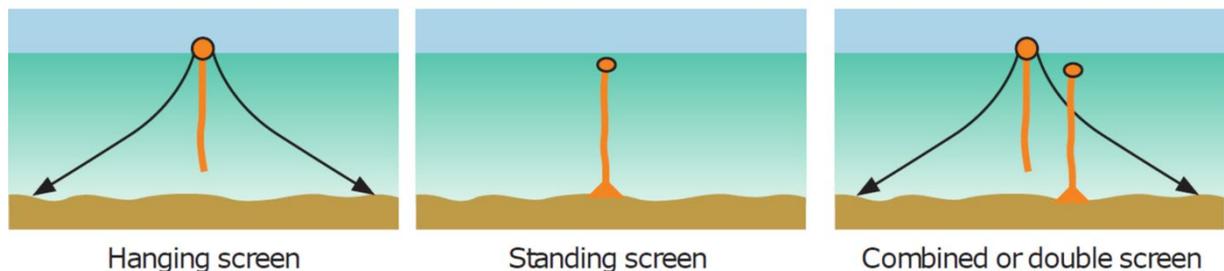
Figure 6.10: Types of silt screens (from Laboyrie et al, 2018; black arrows represent anchors)

The **application of silt screens** is most successful in situations with hard structures at 3 borders (breakwaters, shoreline etc.: Radermacher, 2013; De Wilde, 1995; Yasui et al., 1999). This situation occurs when construction of the breakwater is completed and dredging commences. In “perfect” cases, i.e. no currents, no waves and no tide, retention rates by silt screens can be as high as 80 to 90%. Deviation from these perfect conditions will decrease the efficiency. Currents above 0.5 m/s, waves above 1 m and high tidal range (above 3 m), will result in retention factors of 25 to 40% only (Laboyrie et al, 2018). Since currents and tidal action inside the breakwater structure are negligible and waves are expected to be well below 1 meter for the most of the time, we assume an efficiency of 40% for a combined (or double) screen type (see figure 6.10).

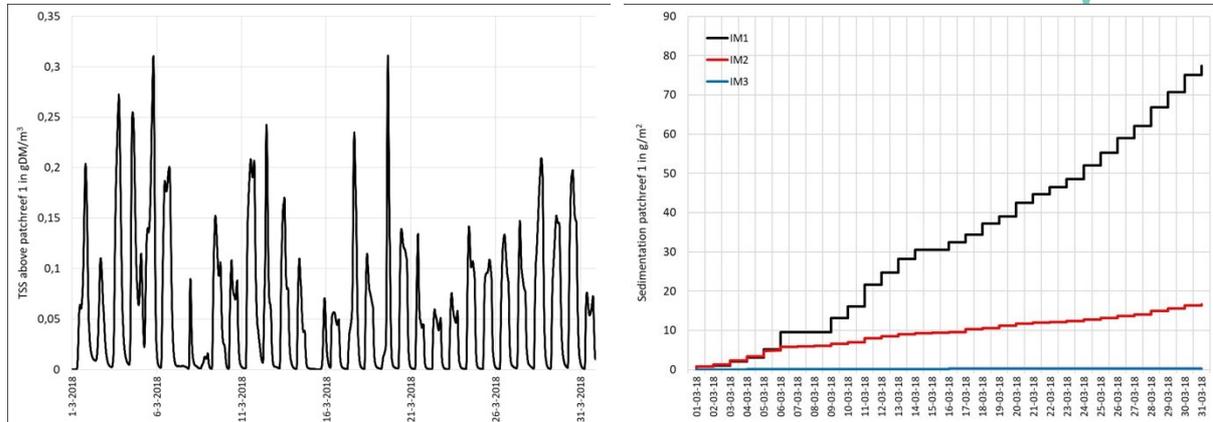
Figure 6.11: Total suspended solids concentration (TSS or SSC in mg/l, left) and deposition (g/m<sup>2</sup>, right) at patch reef 1 during 1 month of dredging (phase 2).

Figure 6.11 shows patterns of suspended solids concentration and (cumulative) deposition at patch reef 1 during 1 month of dredging (dredging phase 2).

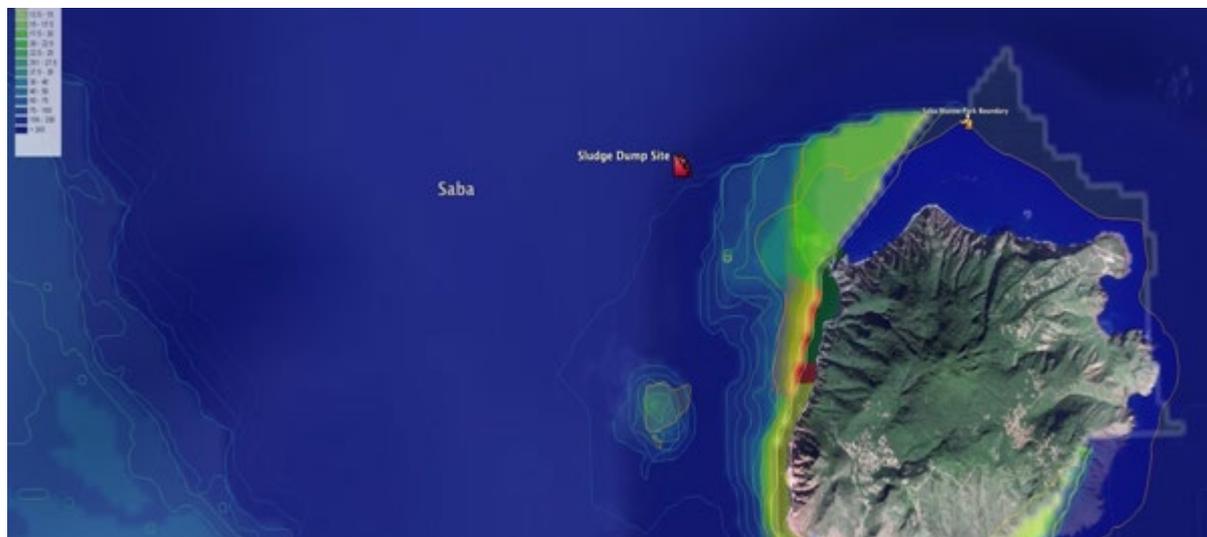
Figure 6.11: Location where excess sediments have been deposited in deep waters

If more sediments are excavated than needed in the project, it may be necessary to dispose of the sediments in open sea. The location that has been used in the past is indicated in figure 6.11. This location was selected by SCF to balance burden for contractors and impact on maritime flora and fauna (coordinates: 17° 39.215'N 63° 16.194'W, see figure 6.11).

In this discharge area, the depth of the seafloor is approximately 200 meters. The main impacts from the discharge will be a local and temporal plume of fine sediments, and the sinking of larger particles (sand, gravel, stones) to the seafloor. The exact impacts cannot be adequately assessed because of lack of information about sea life in this area (pelagic and benthic). It is unlikely however, that any biodiverse marine ecosystem is present in this area. The impact is qualified as “low”.

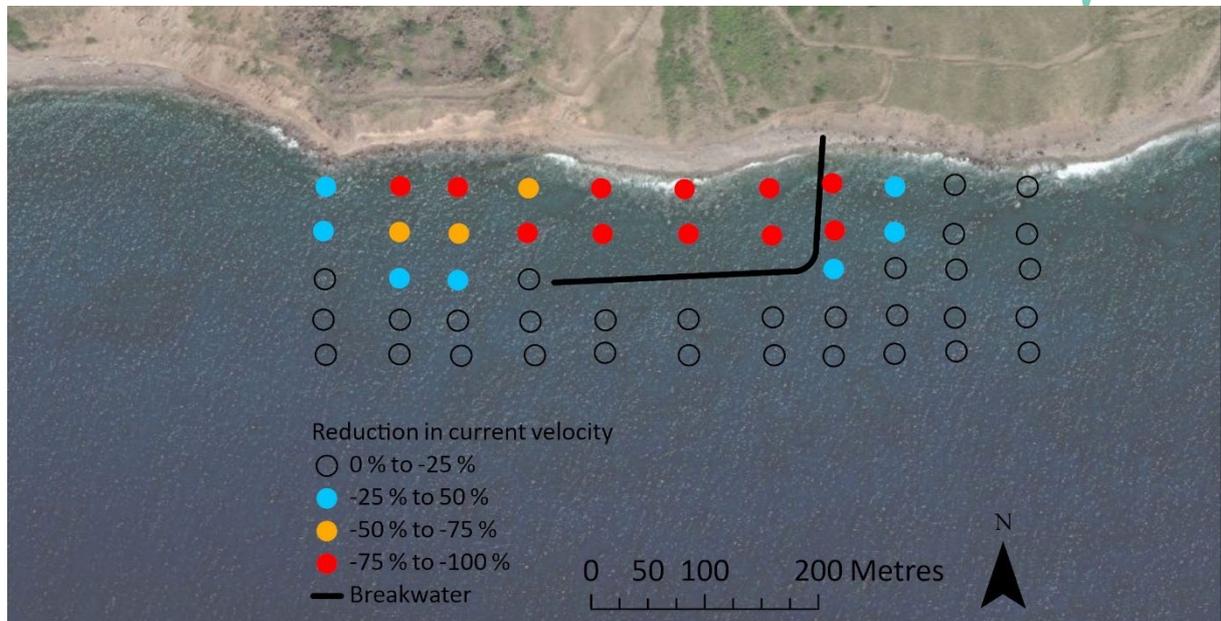
Figure 7.1: Areas with reduced current velocities

Figure 7.1 shows areas near the breakwater where average current velocities are reduced by more than 25%, because of the presence of this new structure. In these areas, just east and west of the projected breakwater, benthos (organisms that live on the seafloor), will suffer from less water circulation. Less circulation will result in more sediment deposition and poorer water qualities. Another anticipated impact by altered currents and wave action is reduced effectiveness of passive sediment rejection in different species of corals. Especially branched corals, such as *Acropora palmata*, depend on passive rejection (Erftemeijer, 2012). Altered waves are expected mainly west of the breakwater.

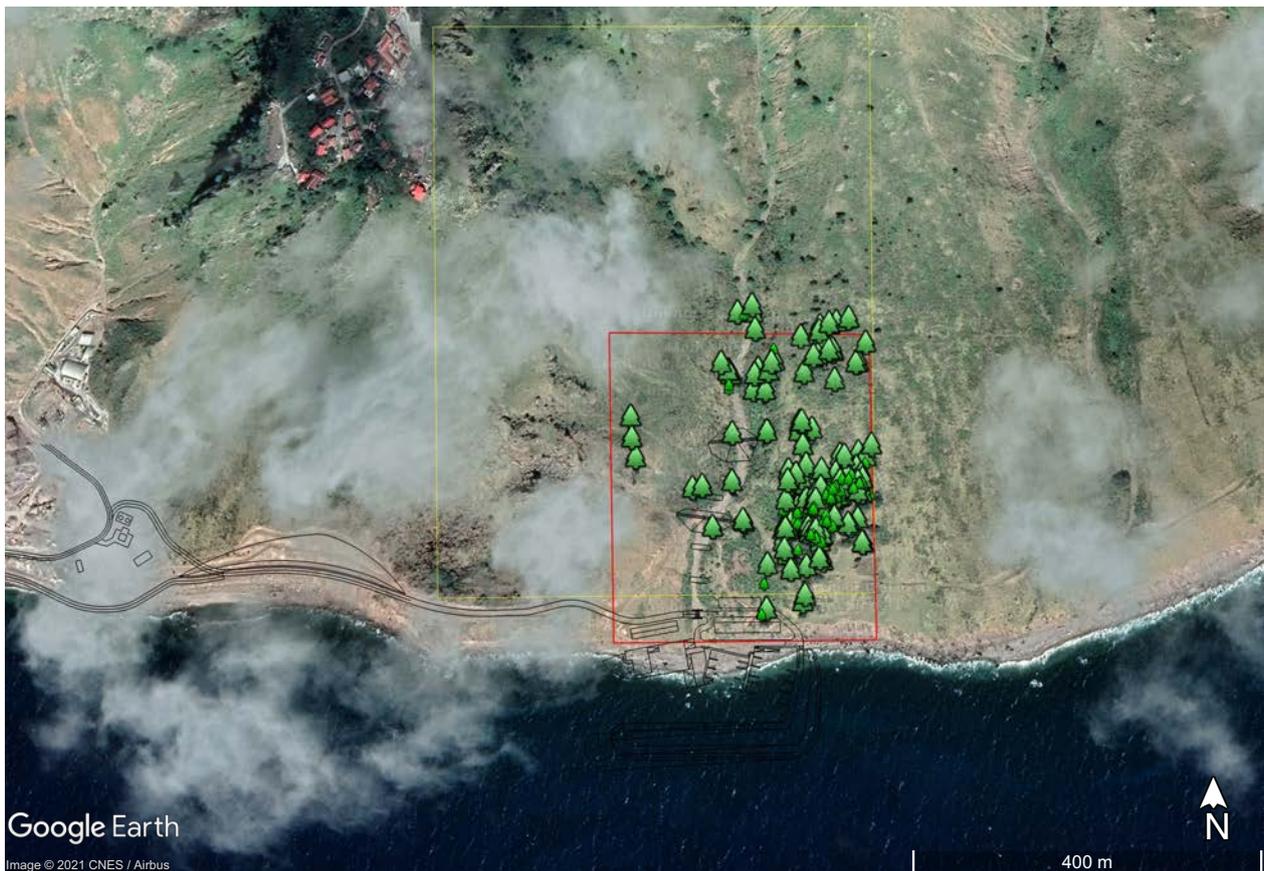
Figure 1 Harbour and survey site

Legend: Large Green trees = dbh >50cm, small trees = dbh 30cm-50cm,  
Red line= tree survey area, yellow line = bird survey area

Following plans to redevelop the harbour at Fort Bay, a site for a new harbour complex was identified at Giles Quarter and proposed in 2019/2020. This report provides the results of a literature study and terrestrial survey work, carried out by staff of the Saba Conservation Foundation within the proposed development area. Brief field surveys focused on the vegetation and bird species present in the vicinity of the proposed development area. Vegetation was surveyed and fauna noted throughout the area shown in red on the map below (Figure 1) where the presence of trees 30cm – 50 cm stem circumference (dbh) as well as trees with a stem circumference over 50cm was recorded with GPS co-ordinates. The presence of birds was recorded within the yellow area in Figure 1.

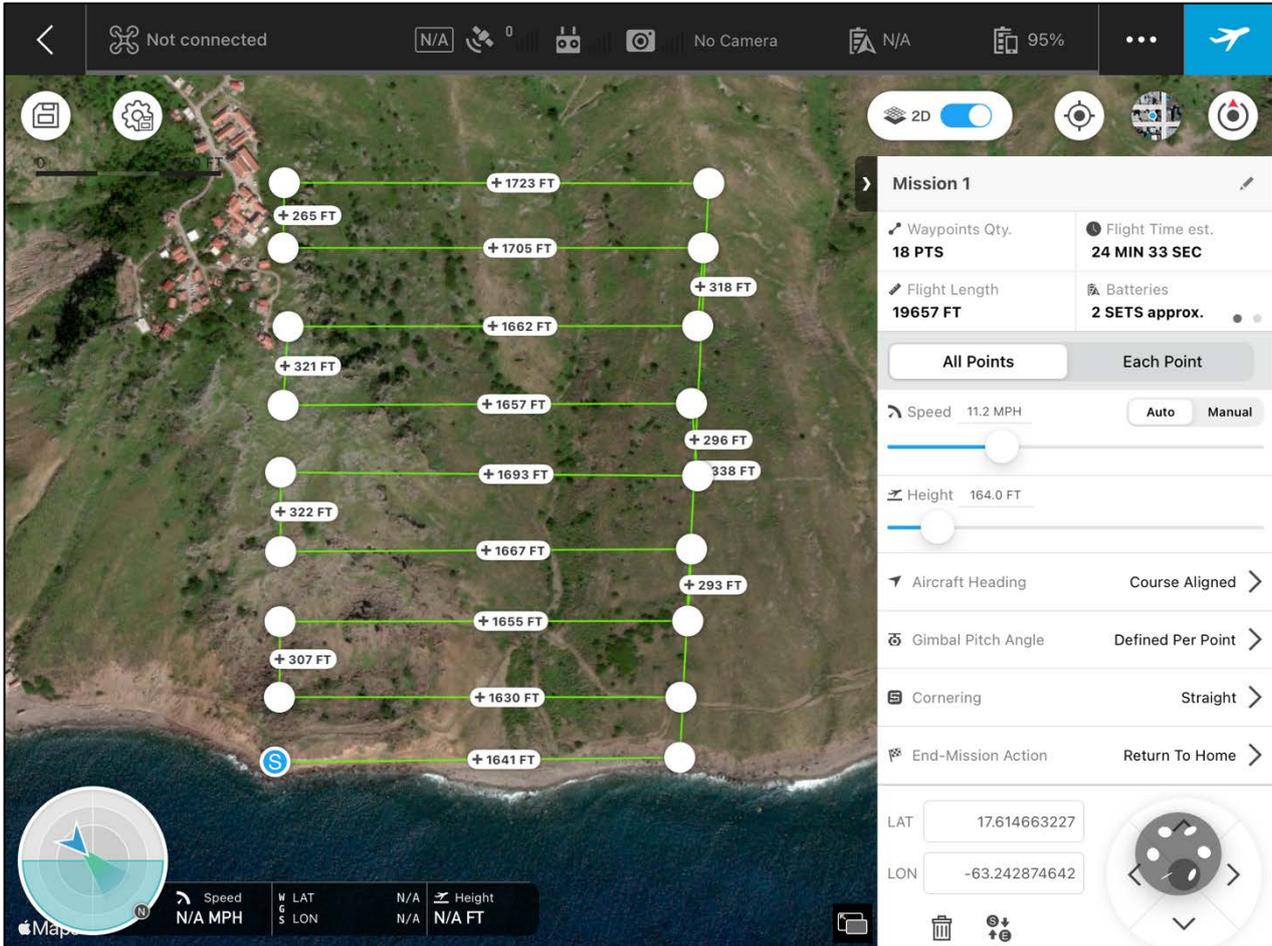
Figure 3 Drone transects recorded by Saba Conservation Foundation staff

The staff of Saba conservation Foundation carried out field surveys of the area selected in the final quarter of 2020. Data collected included the circumference of tree trunks using the standard measure Diameter at Breast Height (DBH) in centimetres (which is assumed as 140cm above ground)). Tree height was also recorded for some trees. Georeferenced photographs were taken of each plant surveyed. Other data recorded includes high resolution drone imagery flown on transects crossing the site (Figure 3).

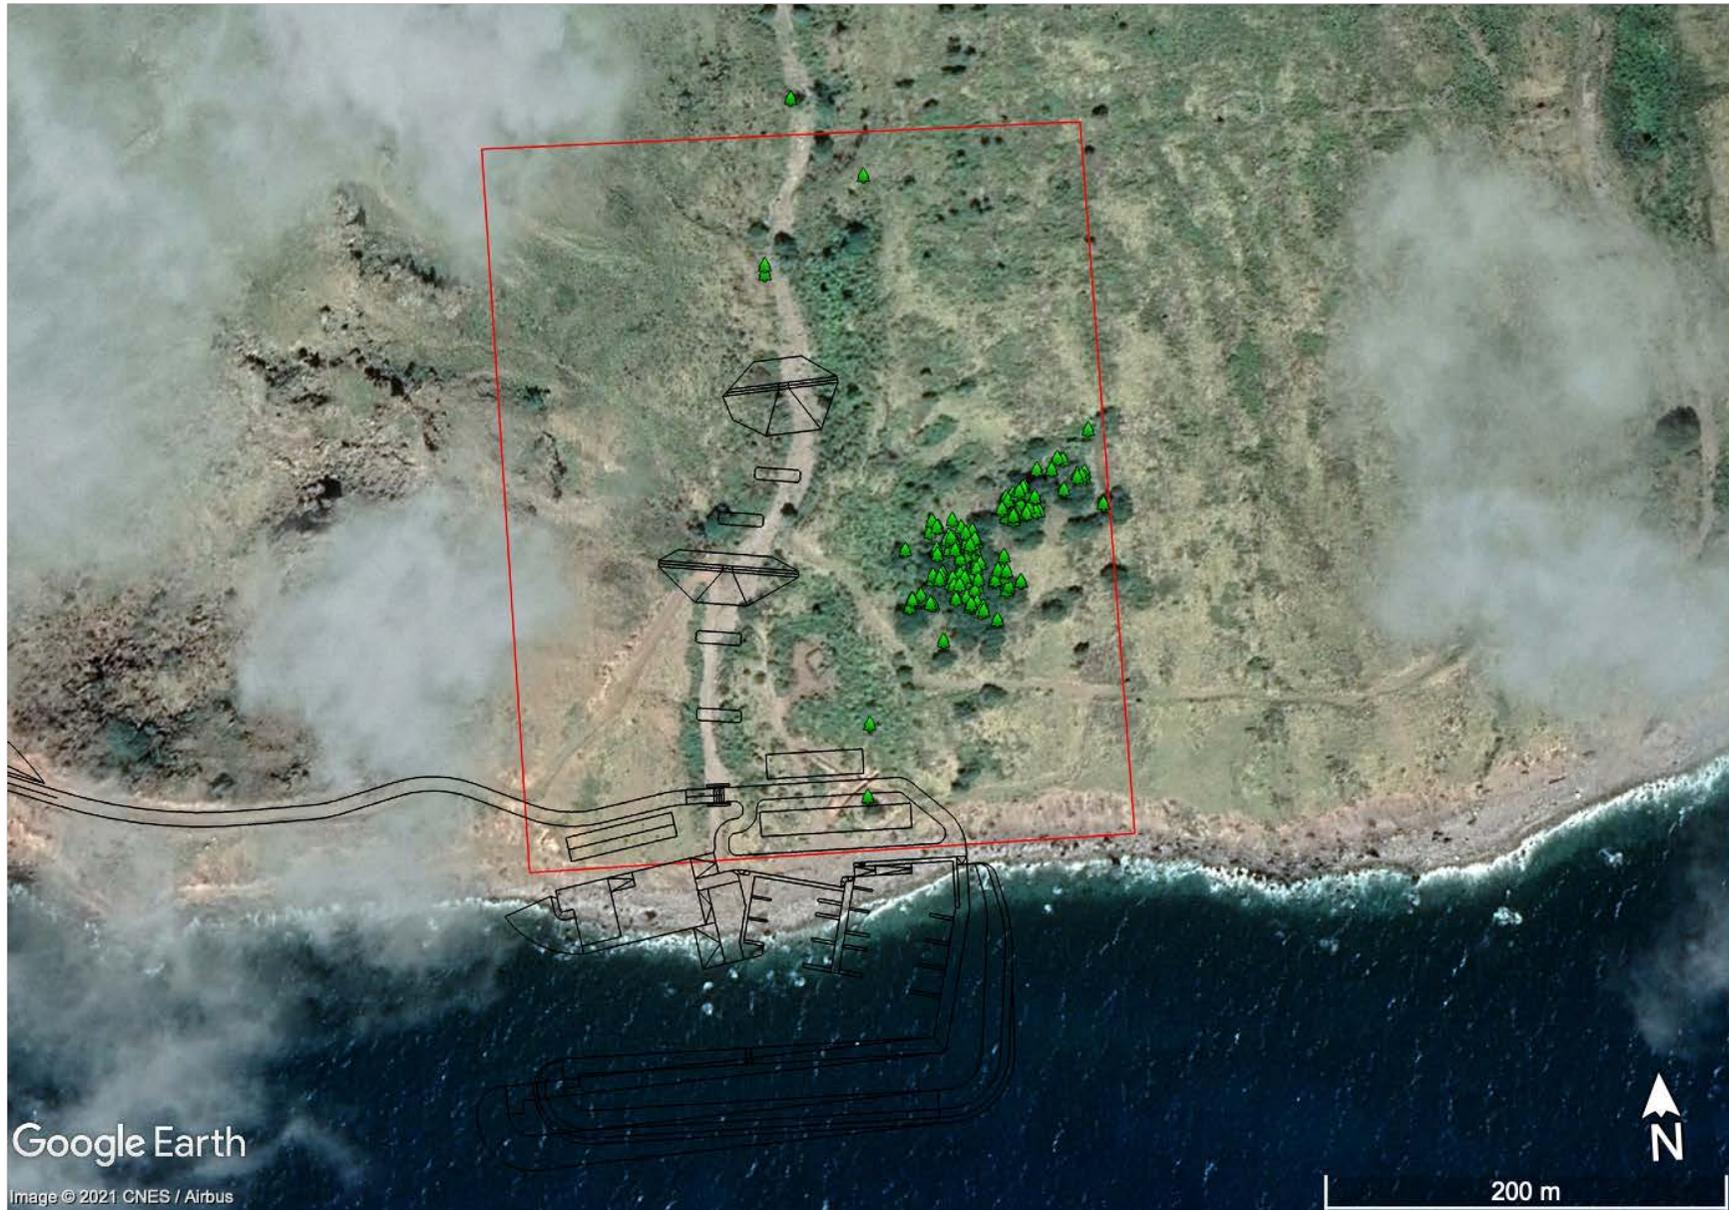
Figure 4 Vegetation surveyed with 30 cm – 50 cm DBH

The results are plotted in Figure 4 Vegetation surveyed with 30 cm – 50 cm DBH and Figure 5 Vegetation recorded with DBH > 50cm.

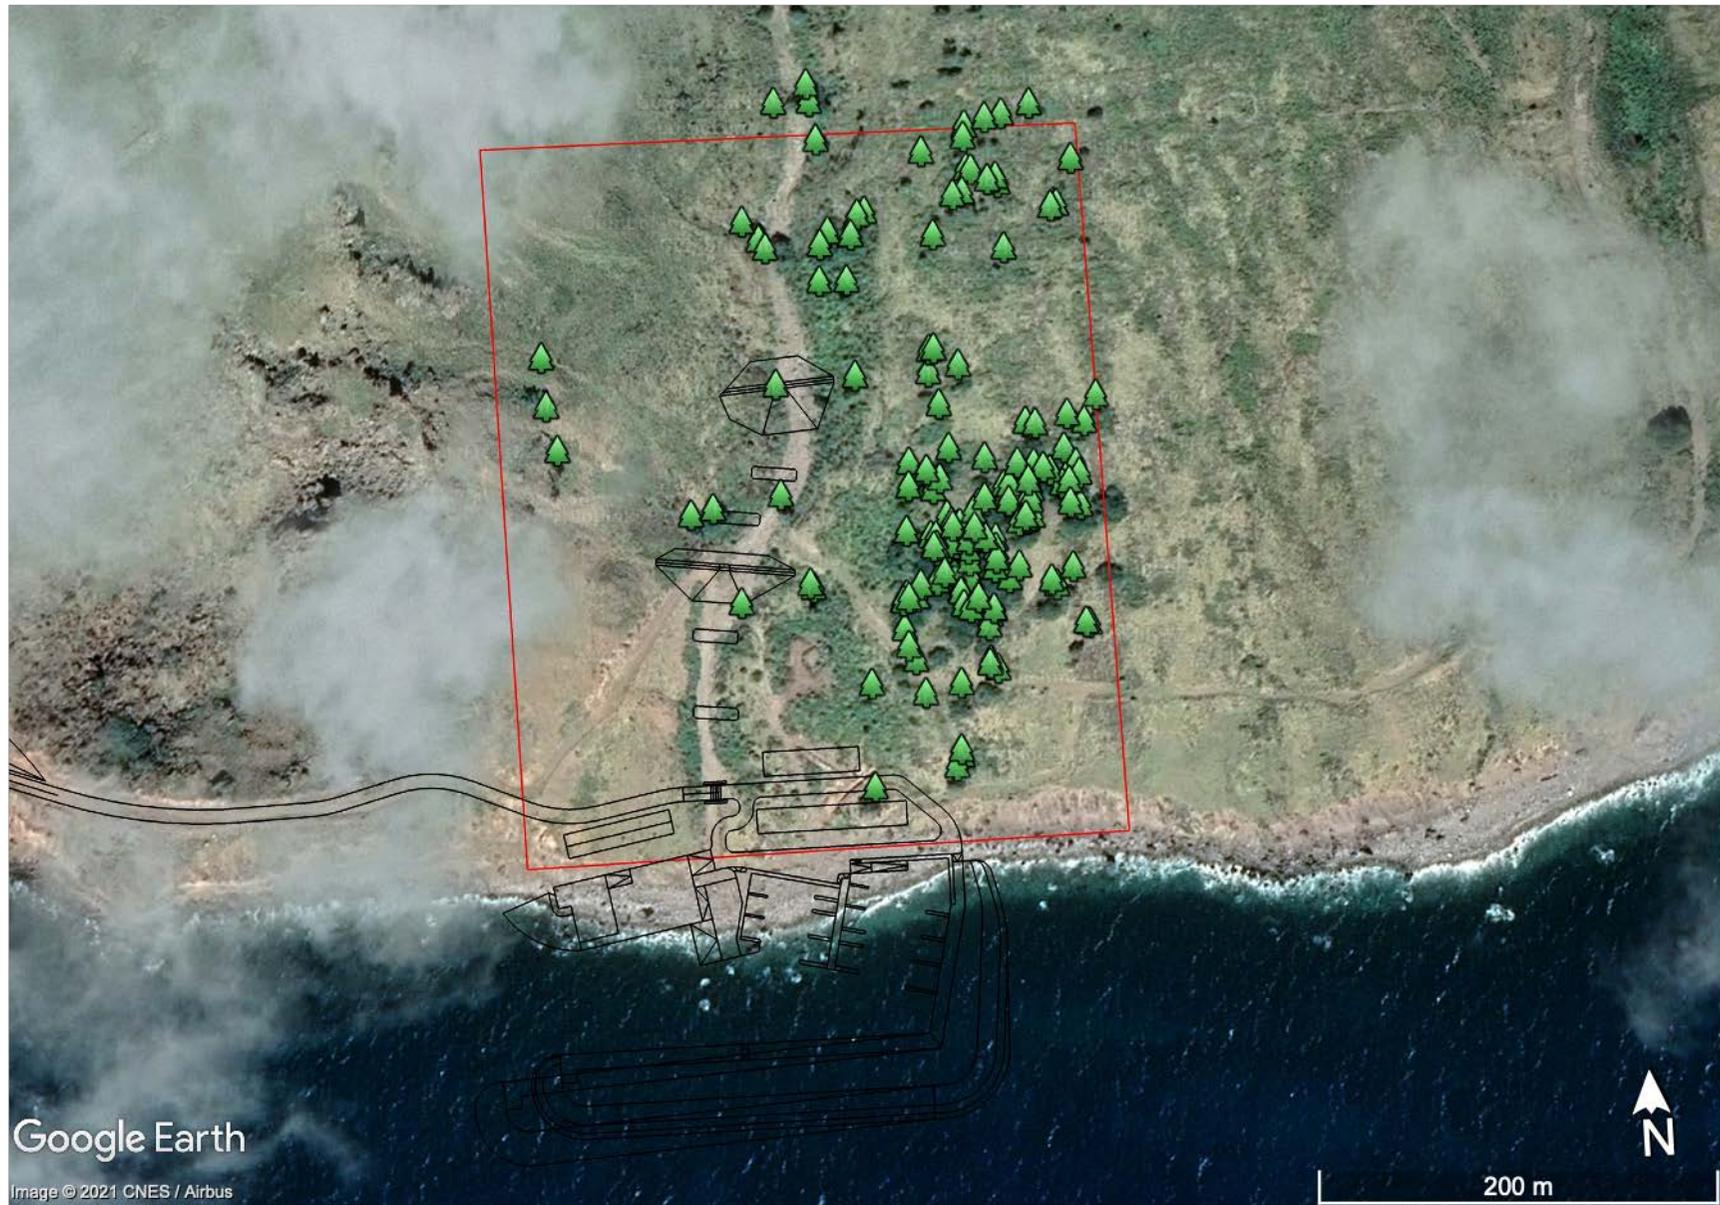
Figure 5 Vegetation recorded with DBH > 50cm

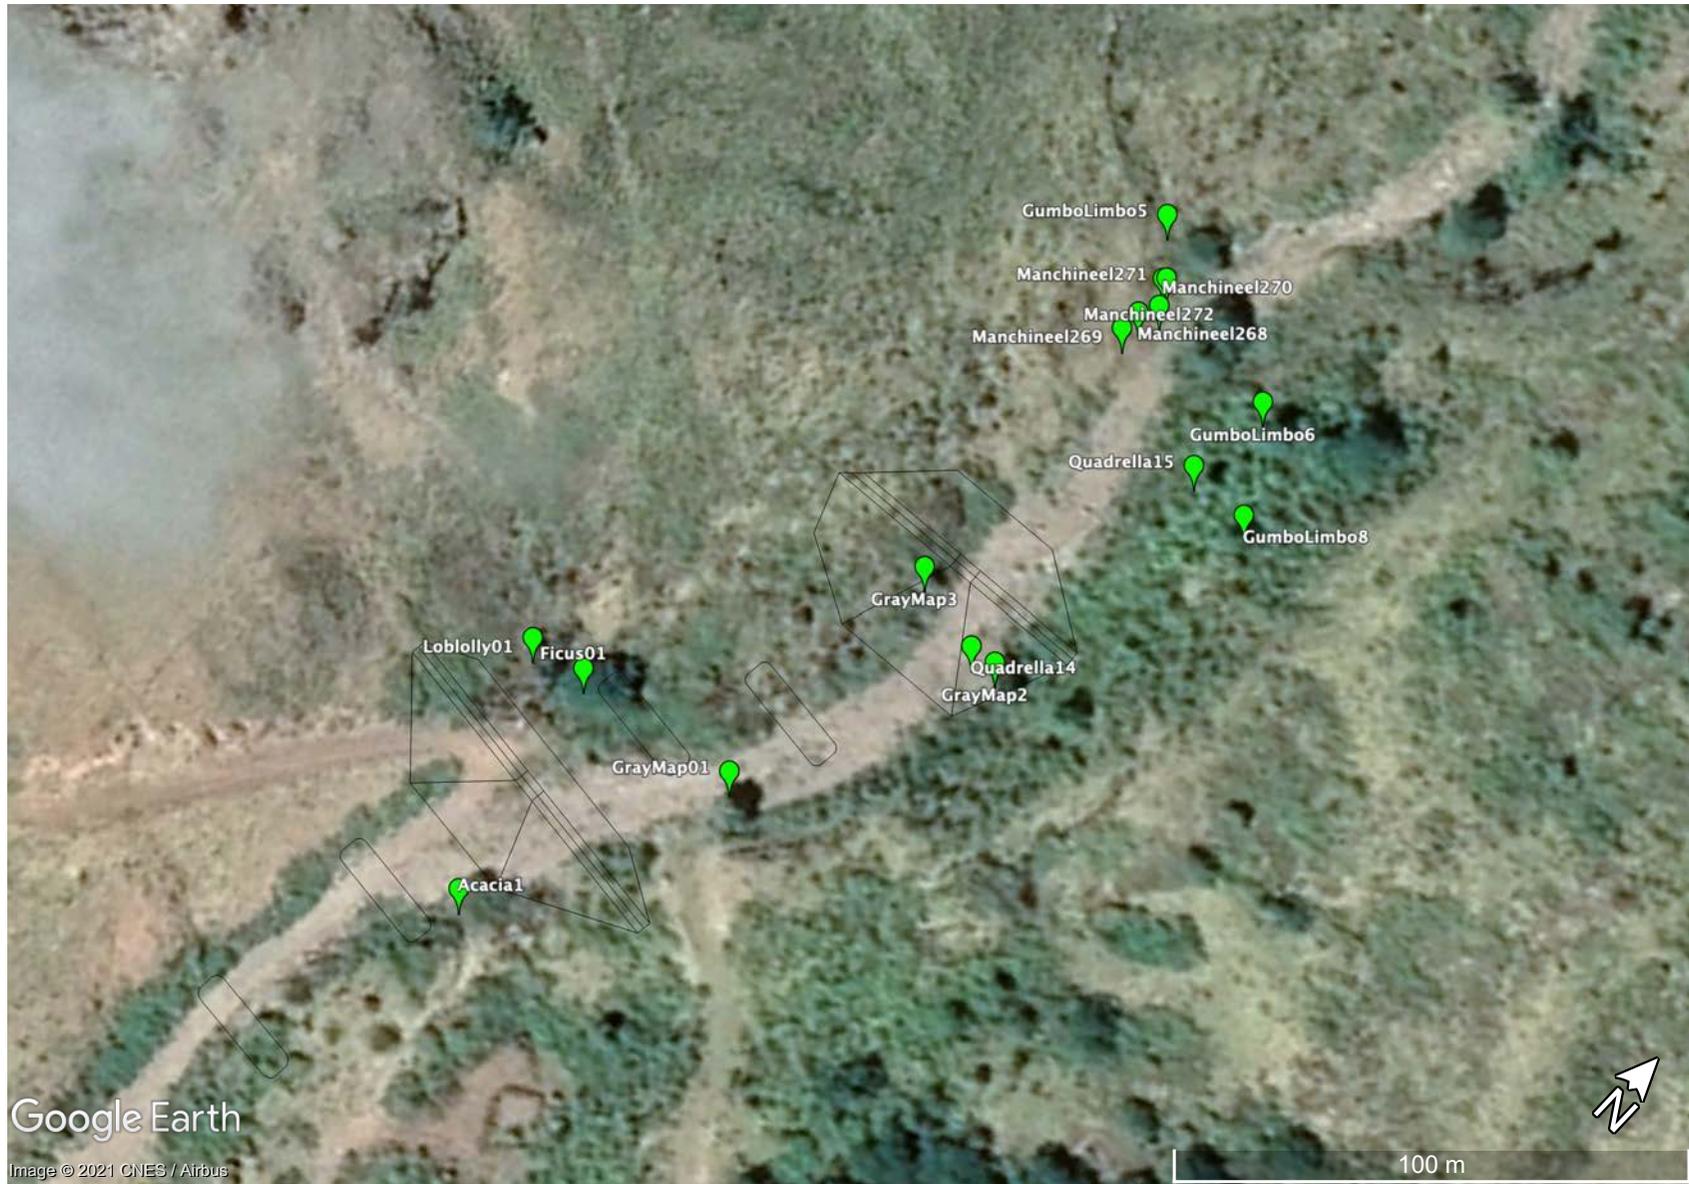
Figure 6 Surveyed trees near the dam construction sites and close upstream

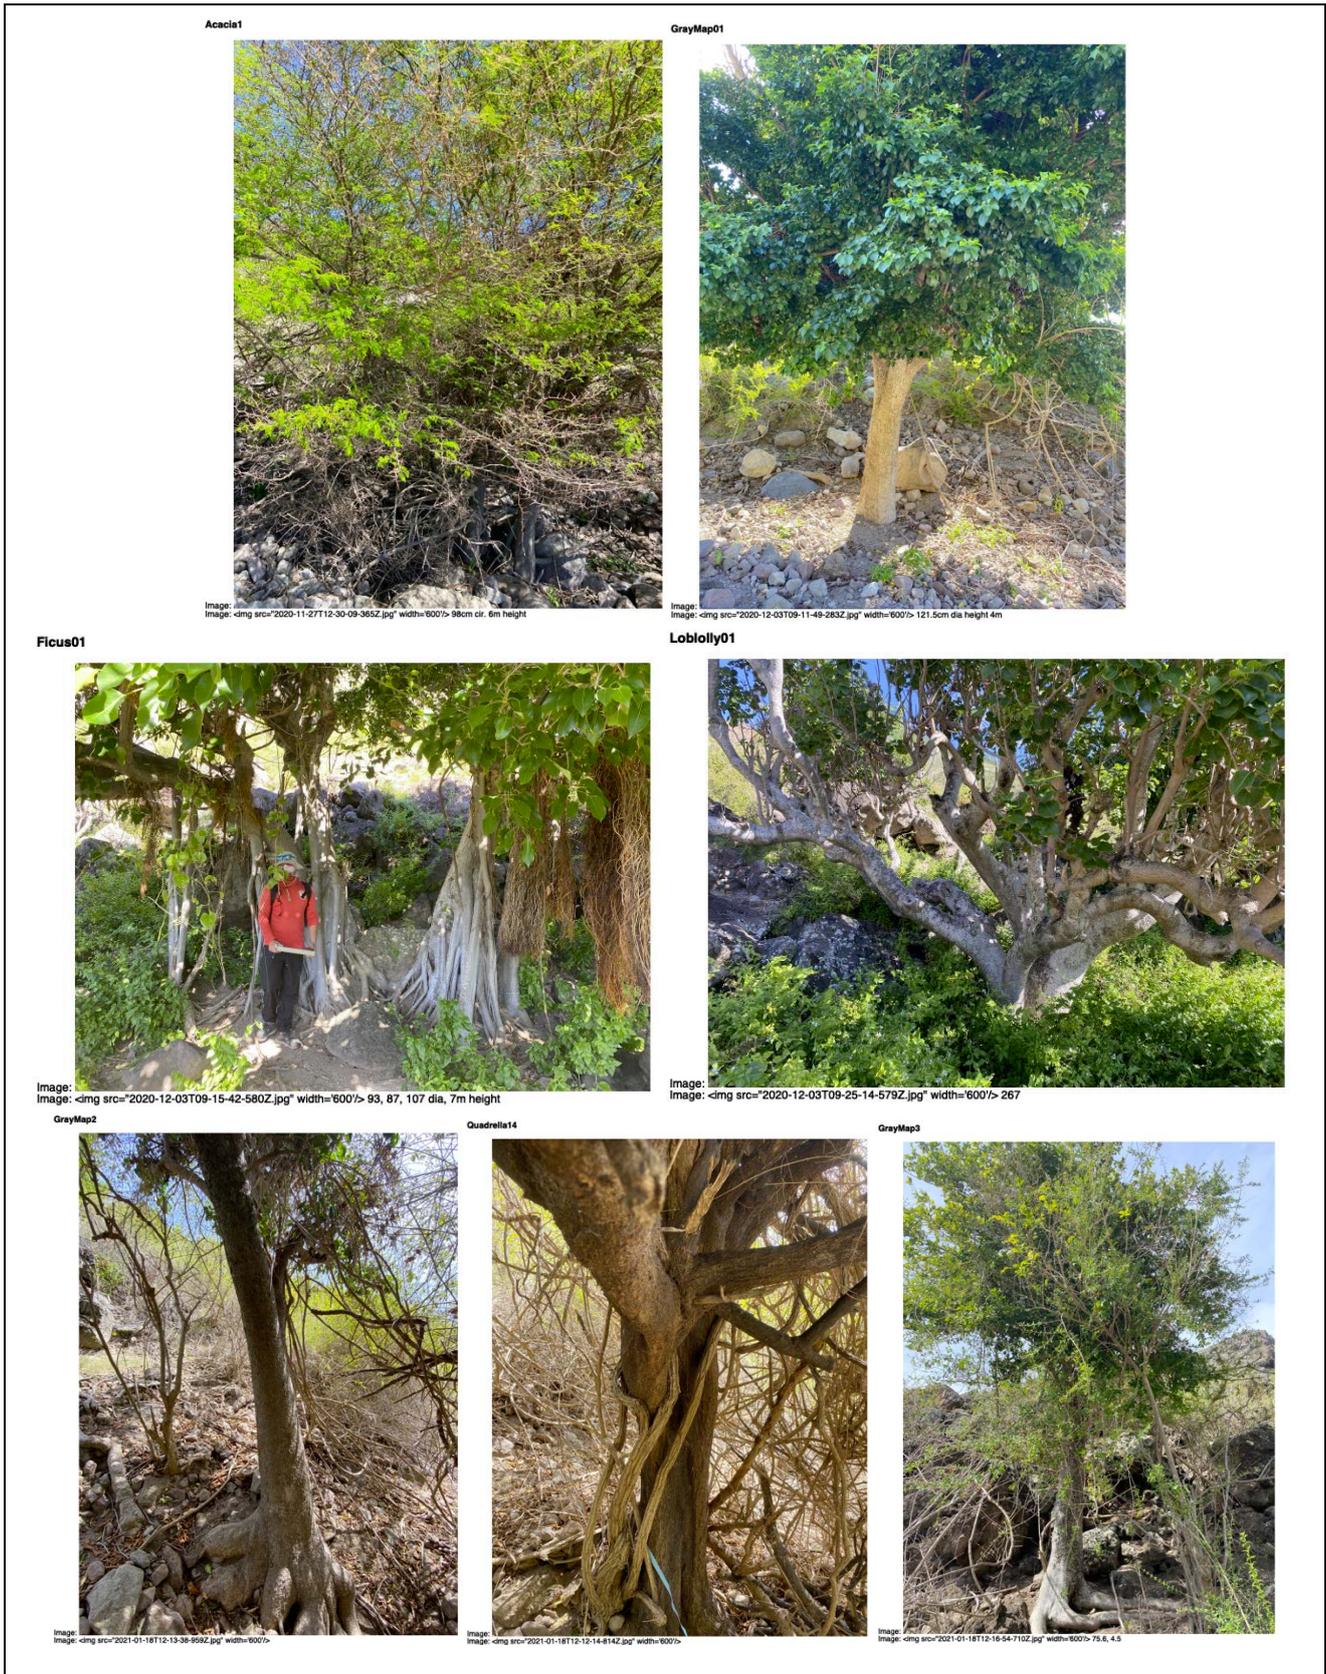
Figure 7 Trees within the construction site of the dams

All images of the trees within the construction sites of the dams and at close upstream locations are included in the Appendix.

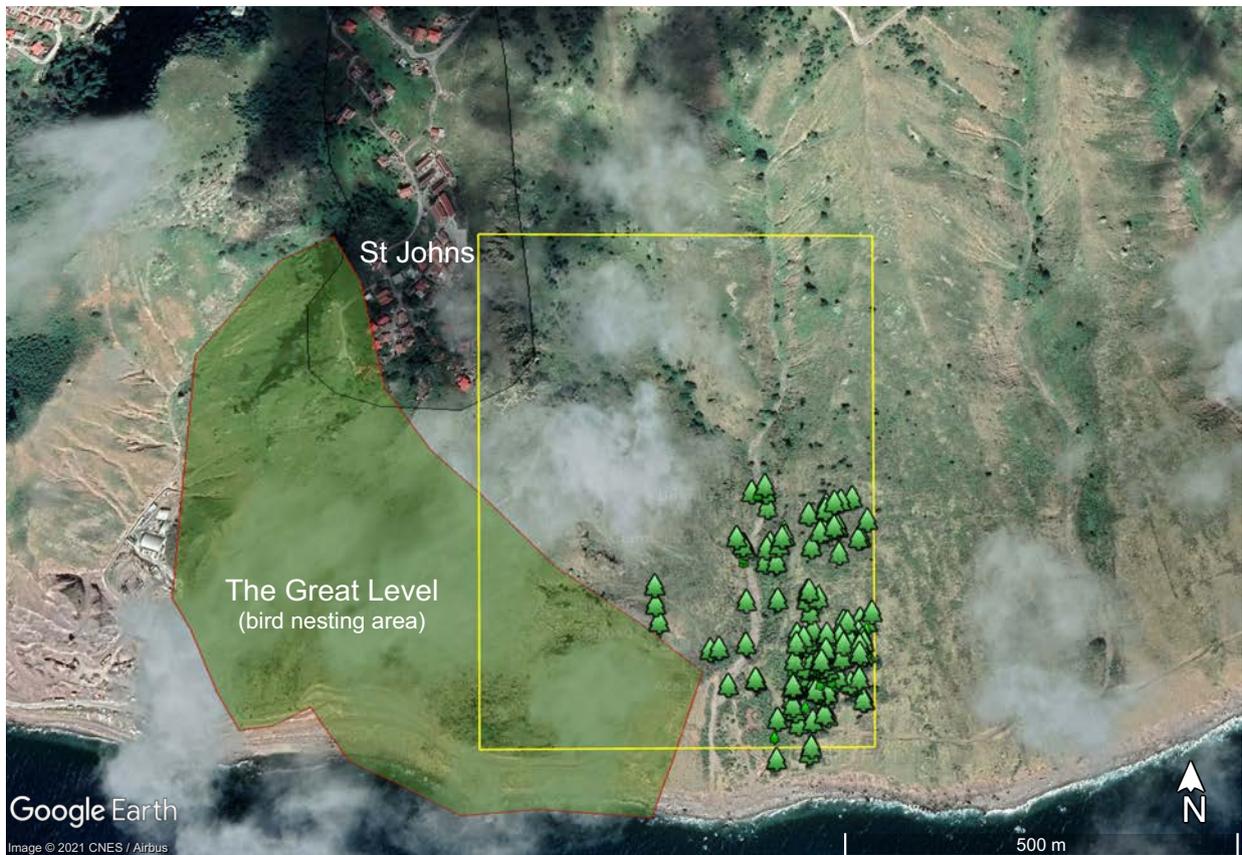
Figure 10 Bird survey area shown in yellow.

The area for the bird survey is approximately 500x650 m and includes steep, inaccessible cliffs, particularly near the settlement of St. Johns, which are favoured by nesting seabirds (Figure 10).
