**Report:**

**Environmental Impact Assessment  
(EIA) for the harbor construction at  
Black Rocks, Saba**

Final report

June, 2022

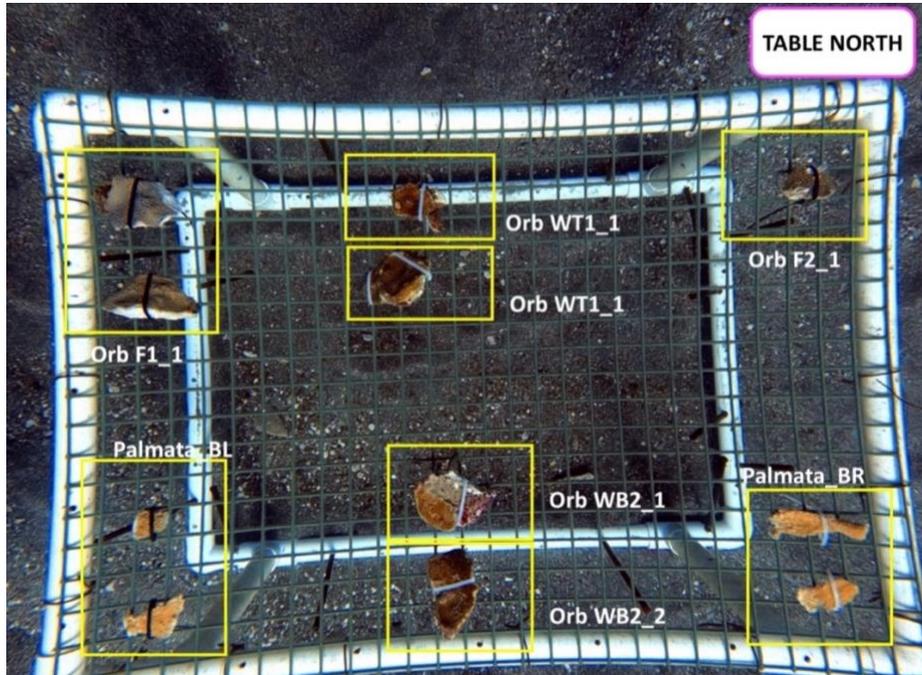
FIGURE 2. TABLE NORTH SET UP

In order to prevent that the tables will have the same set-up; coral species were randomized. This prevents corals of the same species or the same colony to be placed on the same place on the two tables.

TABLE NORTH					
Coding	Description	Species	Relocation_Date	Health_Start	Health_Interim
Orb F1_1	Orbicella Colony 1_fragment 1	<i>Orbicella spp.</i>	25-Feb-2021	100%	90% (March 12)
Orb WT1_1	Orbicella Whole Top 1_fragment 1	<i>Orbicella spp.</i>	25-Feb-2021	100%	90% (March 12)
Orb WT1_2	Orbicella Whole Top 1_fragment 2	<i>Orbicella spp.</i>	25-Feb-2021	100%	90% (March 12)
Orb F2_1	Orbicella Colony 2_fragment 1	<i>Orbicella spp.</i>	25-Feb-2021	100%	90% (March 12)
Palmata_BL	Palmata fragment_Bottom Left	<i>A. palmata.</i>	25-Feb-2021	100%	90% (March 12)
Orb WB2_1	Orbicella Whole Bottom 1_fragment 1	<i>Orbicella spp.</i>	25-Feb-2021	100%	90% (March 12)
Orb WB2_2	Orbicella Whole Bottom 1_fragment 2	<i>Orbicella spp.</i>	25-Feb-2021	100%	90% (March 12)
Palmata_BR	Palmata fragment_Bottom Right	<i>A. palmata</i>	25-Feb-2021	100%	90% (March 12)

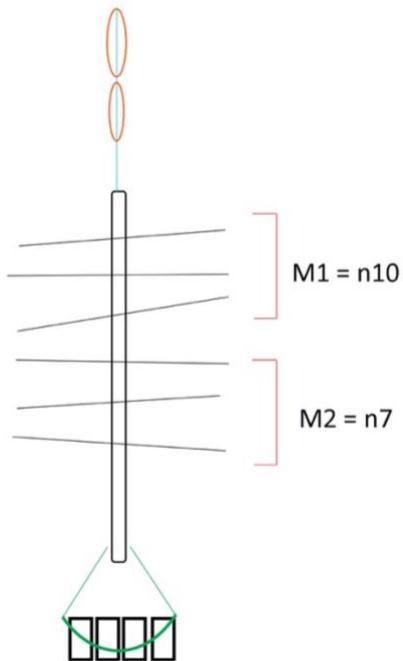
FIGURE 4. TREE 1

To prevent that all fragments from the same colony were placed on the same depth, fragments were divided evenly between two trees where the first half is placed on top of tree 1 and the other half is placed on the bottom of tree 2.

The X-number of fragments were then randomly distributed between the tree branches to prevent that too many fragments are attached to only the top branches.

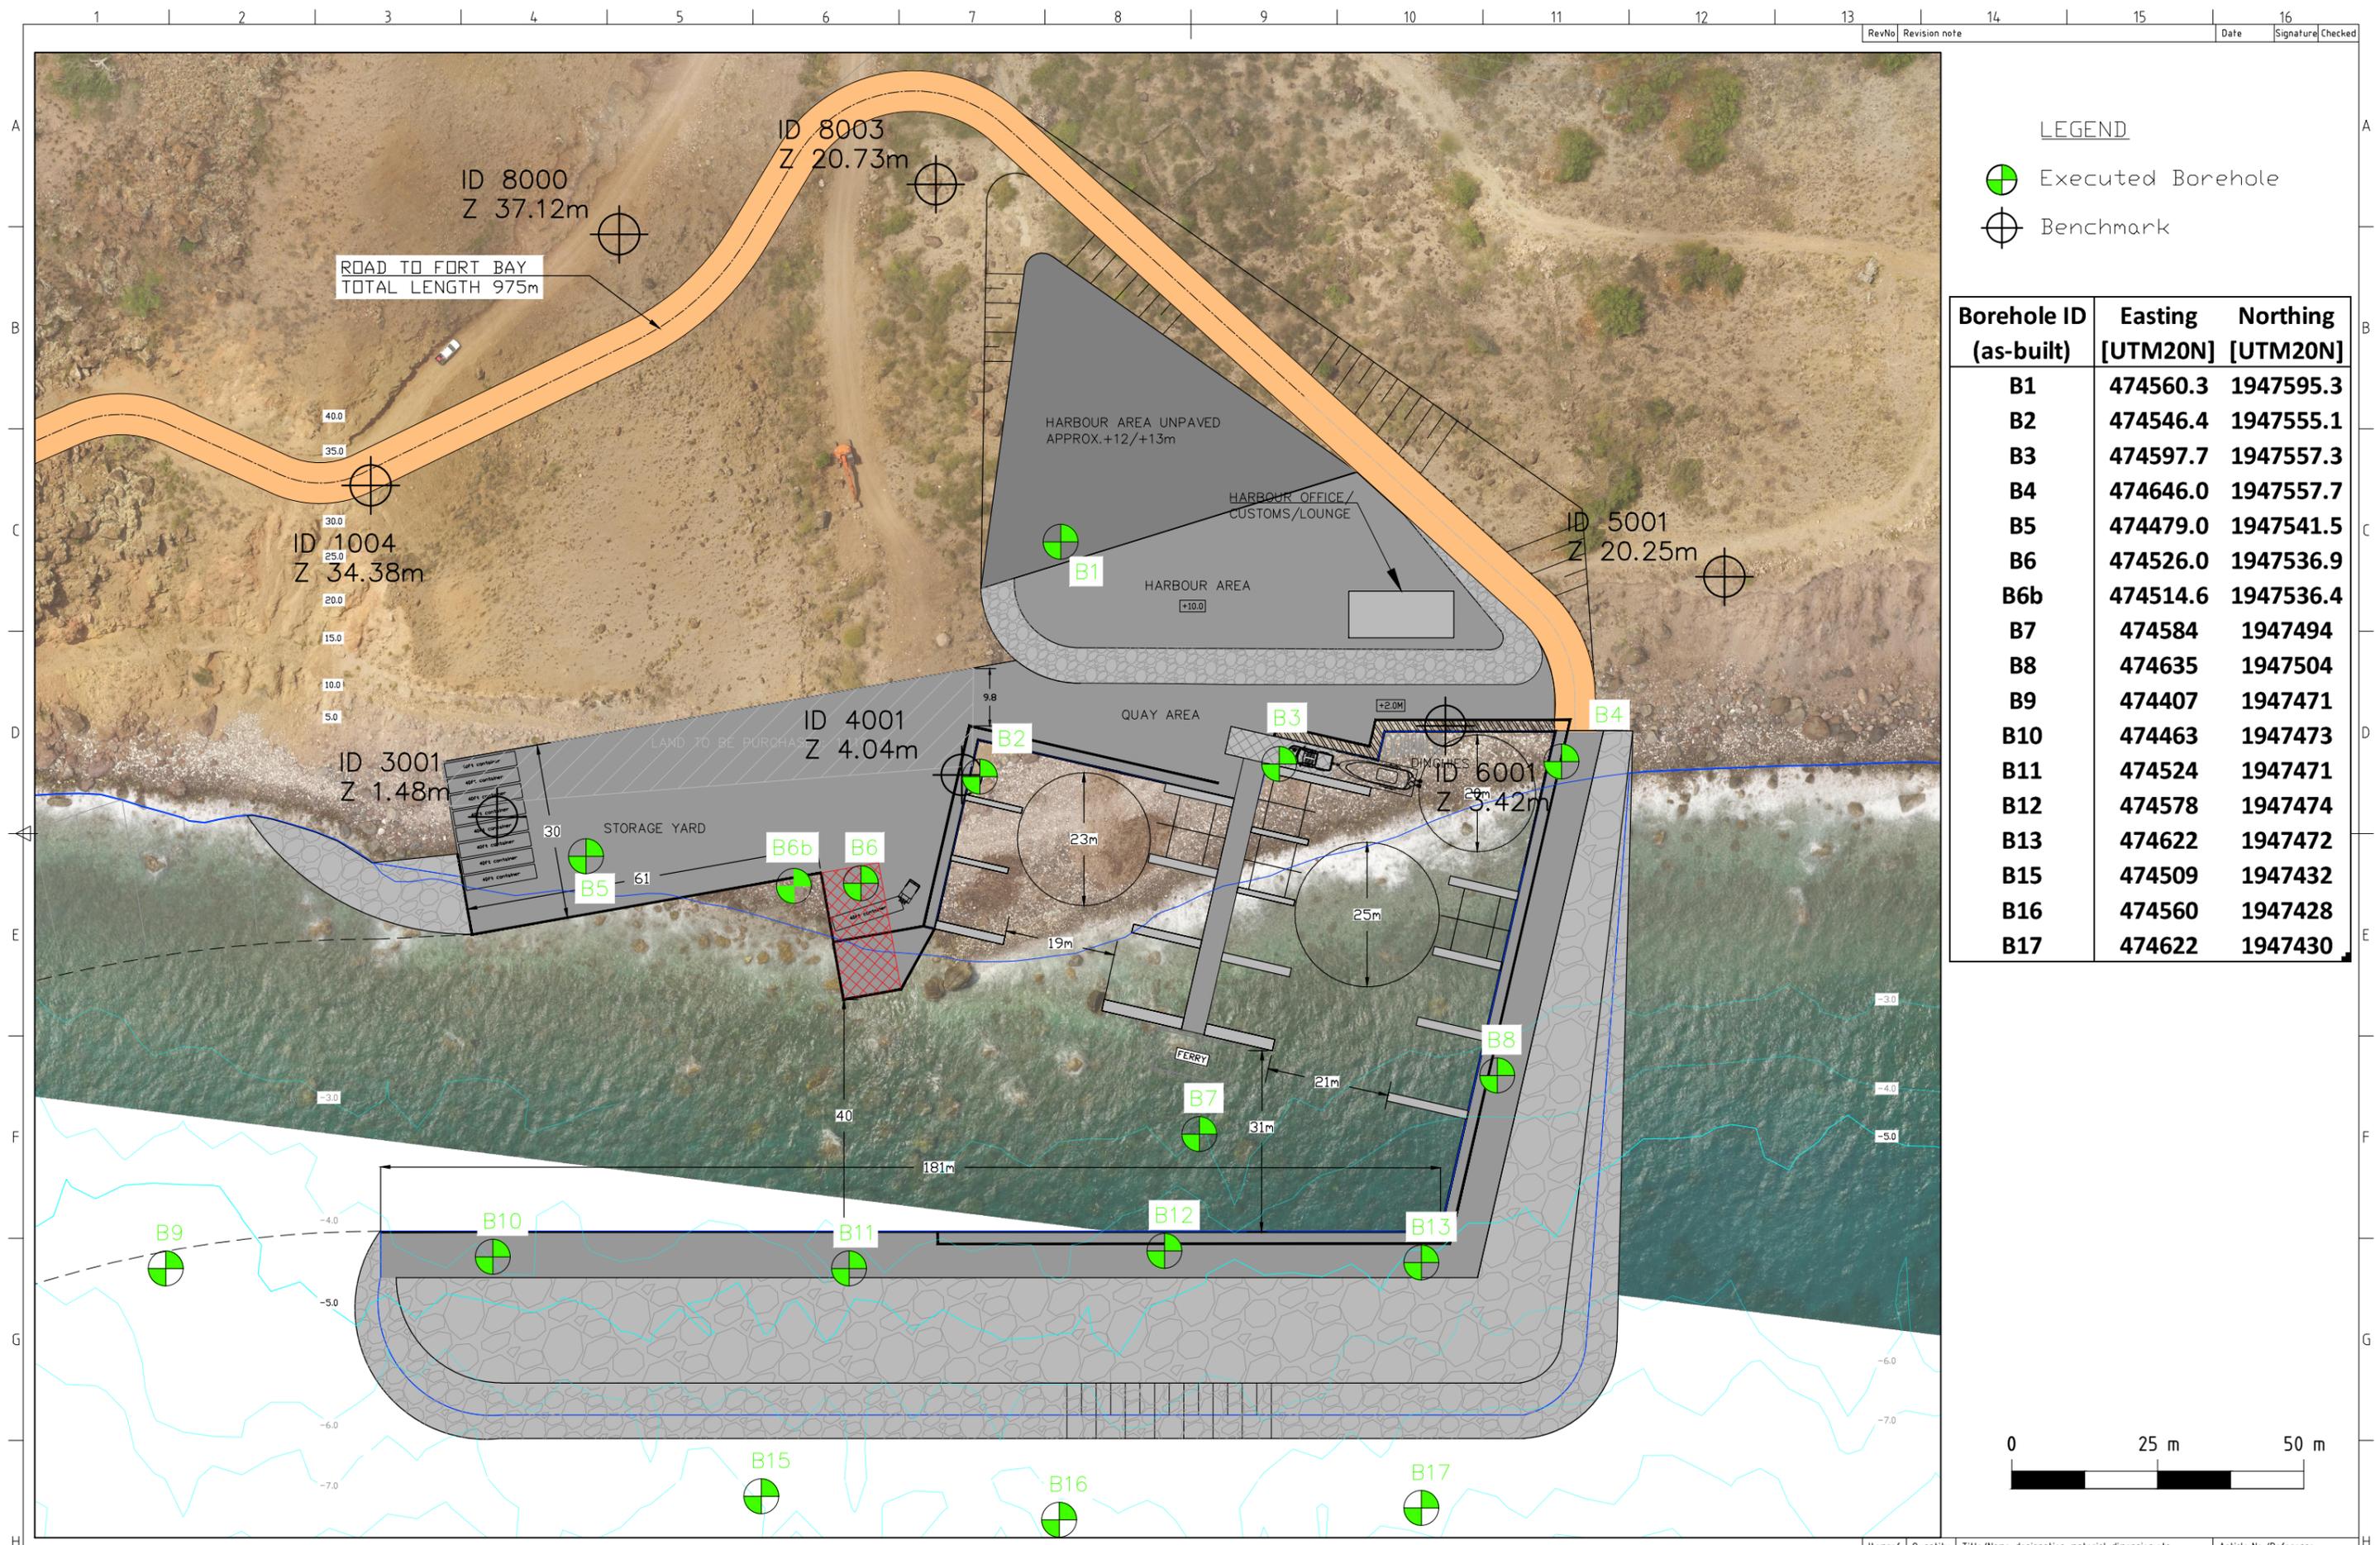
## Annex 3: Overview of sampling points and sample types (map and table)

- ⊕ Executed Borehole
- ⊕ Benchmark

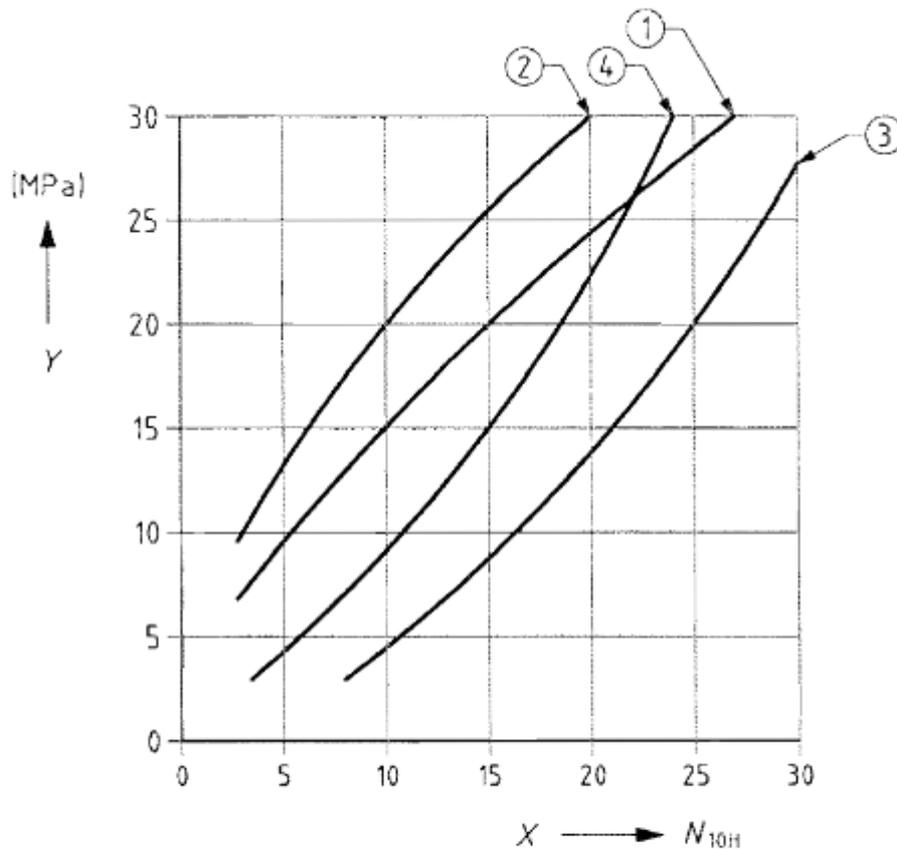
Figure 3-2 Relation  $q_{dyn}$  and  $q_c$  for varying granular materials [6]

- (x) Number of blows, (y) Cone penetration resistance ( $q_c$ ),
- 1 Poorly-graded sand above groundwater,
  - 2 Poorly-graded sand below groundwater,
  - 3 Well-graded sand and gravel above groundwater,
  - 4 Well-graded sand and gravel below groundwater.

For an initial assessment the DPT blow-count can be correlated to static cone resistance (CPT)  $q_c$  in MPa using Figure 3-2 [6]. For the assessment line 4 is used (refer to paragraph 5.2.3). This is considered a conservative approach taking into account the relatively low coefficient of uniformity ( $C_u = 3.3$ ) and the fact that poorly graded material (line 2) will lead to higher  $q_c$  values.

Note that Figure 3-2 requires  $N_{10}$  based on DPT heavy type, these values are back-calculated based on the dynamic cone resistance  $q_{dyn}$ .

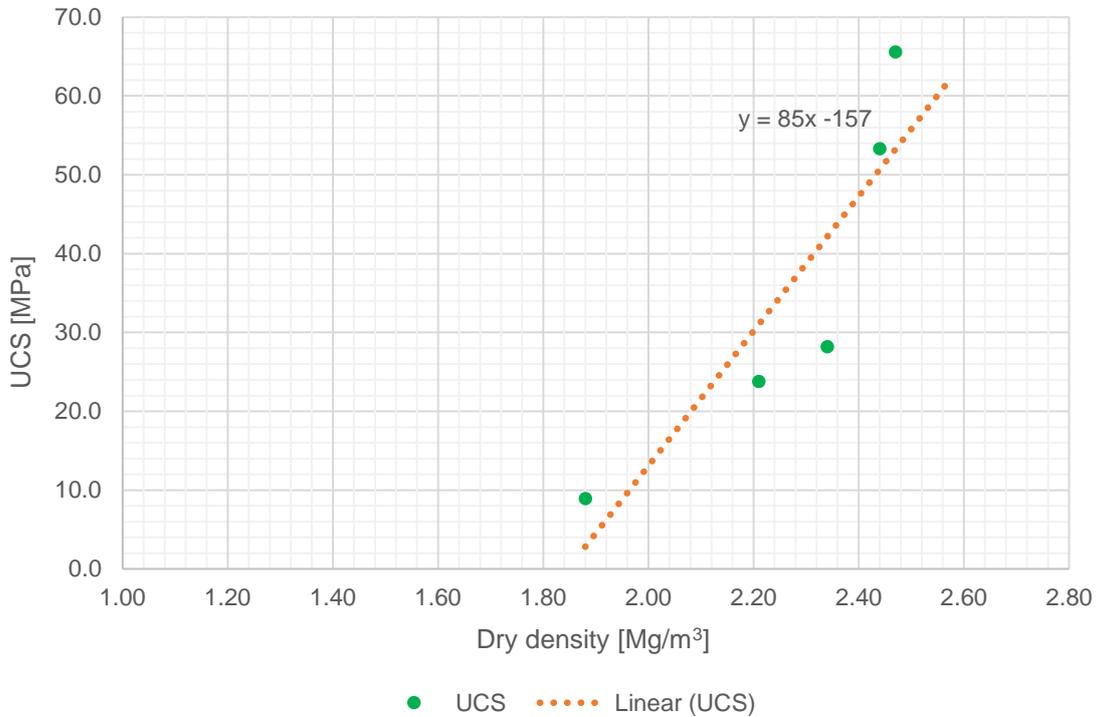
Figure 5-1 Correlation between Dry density and Unconfined Compression Strength; Saba Andesite

Figure 4.1 presents the correlation between the measured dry densities and the corresponding UCS-values. The regression line equation equals  $q_u = 85\rho_{dry} - 157$  MPa where  $\rho_{dry}$  equals the dry density in Mg/m<sup>3</sup>.

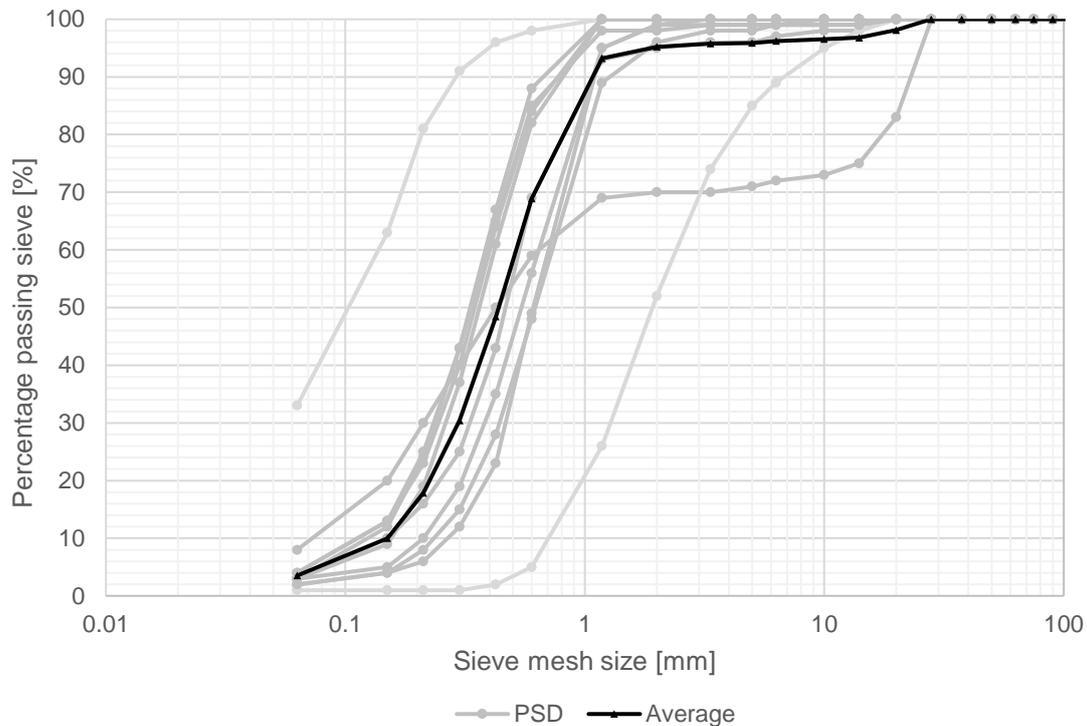
Figure 5-2 Summary graph PSD results

Figure 5-2 shows the results from PSD as well as the average PSD based on all results except the two outliers shown in the graph (far left and far right). The fines content (silt + clay, defined as material <63  $\mu\text{m}$ ) equals 4%, sand 91% and gravel 4% on average.

With the results shown in Figure 5-2 a coefficient of uniformity  $C_u = \frac{D_{60}}{D_{10}} = \frac{0.5}{0.15} = 3.33$  and coefficient of curvature  $C_c = \frac{D_{30}^2}{D_{10} \cdot D_{60}} = \frac{0.3^2}{0.15 \cdot 0.5} = 1.1$  can be determined. With these values the material can be described as well graded.

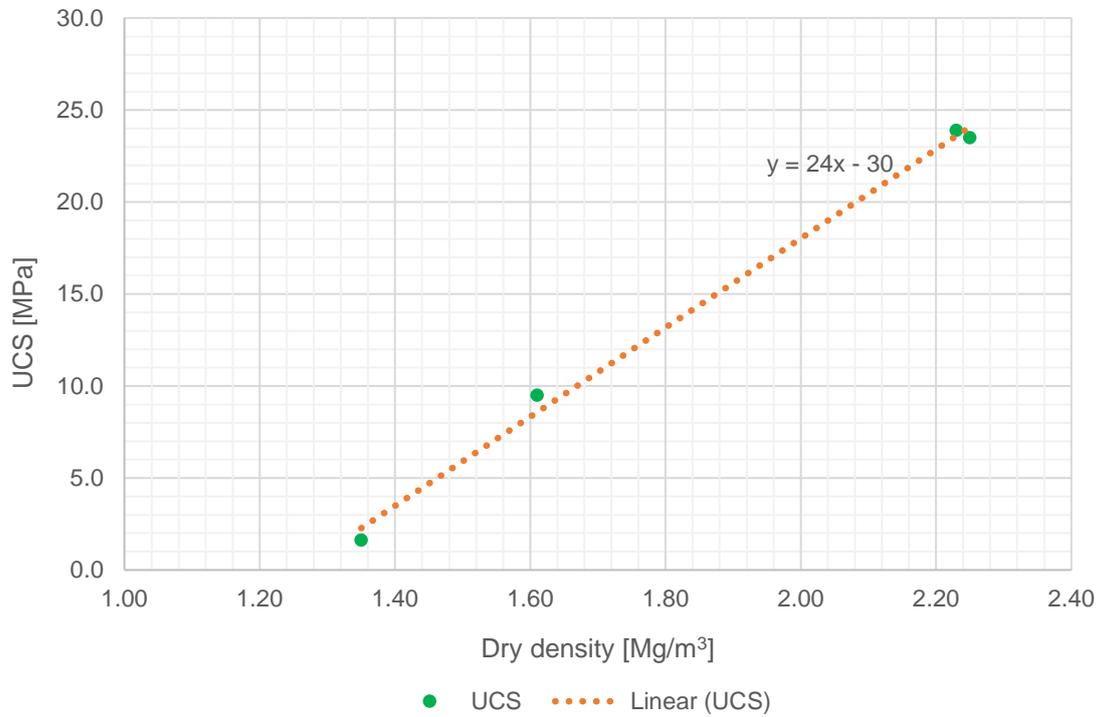
Figure 5-3 Correlation between Dry density and Unconfined Compression Strength; Saba Limestone

Figure 4.1 presents the correlation between the measured dry densities and the corresponding UCS-values. The regression line equation equals  $q_u = 24\rho_{dry} - 30$  MPa where  $\rho_{dry}$  equals the dry density in Mg/m<sup>3</sup>.

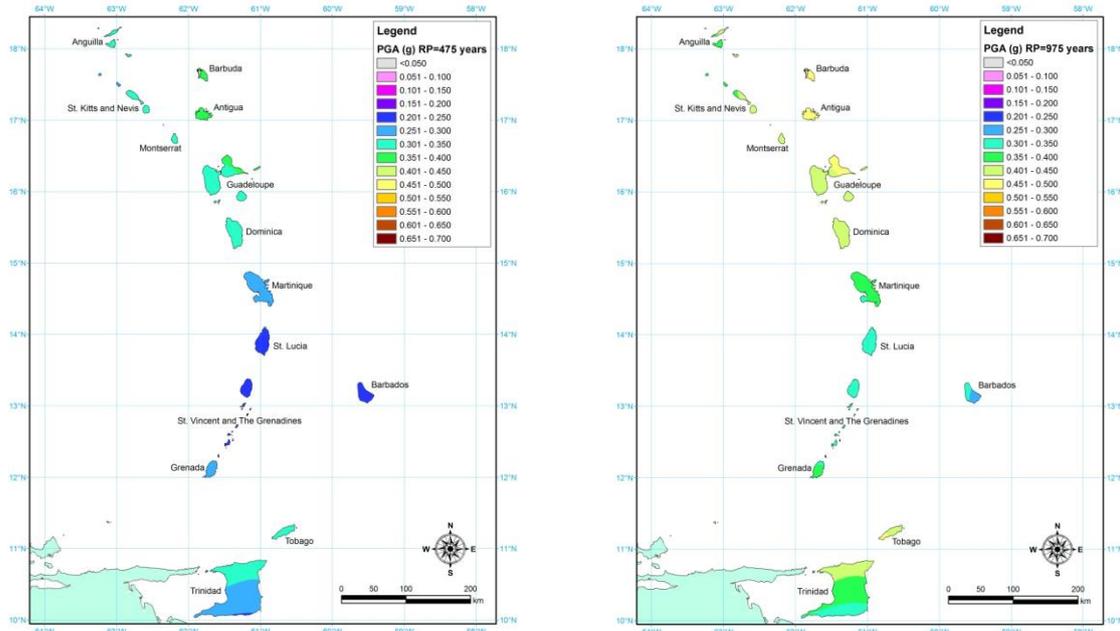
Figure 6-1 Peak ground accelerations for the eastern Caribbean Island arc. Source UWI Trinidad

The University of the West Indies studied the earthquake hazard for the Leeward Islands and considered the island of Saba to have a moderate to high hazard for earthquakes. The Peak Ground Acceleration (PGA) is assessed (John B. Shepperd, 1996) on approximately  $2.5 \text{ m/sec}^2$ , having 10% probability of exceeding in 50 years. This acceleration corresponds with a return period of 475 years. The probabilities refer to the levels of acceleration on firm ground (solid rock).

The USGS [8] does not provide a specific PGA for Saba, however islands in direct vicinity are assigned category  $1.6\text{-}3.2 \text{ m/sec}^2$ .

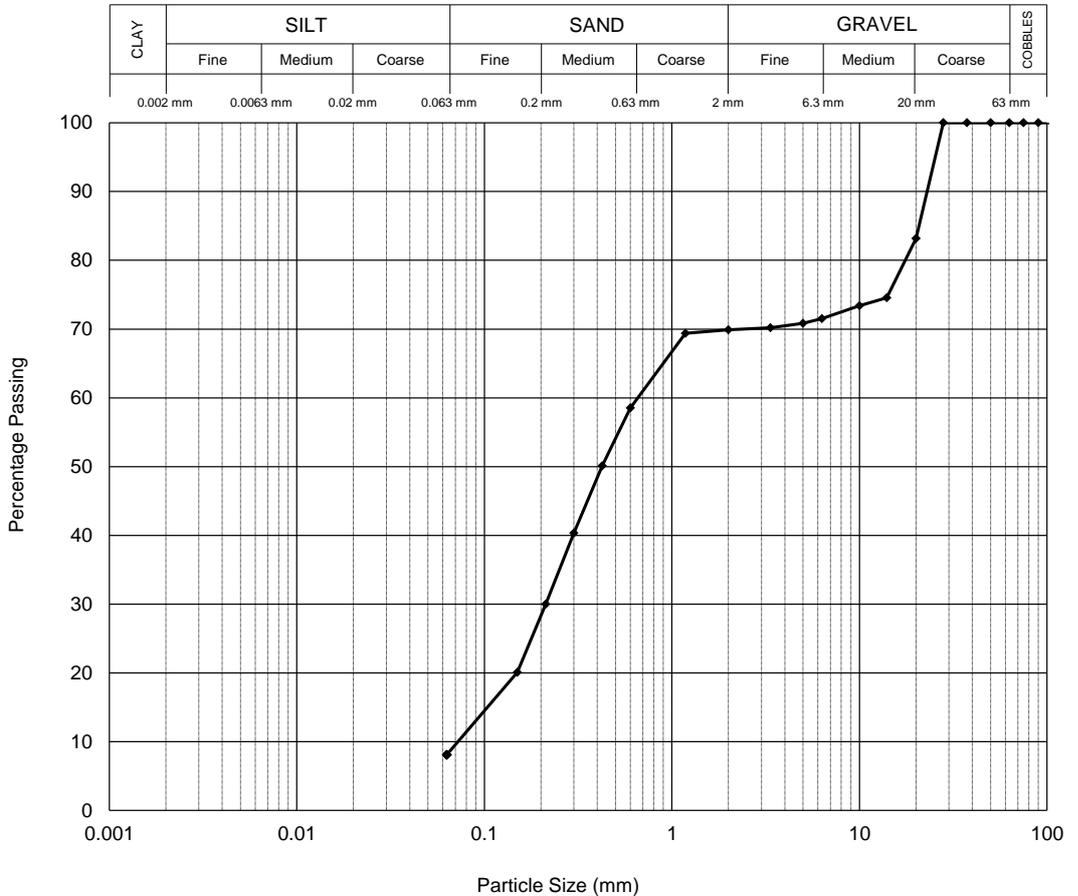
1262 - PSD BH01 00.30 D - 32168-383439.XLSM

Sieve	
Size	% Pass
200.0 mm	100
125.0 mm	100
90.0 mm	100
75.0 mm	100
63.0 mm	100
50.0 mm	100
37.5 mm	100
28.0 mm	100
20.0 mm	83
14.0 mm	75
10.0 mm	73
6.30 mm	72
5.00 mm	71
3.35 mm	70
2.00 mm	70
1.18 mm	69
600 µm	59
425 µm	50
300 µm	40
212 µm	30
150 µm	20
63 µm	8

Particle Proportions	
Cobbles	0.0
Gravel	30.1
Sand	61.8
Silt & Clay	8.1

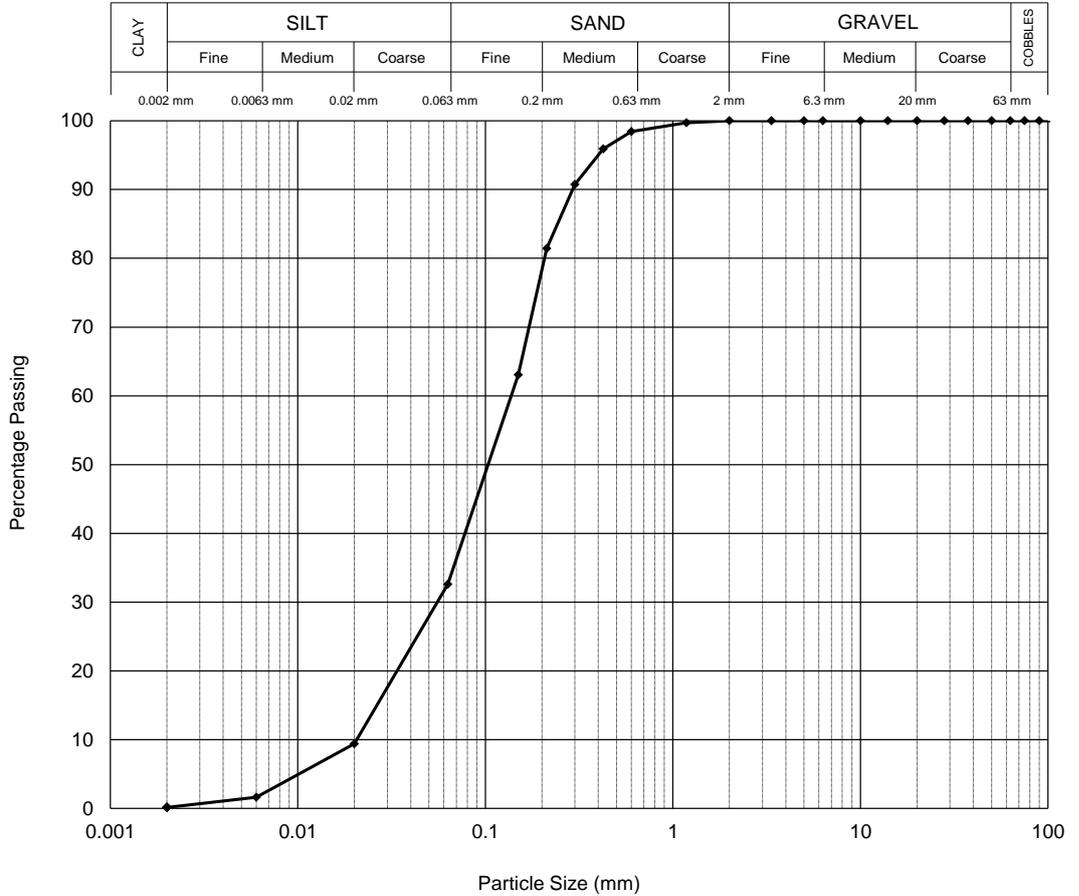
Sieve	
Size	% Pass
200.0 mm	100
125.0 mm	100
90.0 mm	100
75.0 mm	100
63.0 mm	100
50.0 mm	100
37.5 mm	100
28.0 mm	100
20.0 mm	100
14.0 mm	100
10.0 mm	100
6.30 mm	100
5.00 mm	100
3.35 mm	100
2.00 mm	100
1.18 mm	100
600 µm	98
425 µm	96
300 µm	91
212 µm	81
150 µm	63
63 µm	33

Sedimentation	
No Pre-treatment used	
Temp (°C)	25
Size	% Pass
20 µm	9
6 µm	2
2 µm	0

Particle Density 2.70(A) Mg/m<sup>3</sup>

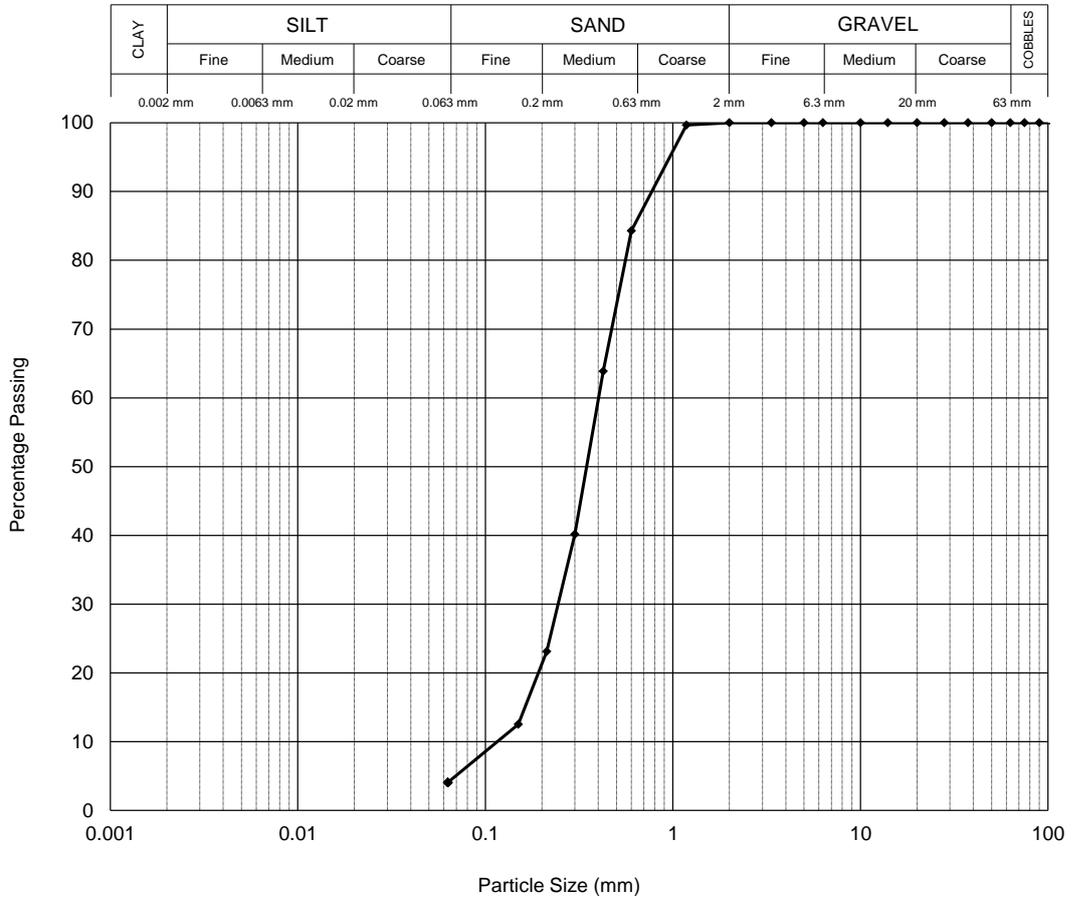
1262 - PSD BH07 03.00 D - 32168-383428.XLSM

Sieve	
Size	% Pass
200.0 mm	100
125.0 mm	100
90.0 mm	100
75.0 mm	100
63.0 mm	100
50.0 mm	100
37.5 mm	100
28.0 mm	100
20.0 mm	100
14.0 mm	100
10.0 mm	100
6.30 mm	100
5.00 mm	100
3.35 mm	100
2.00 mm	100
1.18 mm	100
600 µm	84
425 µm	64
300 µm	40
212 µm	23
150 µm	13
63 µm	4

Particle Proportions	
Cobbles	0.0
Gravel	0.0
Sand	95.9
Silt & Clay	4.1

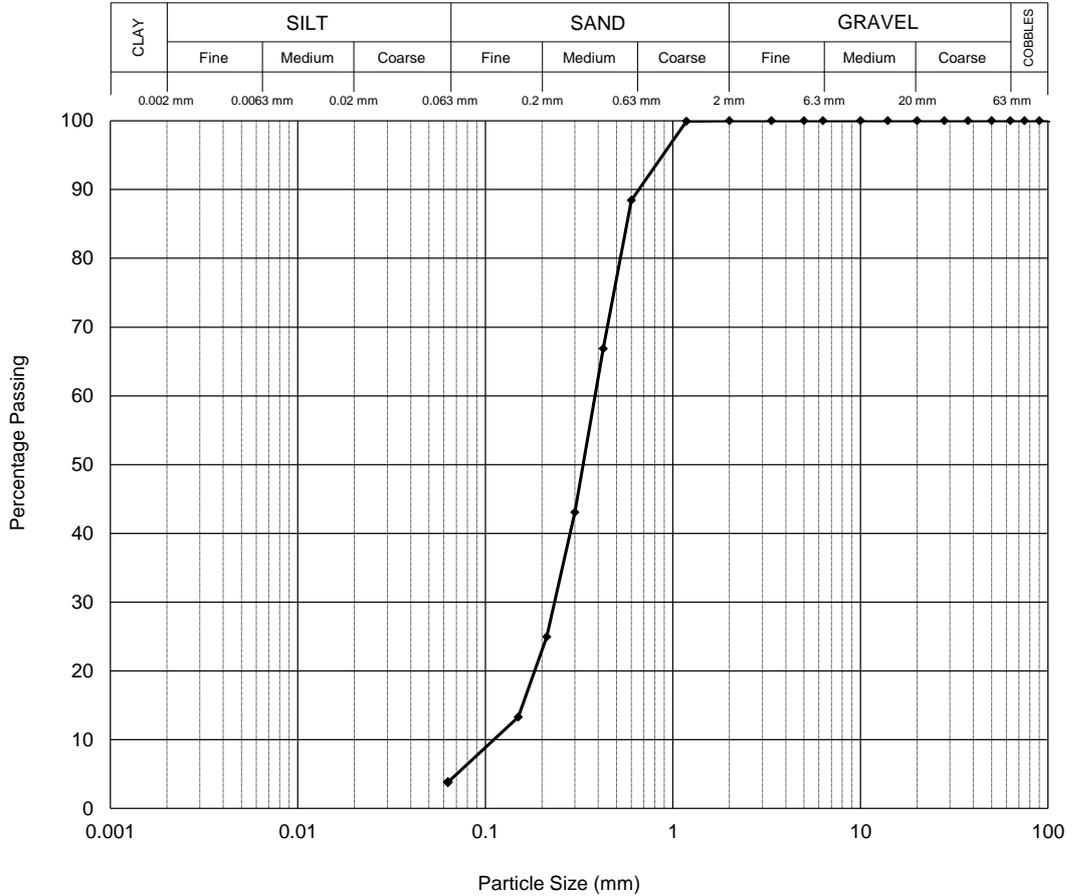
1262 - PSD BH07 07.00 D - 32168-383424-XLSM

Sieve	
Size	% Pass
200.0 mm	100
125.0 mm	100
90.0 mm	100
75.0 mm	100
63.0 mm	100
50.0 mm	100
37.5 mm	100
28.0 mm	100
20.0 mm	100
14.0 mm	100
10.0 mm	100
6.30 mm	100
5.00 mm	100
3.35 mm	100
2.00 mm	100
1.18 mm	100
600 µm	88
425 µm	67
300 µm	43
212 µm	25
150 µm	13
63 µm	4

Particle Proportions	
Cobbles	0.0
Gravel	0.0
Sand	96.2
Silt & Clay	3.8

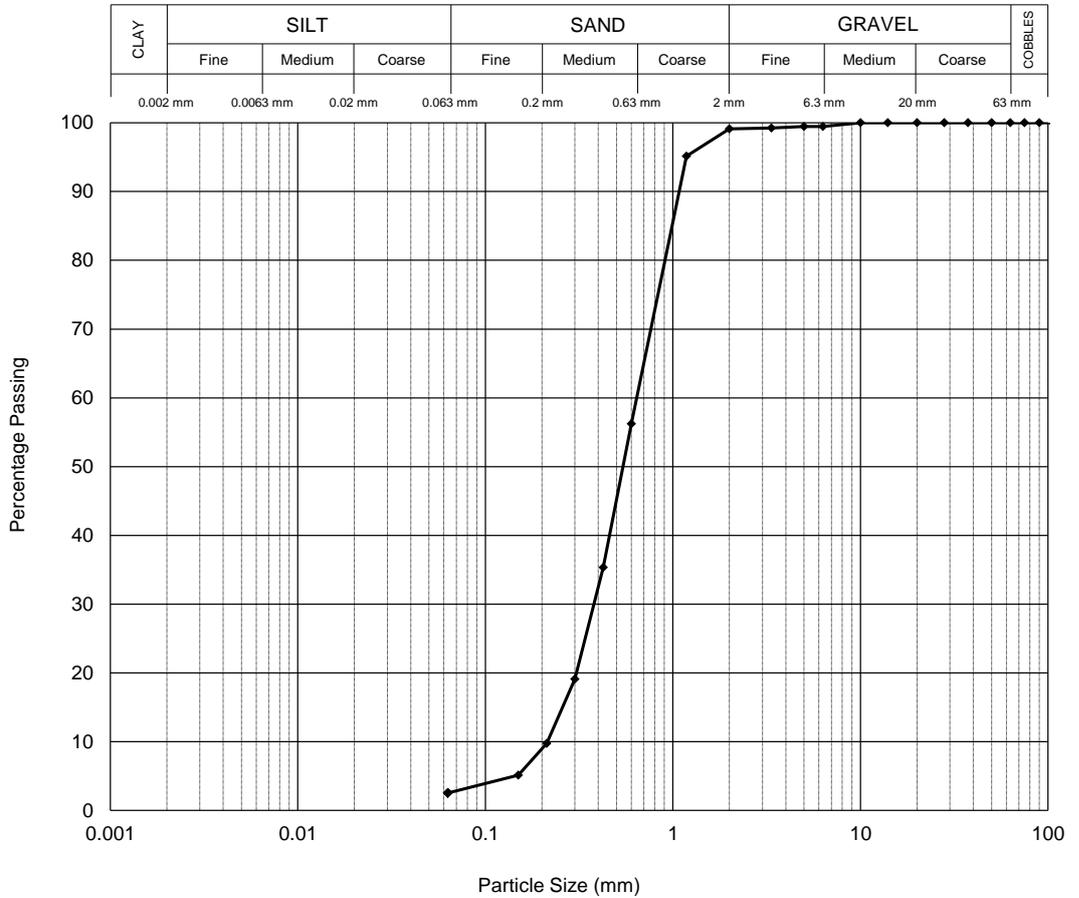
1262 - PSD BH8 04.00 AMAL - 32168-505454-XLSM

Sieve	
Size	% Pass
200.0 mm	100
125.0 mm	100
90.0 mm	100
75.0 mm	100
63.0 mm	100
50.0 mm	100
37.5 mm	100
28.0 mm	100
20.0 mm	100
14.0 mm	100
10.0 mm	100
6.30 mm	99
5.00 mm	99
3.35 mm	99
2.00 mm	99
1.18 mm	95
600 µm	56
425 µm	35
300 µm	19
212 µm	10
150 µm	5
63 µm	3

Particle Proportions	
Cobbles	0.0
Gravel	0.9
Sand	96.6
Silt & Clay	2.5

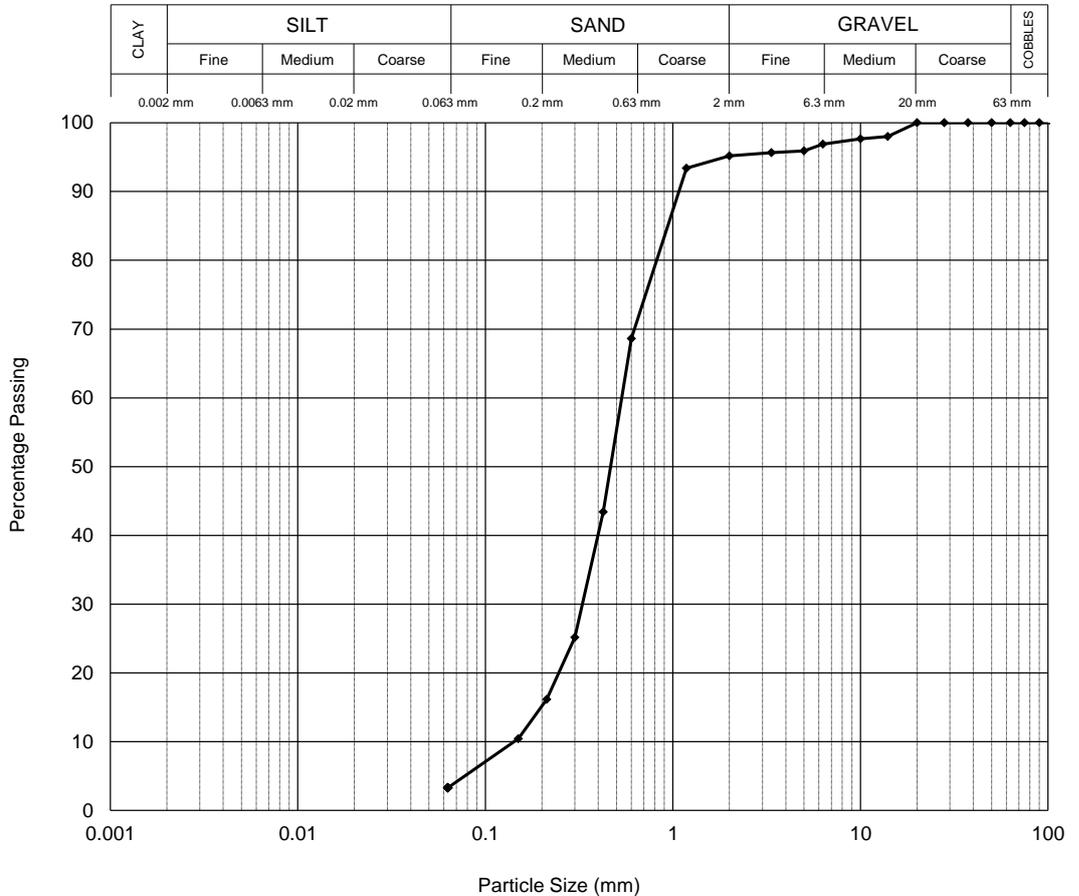
1262 - PSD BH09 01.00 D - 32168-383434.XLSM

Sieve	
Size	% Pass
200.0 mm	100
125.0 mm	100
90.0 mm	100
75.0 mm	100
63.0 mm	100
50.0 mm	100
37.5 mm	100
28.0 mm	100
20.0 mm	100
14.0 mm	98
10.0 mm	98
6.30 mm	97
5.00 mm	96
3.35 mm	96
2.00 mm	95
1.18 mm	93
600 µm	69
425 µm	43
300 µm	25
212 µm	16
150 µm	10
63 µm	3

Particle Proportions	
Cobbles	0.0
Gravel	4.8
Sand	91.9
Silt & Clay	3.3

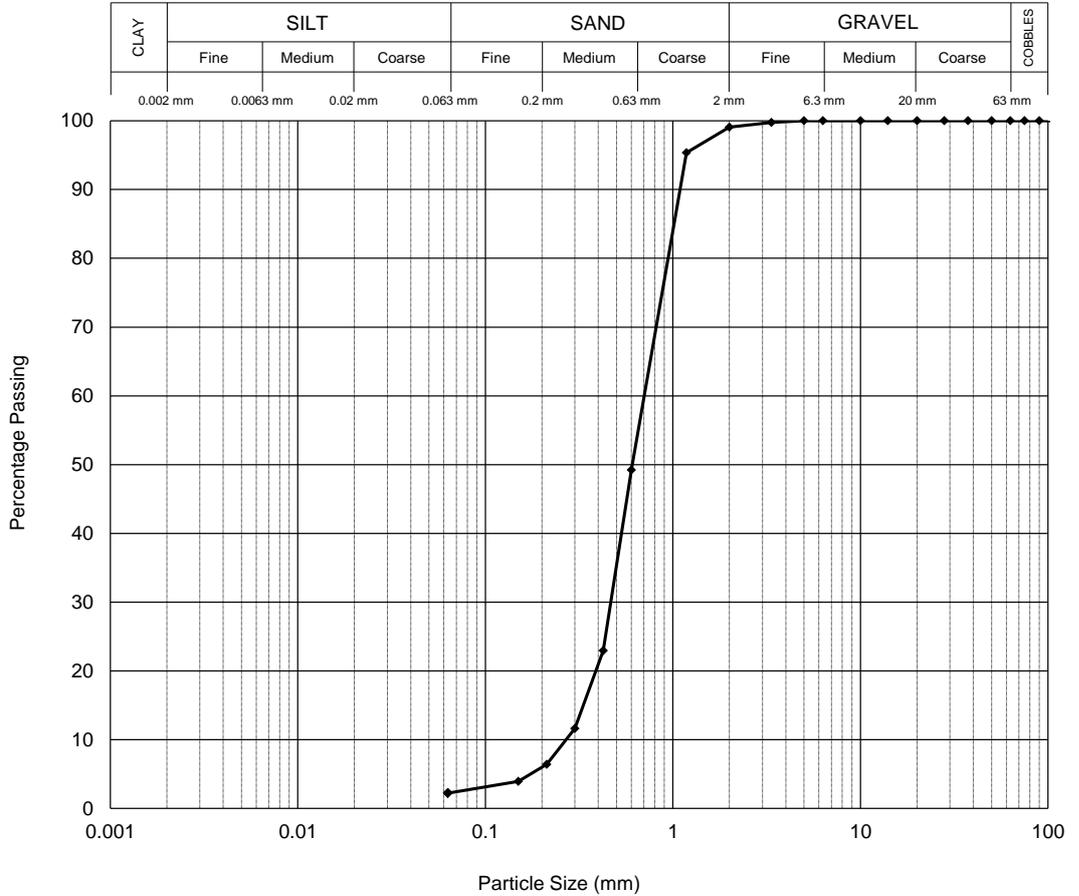
1262 - PSD BH09 06.30 D - 32168-383437-XLSM

Sieve	
Size	% Pass
200.0 mm	100
125.0 mm	100
90.0 mm	100
75.0 mm	100
63.0 mm	100
50.0 mm	100
37.5 mm	100
28.0 mm	100
20.0 mm	100
14.0 mm	100
10.0 mm	100
6.30 mm	100
5.00 mm	100
3.35 mm	100
2.00 mm	99
1.18 mm	95
600 µm	49
425 µm	23
300 µm	12
212 µm	6
150 µm	4
63 µm	2

Particle Proportions	
Cobbles	0.0
Gravel	0.9
Sand	96.8
Silt & Clay	2.3

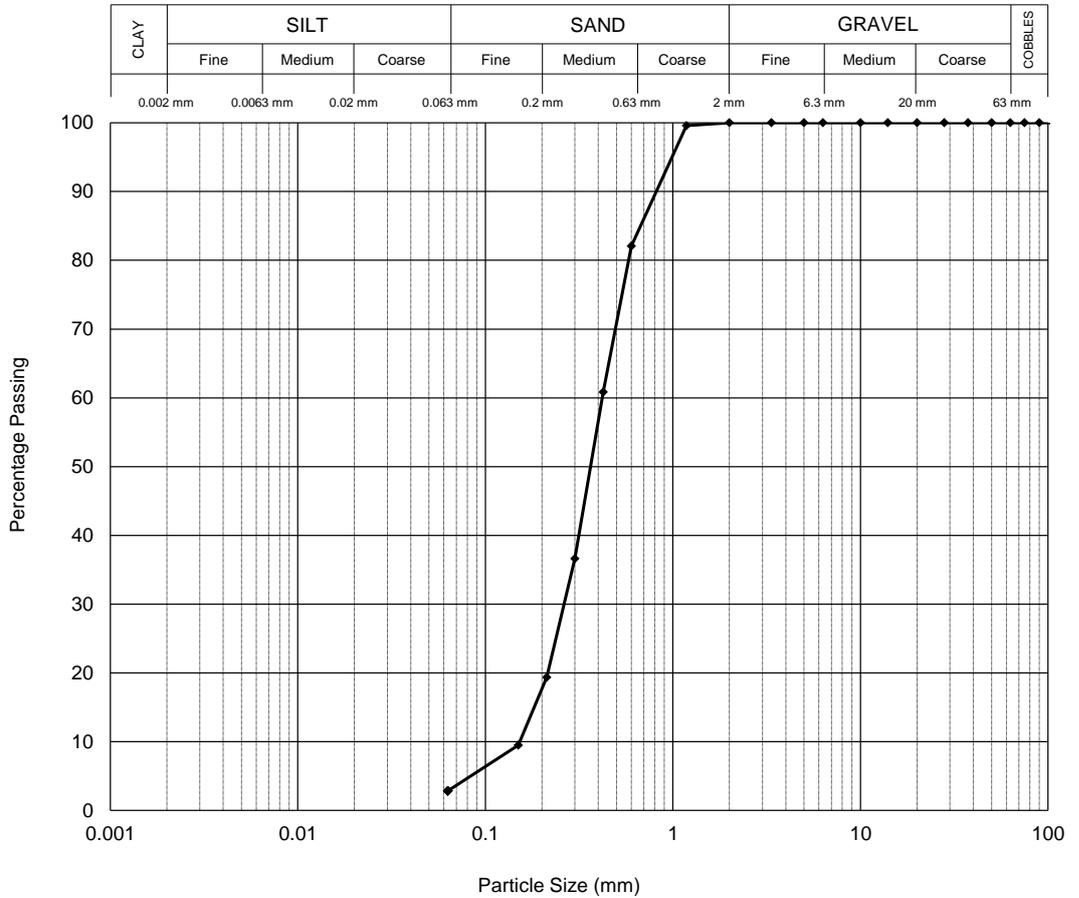
1262 - PSD BH10 06.00 D - 32168-383429-XLSM

Sieve	
Size	% Pass
200.0 mm	100
125.0 mm	100
90.0 mm	100
75.0 mm	100
63.0 mm	100
50.0 mm	100
37.5 mm	100
28.0 mm	100
20.0 mm	100
14.0 mm	100
10.0 mm	100
6.30 mm	100
5.00 mm	100
3.35 mm	100
2.00 mm	100
1.18 mm	100
600 µm	82
425 µm	61
300 µm	37
212 µm	19
150 µm	9
63 µm	3

Particle Proportions	
Cobbles	0.0
Gravel	0.0
Sand	97.2
Silt & Clay	2.8

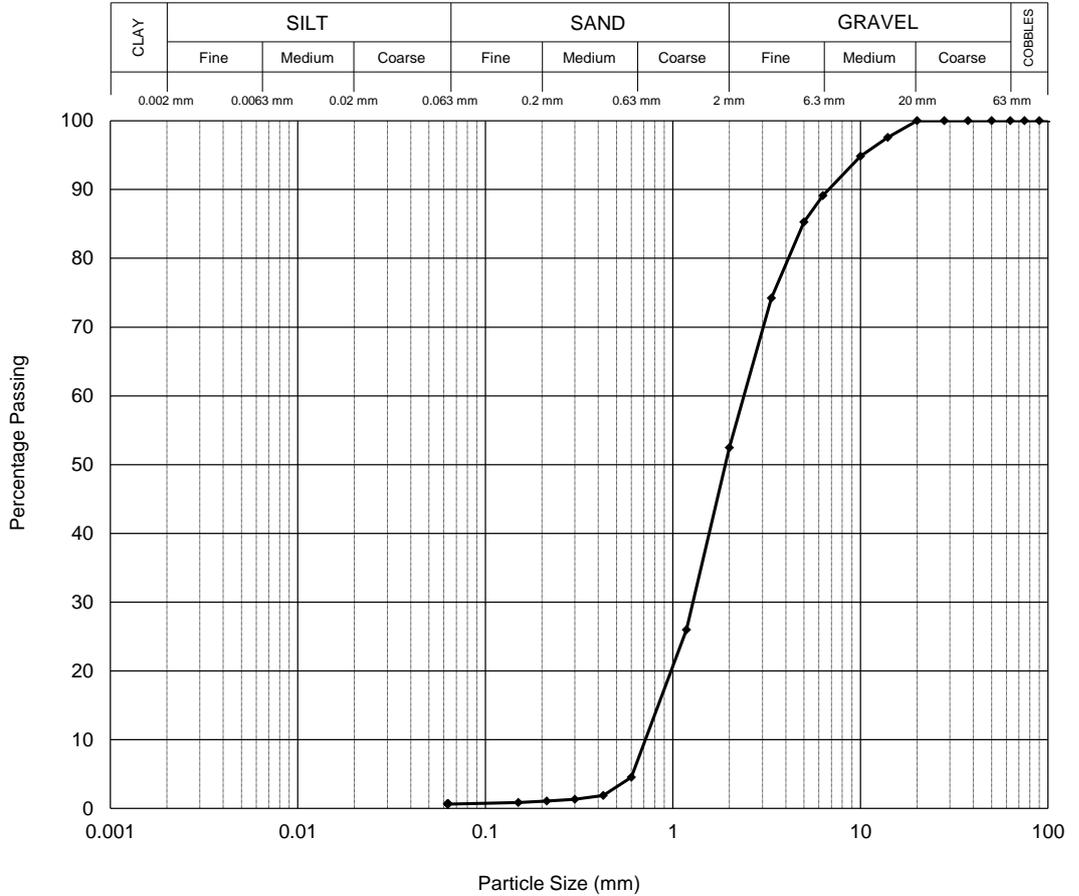
1262 - PSD BH12 03.00 D - 32168-383436-XLSM

Sieve	
Size	% Pass
200.0 mm	100
125.0 mm	100
90.0 mm	100
75.0 mm	100
63.0 mm	100
50.0 mm	100
37.5 mm	100
28.0 mm	100
20.0 mm	100
14.0 mm	98
10.0 mm	95
6.30 mm	89
5.00 mm	85
3.35 mm	74
2.00 mm	52
1.18 mm	26
600 µm	5
425 µm	2
300 µm	1
212 µm	1
150 µm	1
63 µm	1

Particle Proportions	
Cobbles	0.0
Gravel	47.5
Sand	51.8
Silt & Clay	0.7

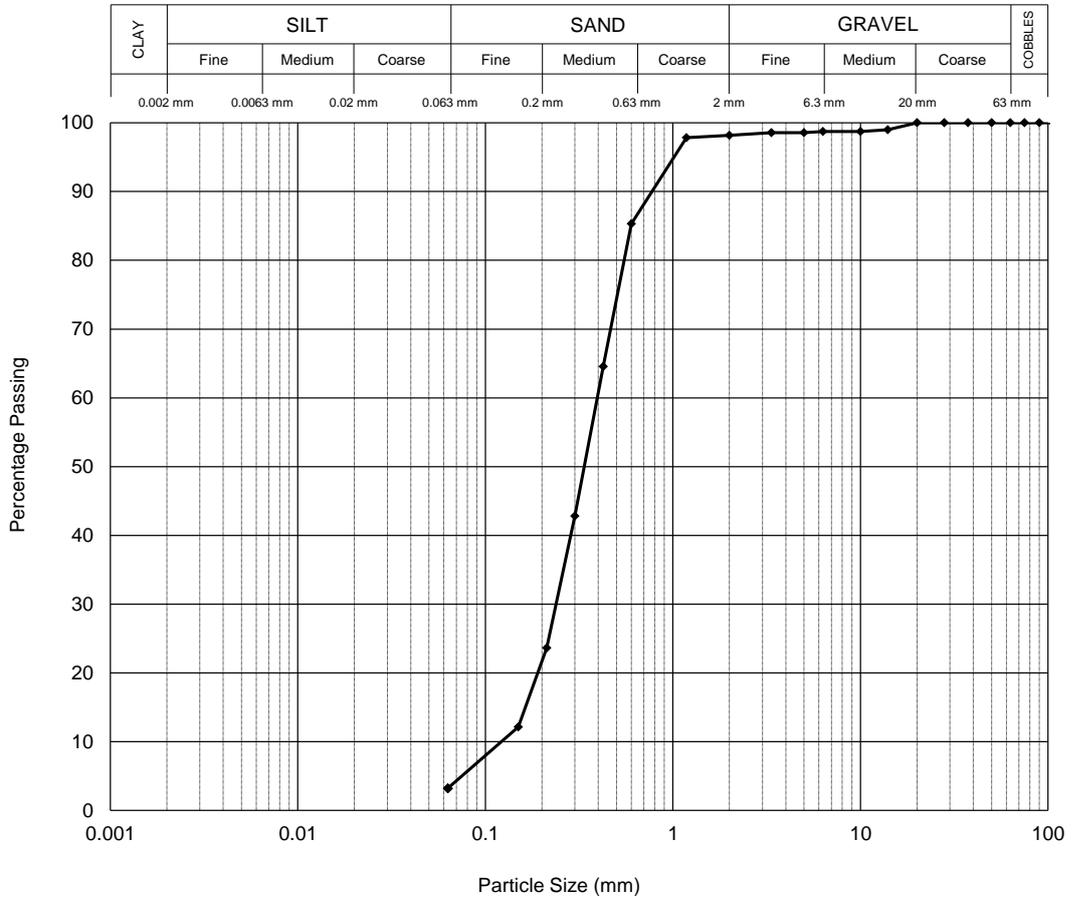
1262 - PSD BH12 07.00 D - 32168-383440-XLSM

Sieve	
Size	% Pass
200.0 mm	100
125.0 mm	100
90.0 mm	100
75.0 mm	100
63.0 mm	100
50.0 mm	100
37.5 mm	100
28.0 mm	100
20.0 mm	100
14.0 mm	99
10.0 mm	99
6.30 mm	99
5.00 mm	99
3.35 mm	99
2.00 mm	98
1.18 mm	98
600 µm	85
425 µm	65
300 µm	43
212 µm	24
150 µm	12
63 µm	3

Particle Proportions	
Cobbles	0.0
Gravel	1.8
Sand	95.0
Silt & Clay	3.2

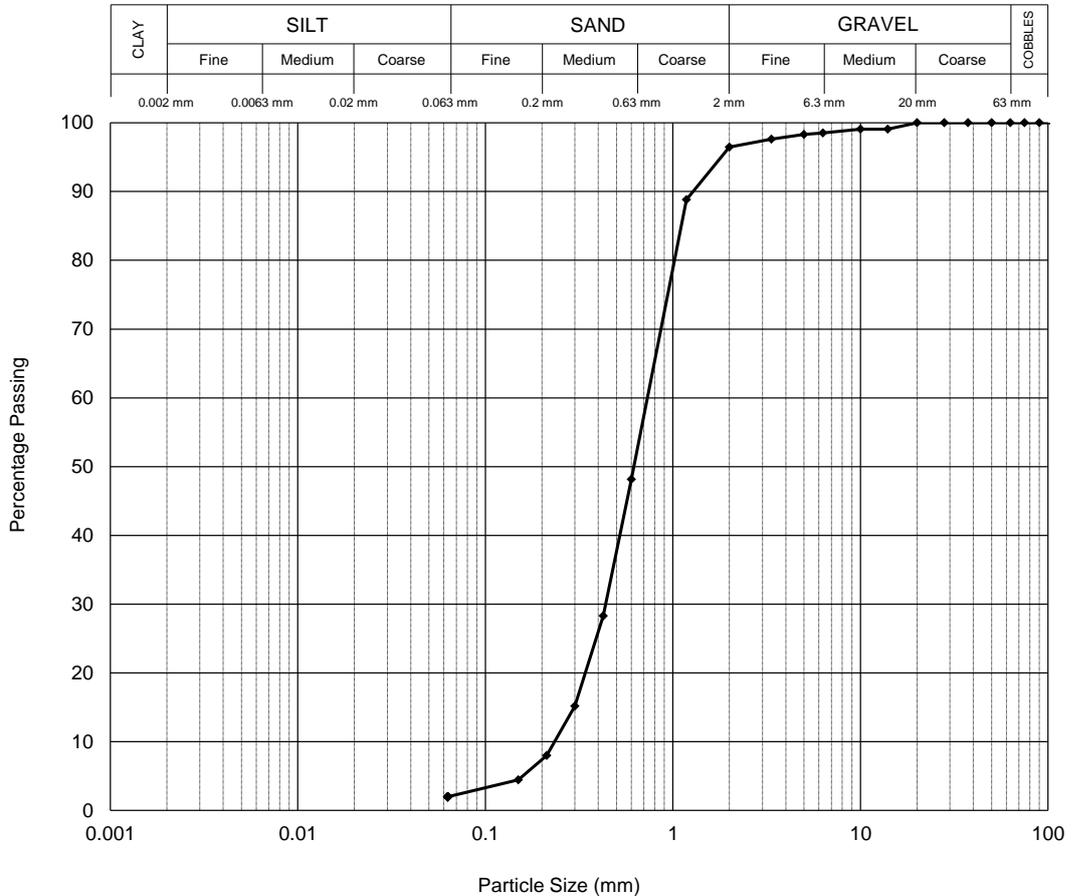
1262 - PSD BH16 03.50 D - 32168-383438-XLSM

Sieve	
Size	% Pass
200.0 mm	100
125.0 mm	100
90.0 mm	100
75.0 mm	100
63.0 mm	100
50.0 mm	100
37.5 mm	100
28.0 mm	100
20.0 mm	100
14.0 mm	99
10.0 mm	99
6.30 mm	99
5.00 mm	98
3.35 mm	98
2.00 mm	96
1.18 mm	89
600 µm	48
425 µm	28
300 µm	15
212 µm	8
150 µm	4
63 µm	2

Particle Proportions	
Cobbles	0.0
Gravel	3.5
Sand	94.5
Silt & Clay	2.0

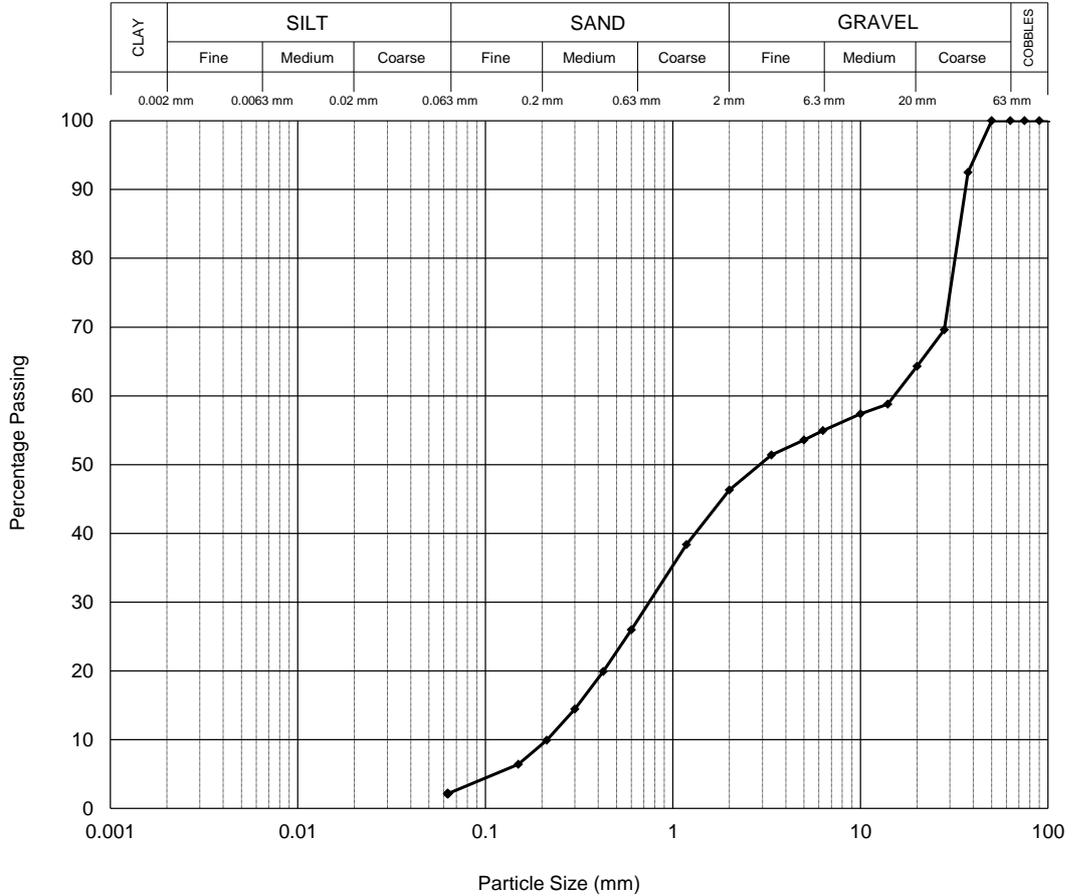
Sieve	
Size	% Pass
200.0 mm	100
125.0 mm	100
90.0 mm	100
75.0 mm	100
63.0 mm	100
50.0 mm	100
37.5 mm	92
28.0 mm	70
20.0 mm	64
14.0 mm	59
10.0 mm	57
6.30 mm	55
5.00 mm	54
3.35 mm	51
2.00 mm	46
1.18 mm	38
600 µm	26
425 µm	20
300 µm	14
212 µm	10
150 µm	6
63 µm	2

Particle Proportions	
Cobbles	0.0
Gravel	53.7
Sand	44.2
Silt & Clay	2.1
