**Report:**

**Environmental Impact Assessment  
(EIA) for the harbor construction at  
Black Rocks, Saba**

Final report

June, 2022

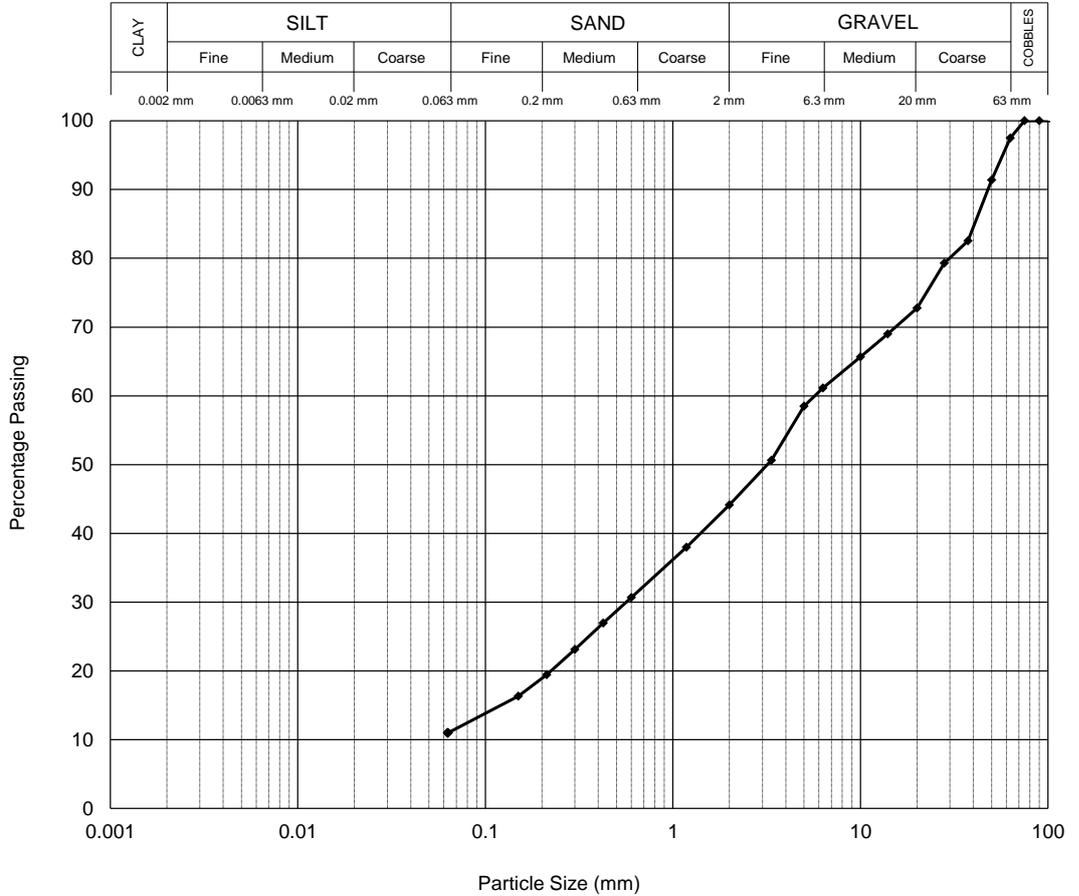
Sieve	
Size	% Pass
200.0 mm	100
125.0 mm	100
90.0 mm	100
75.0 mm	100
63.0 mm	98
50.0 mm	91
37.5 mm	83
28.0 mm	79
20.0 mm	73
14.0 mm	69
10.0 mm	66
6.30 mm	61
5.00 mm	58
3.35 mm	51
2.00 mm	44
1.18 mm	38
600 µm	31
425 µm	27
300 µm	23
212 µm	19
150 µm	16
63 µm	11

Particle Proportions	
Cobbles	2.5
Gravel	53.4
Sand	33.2
Silt & Clay	10.9

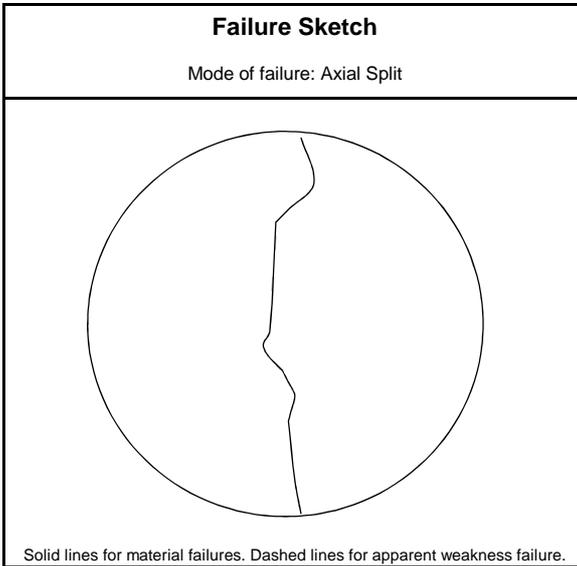
**Failure Sketch**

Mode of failure: Axial Split

Solid lines for material failures. Dashed lines for apparent weakness failure.  
 LF0879C (1000kN) compression frame and steel loading jaws used

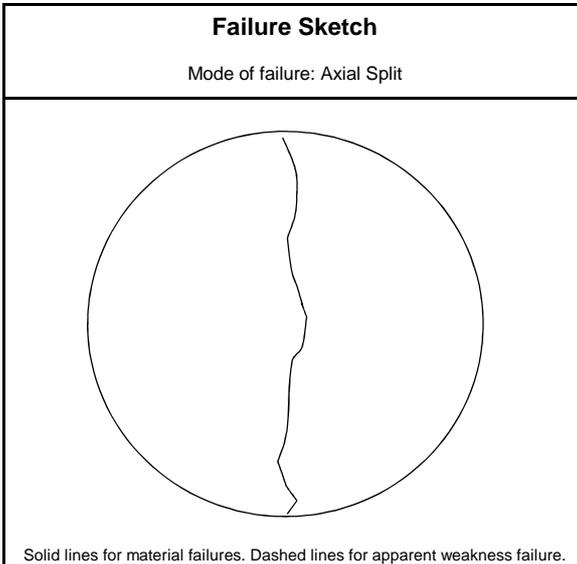
**Failure Sketch**

Mode of failure: Axial Split

Solid lines for material failures. Dashed lines for apparent weakness failure.  
 LF0879C (1000kN) compression frame and steel loading jaws used

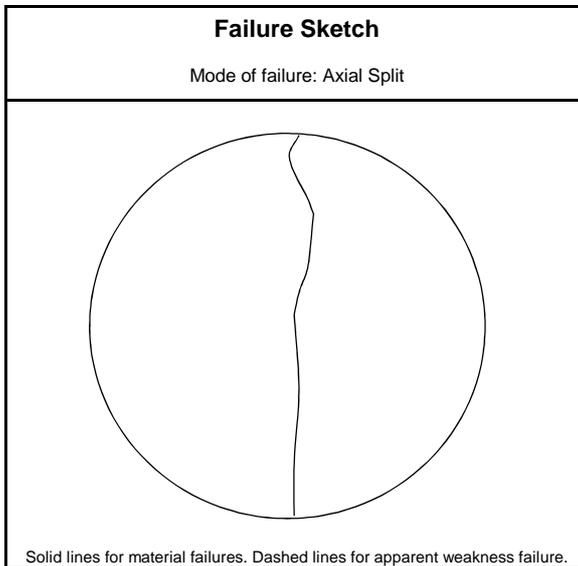
**Failure Sketch**

Mode of failure: Axial Split

Solid lines for material failures. Dashed lines for apparent weakness failure.  
 LF0879C (1000kN) compression frame and steel loading jaws used

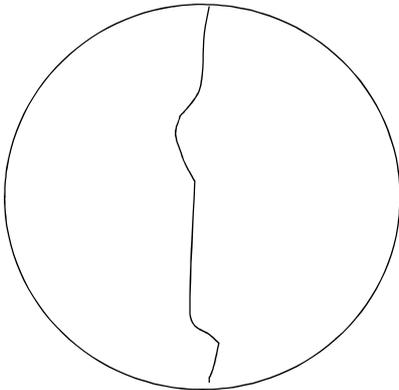
**Failure Sketch**

Mode of failure: Axial Split

Solid lines for material failures. Dashed lines for apparent weakness failure.  
 LF0879C (1000kN) compression frame and steel loading jaws used

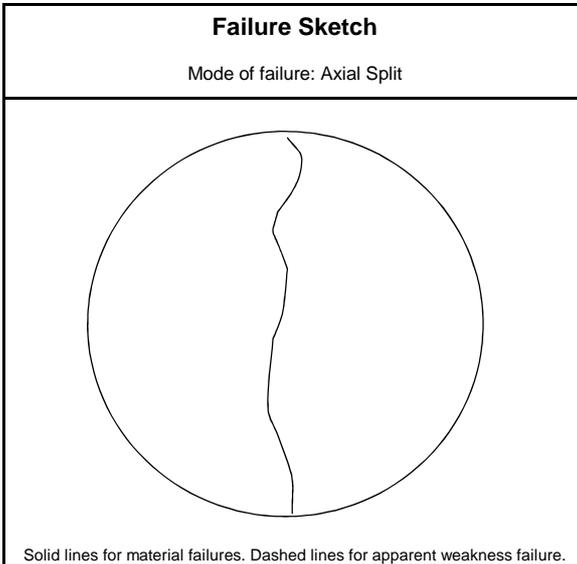
**Failure Sketch**

Mode of failure: Axial Split

Solid lines for material failures. Dashed lines for apparent weakness failure.  
 LF0879C (1000kN) compression frame and steel loading jaws used

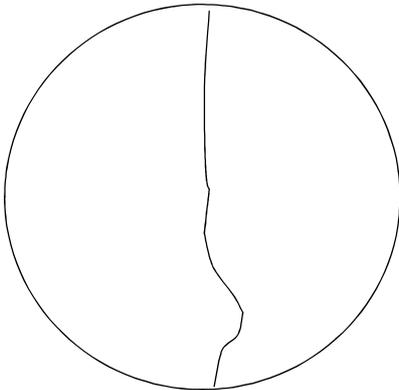
**Failure Sketch**

Mode of failure: Axial Split

Solid lines for material failures. Dashed lines for apparent weakness failure.  
 LF0879C (1000kN) compression frame and steel loading jaws used

<b>Failure Load</b>
<b>8.10 kN</b>

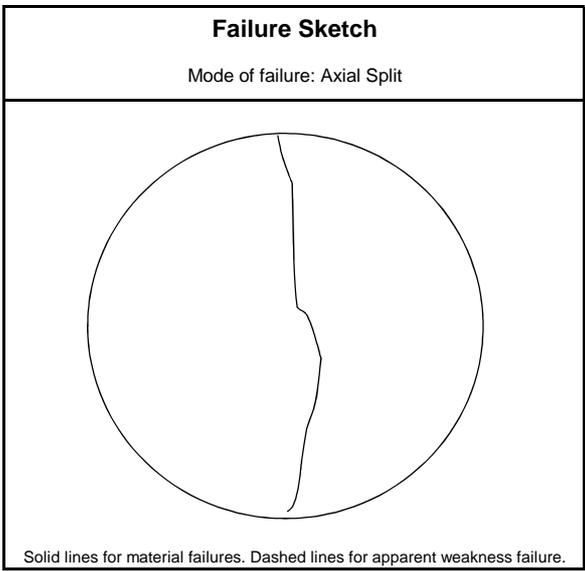
**Failure Sketch**

Mode of failure: Axial Split

Solid lines for material failures. Dashed lines for apparent weakness failure.  
 LF0879C (1000kN) compression frame and steel loading jaws used

**Failure Load**

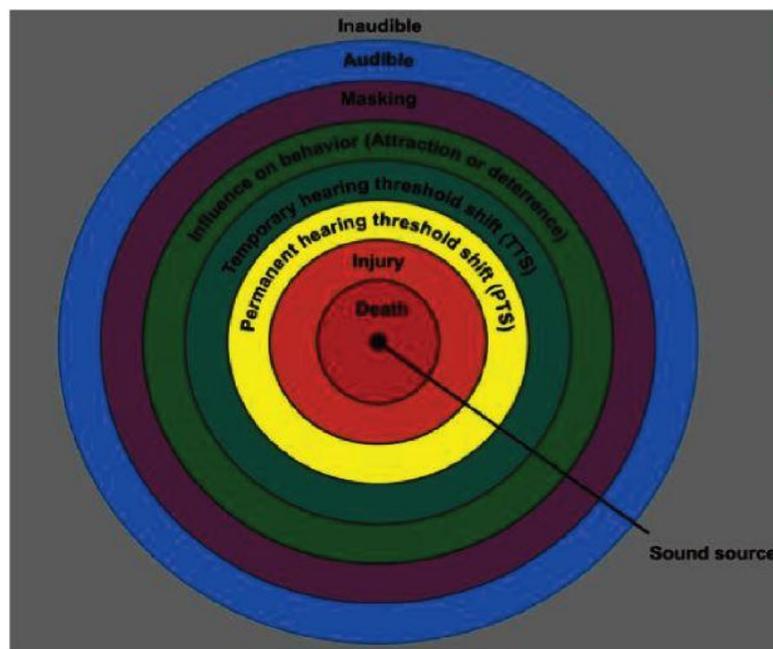
Figure 1. Range of effects of a sound source on marine mammals (Prins, Twisk, Van den Heuvel-Greve, Troost, & Van Beek, 2008)

According to figure 1, underwater noise levels can be categorized at different ranges. The closer the organism is to the source, the higher the probability that it might die (Nedwell, Turnpenny,

Langworthy, & Edwards, 2003). The region marked as red can result in death or injury, which is the closest to the sound source (distance is dependent on the intensity of the sound). Outside of the red zone there is the permanent hearing threshold shift (PTS) and the temporary hearing threshold shift (TTS). PTS and TTS are term used to describe noise-induced hearing loss. For example, TTS (green) can be explained by temporary hearing loss experienced by humans when a firecracker goes off nearby. As for PTS (yellow), this is when permanent damage is done to the hearing threshold (Saleem 2011). Table 1 shows the hearing thresholds of two animal orders.

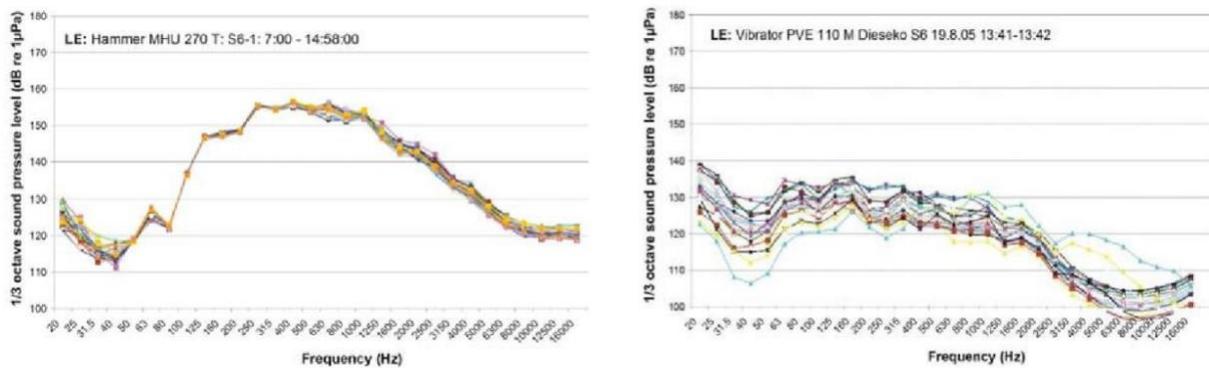
Figure 2: Noise Spectrum of a Impact hammer (Left) vs Vibrational hammer (right) (Elmer, Neumann, Gabriel, Betke, & Glahn, 2007)

be more depending on the type of pile and soil conditions. Figure 2 shows two noise spectrum comparing impact hammer vs vibratory hammer.

Even though vibratory pile driving has advantages it has to be noted that a disadvantage is not being able to control the reliability of the bearing capacity. In permanent applications vibro piles are struck with an impact hammer to check the bearing capacity, which reduces the economic and environmental benefits of using vibratory drivers (Deep Foundations Institute 2015).

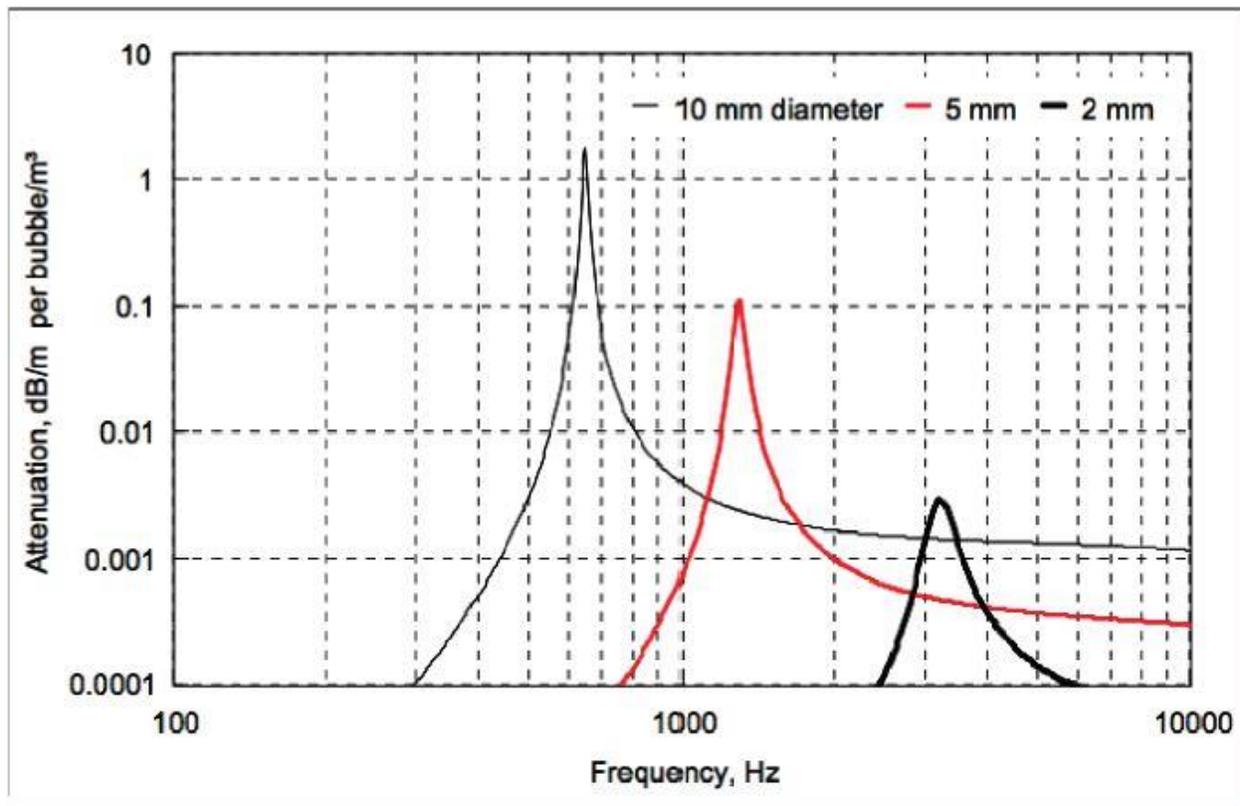
Figure 3: Sound reduction for various bubble sizes in the sound spectrum (Nehls, Betke, Eckelmann, & Ross, 2007)

installation technique. The sound reduction of this method is theoretically calculated to be around 10 dB, and with the combination of other methods such as the sound isolation/damping methods can provide a solution. Sound damping is the isolation and dampening of noise during the pile driving operation, be it hydraulic impact or vibrational pile driving. The two techniques used to achieve this are the confined bubble curtains and pile sleeves (Saleem 2011). According to Saleem, one of the greatest benefits of using these techniques is that the existing installation techniques don't need to be altered (Saleem 2011). The principle of using air bubble for noise reduction is based on a phenomenon of sound scattering and on the resonance of vibrating air bubbles. Different bubbles size dampens different sound in the spectrum, as can be seen in figure 3.

As shown, the bigger the bubble diameter, the wider coverage it has of the spectrum. It is difficult to create larger bubbles, because the larger the bubble, the less stable it becomes and breaks up into smaller bubbles as it is traveling to the water surface (Saleem 2011). Another factor to account for is that the ocean is in constant motion, therefore the bubbles created on the sea bed will be swept by the current and the noise reduction might not occur. Therefore,

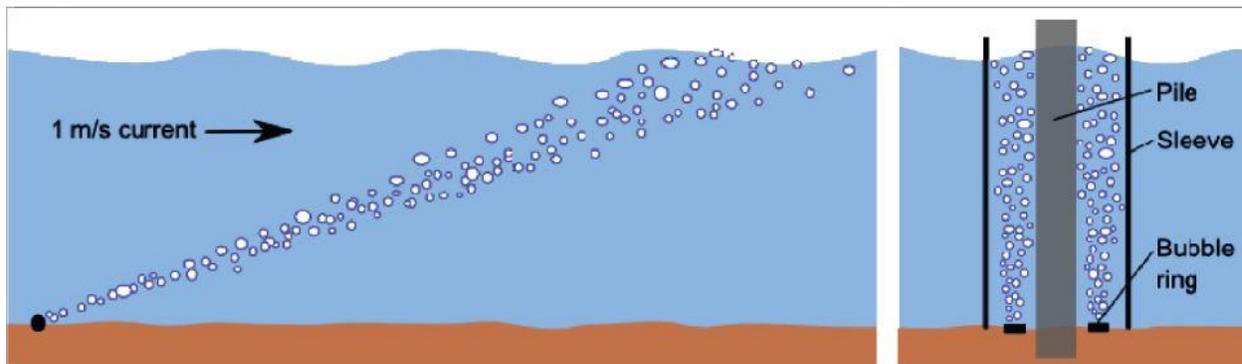
Figure 4: open bubble curtain vs confined bubble curtain (Nehls, Betke, Eckelmann, & Ros, 2007)

using a sleeve as a confinement can contain the bubbles as seen in figure 4.

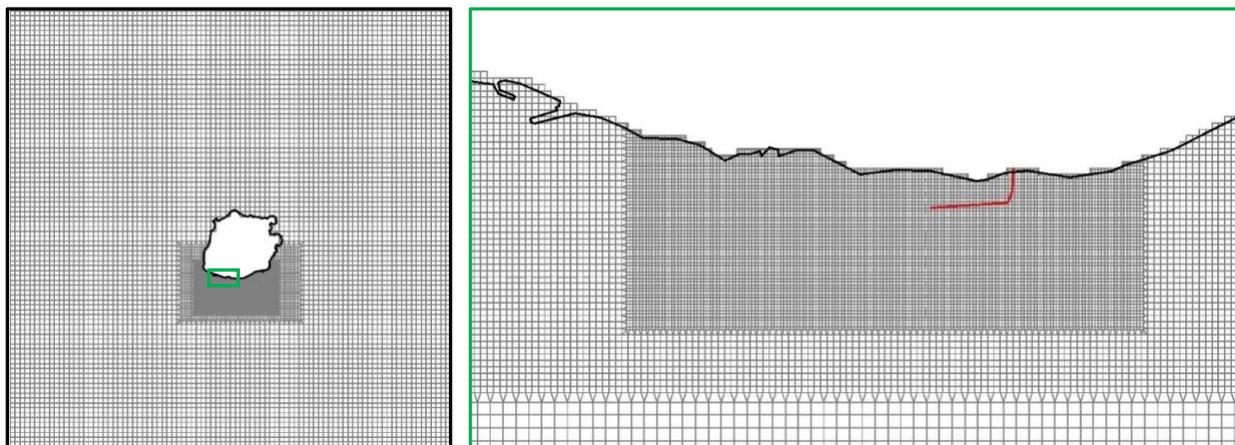
Figure 1: Grid used in model (left) with magnification of grid (right) at harbour area.

The modelling area consists of 625 km<sup>2</sup> (25x25km) with the island of Saba situated in the centre of the modelling area. A grid was projected on the modelling area including several refinements at the area to study. The finer grid consists of cells of 18 by 18 metres. A figure of the grid is shown in figure 1.

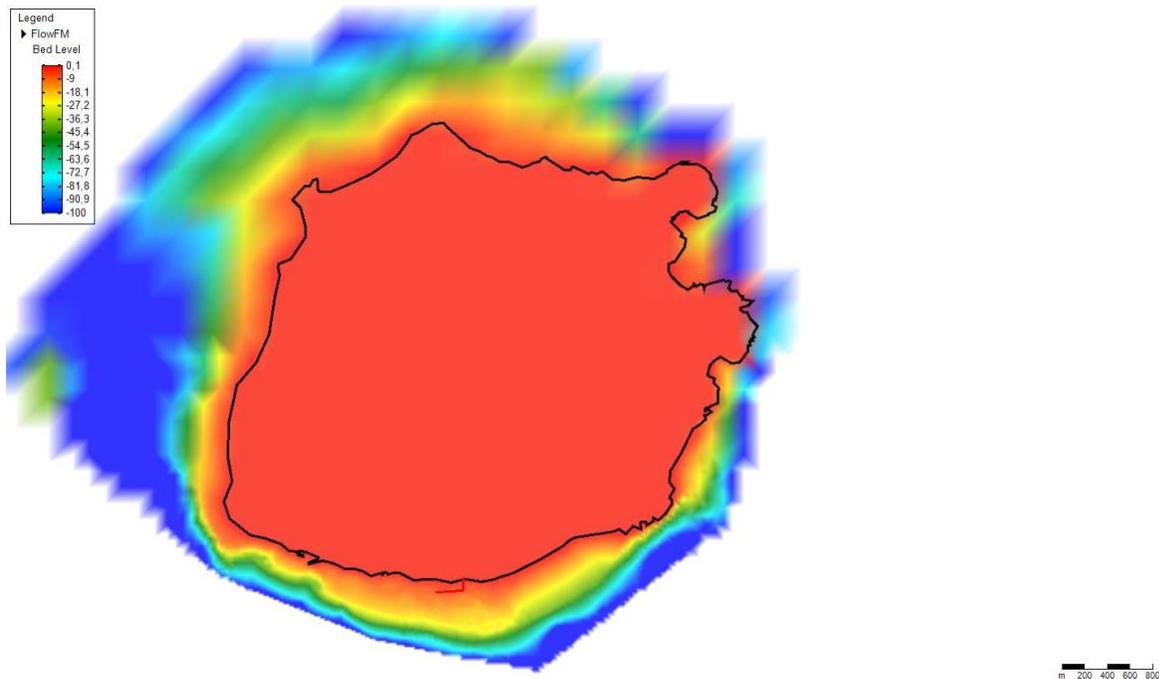
Figure 2: Bathymetry around Saba used for the Delft3D model.

For the bathymetry depth contours surrounding Saba were introduced. As a simplification of the model, all depths greater than 100 metres were set to a fixed value of 100 metres. This improves the water balance over the boundaries, and has only minor ramifications for the final results (pers. comm. Deltares).

For bottom roughness, used by Delft3D to determine the bottom friction, the uniform friction type 'Manning' was selected with a uniform friction coefficient of 0.023 (comparable to roughness of firm gravel). An illustration of the bathymetry is shown in figure 2.

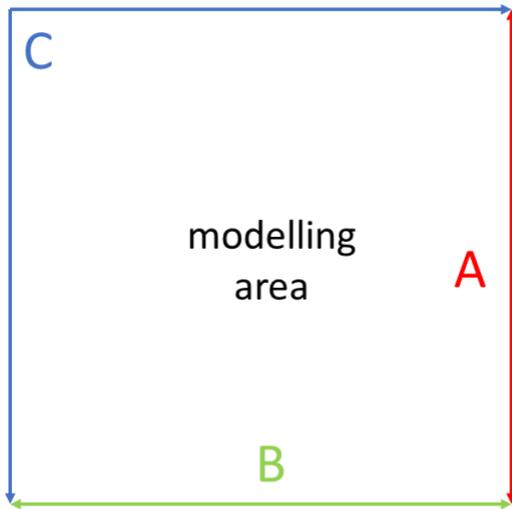
Figure 3 Illustration of orientation boundaries to modelling area

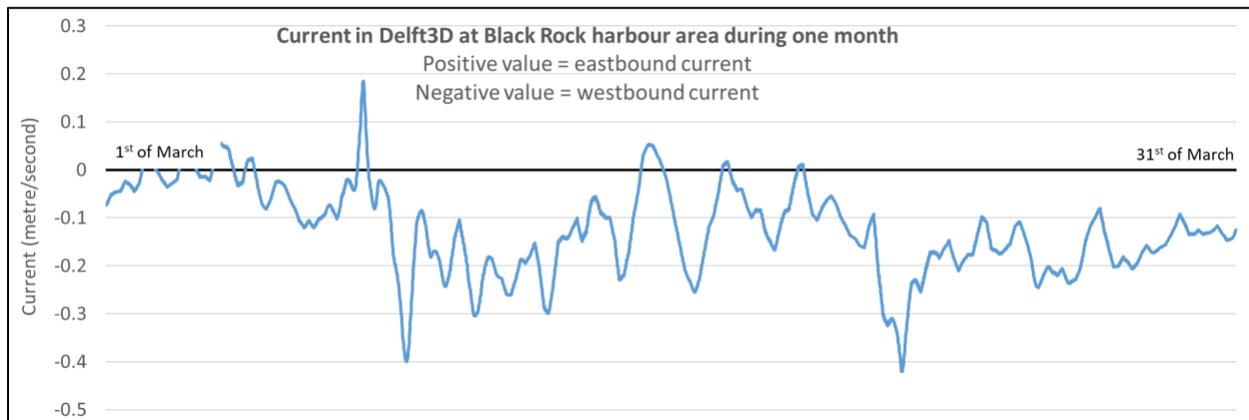
Figure 4 Modelled current velocity during March 2018 at Black Rock Harbour (average 11 cm/s; positive values indicate current reversals).

Figure 4 shows current velocities modelled near the Black Rock harbour area during one month (March 2018). Note that the current reverses several times during that month.

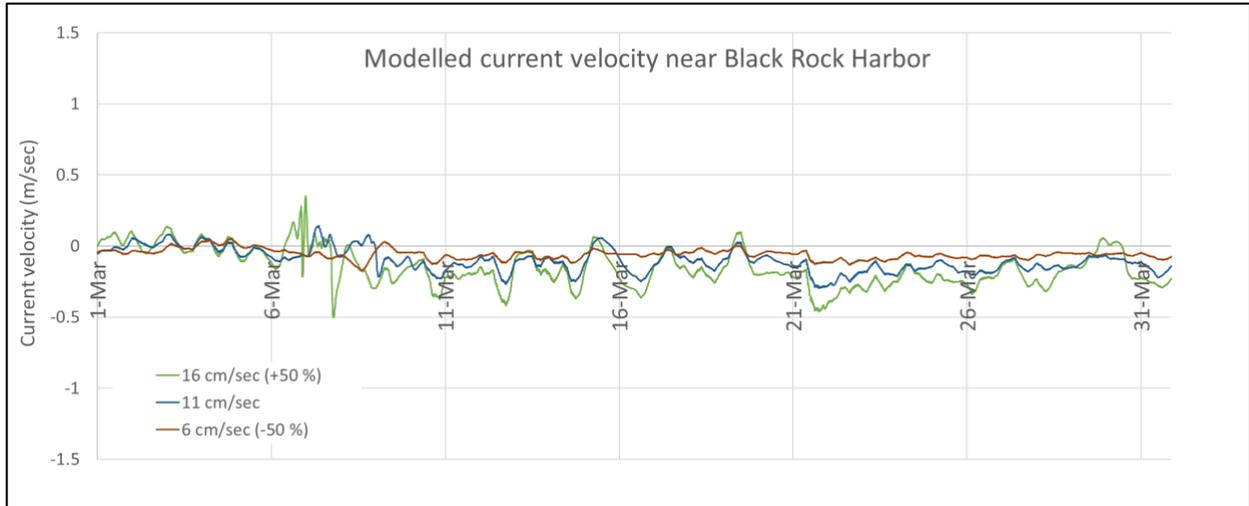
Figure 5: Current velocities sensitivity analysis

The resulting current velocities are included in figure 5.

The analysis points out that suspended solids concentration (SSC) and deposition increase by a factor of maximally 30% (deposition) to 48% (average SSC) in the low current scenario, as compared to the 11 cm/s scenario (see tables 7-10).

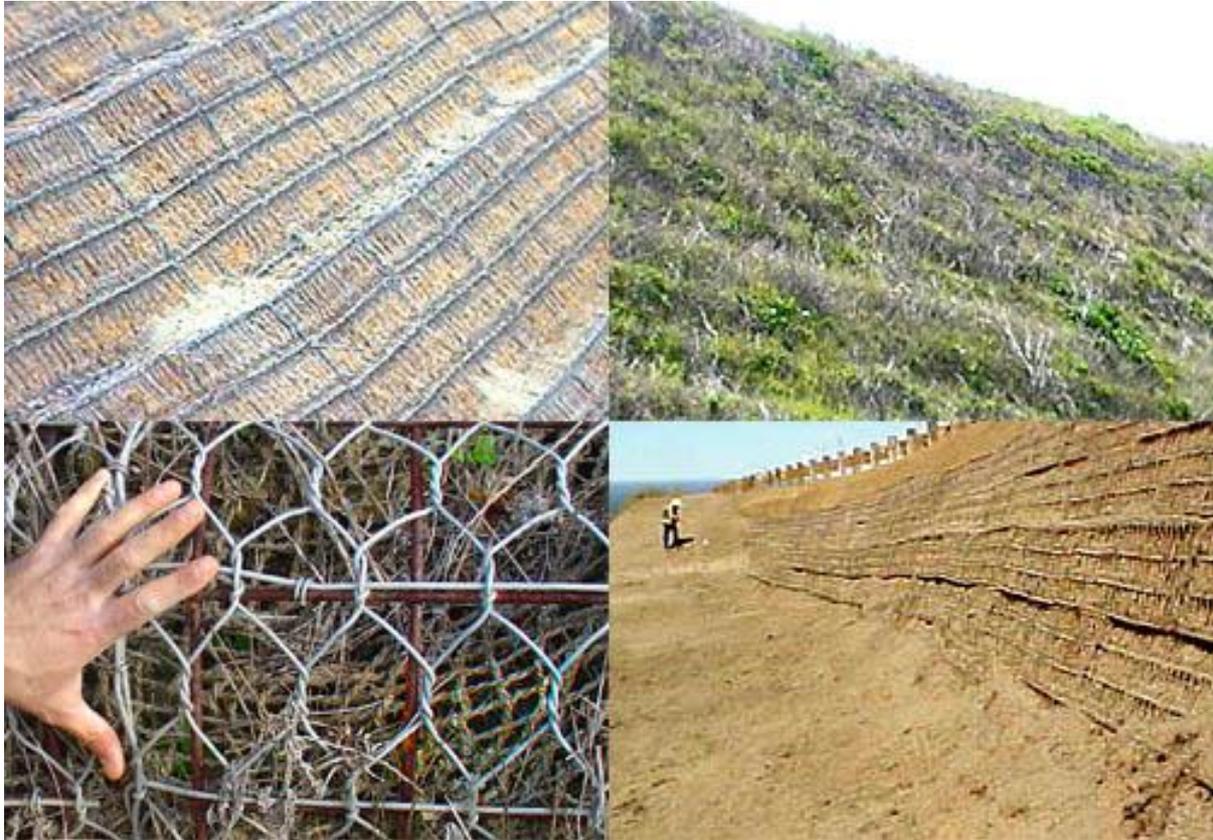
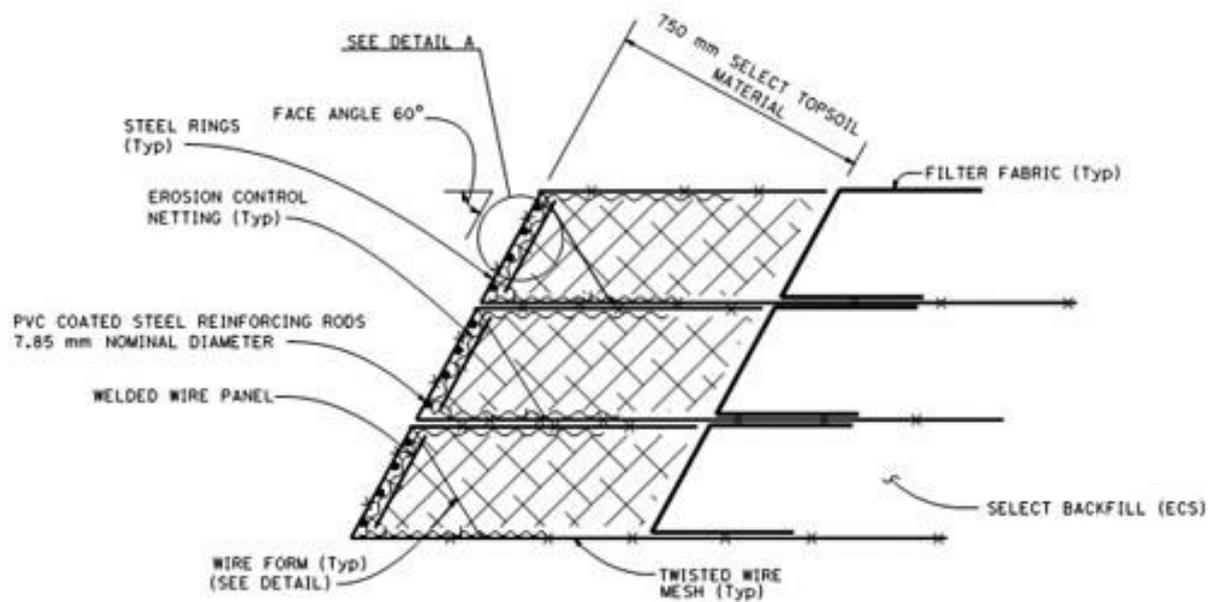
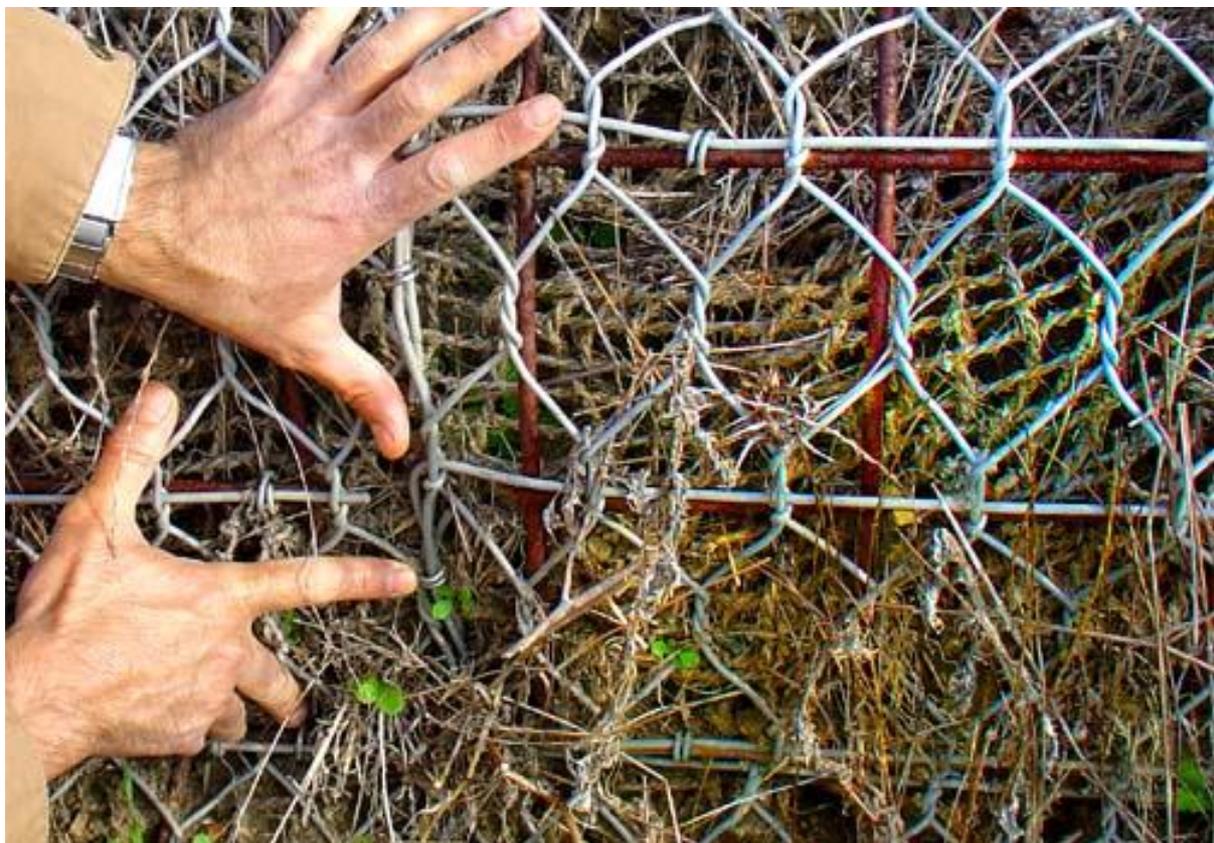
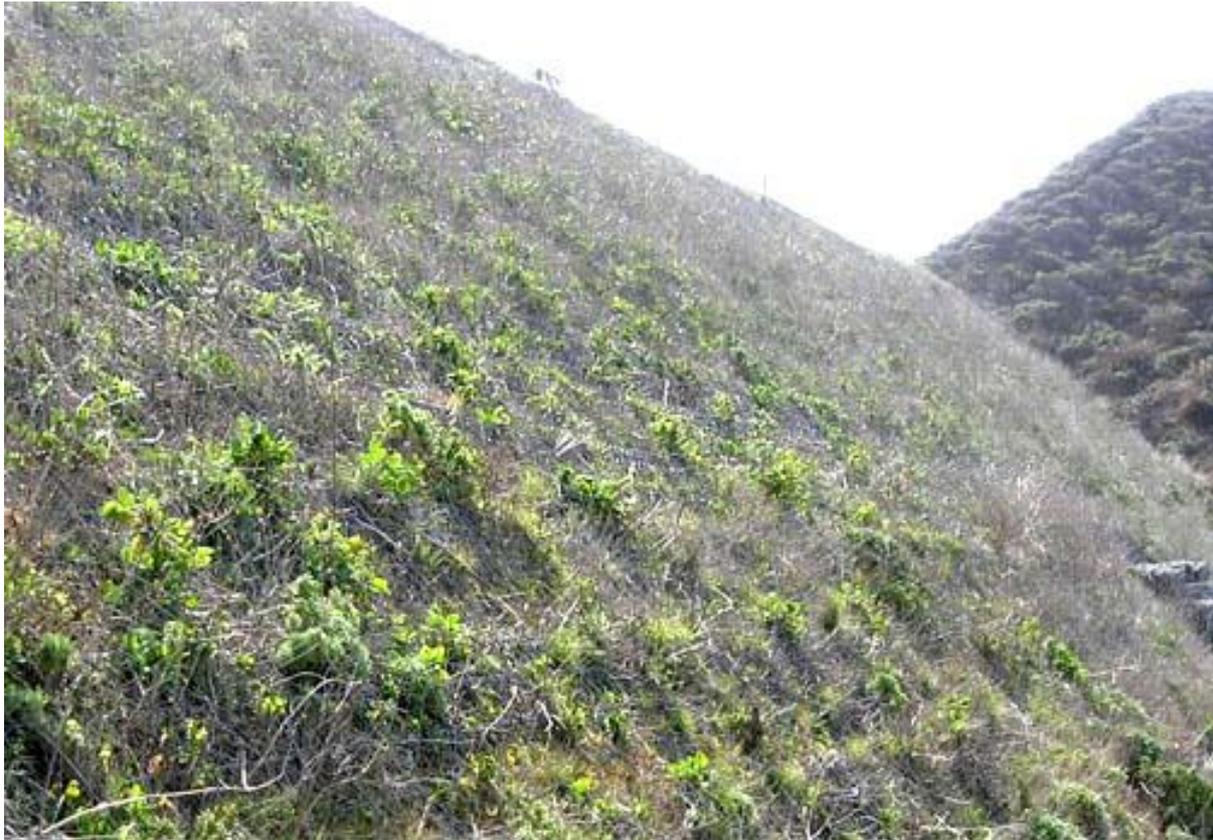
# Erosion Control Toolbox: Wire Mesh Confinement System

Slopes steeper than 1:1 (H:V) will not reliably support vegetation and require a more permanent confinement technique than Rolled Erosion Control Products (RECP). A wire mesh confinement system provides additional shear strength necessary to hold non-vegetated fill material in place. Key features include:

- Structural backfill material is placed in a double twisted wire mesh enclosure with an articulated front face that can be set to match the desired slope angle
- The bottom of the confinement system can function as a geosynthetic reinforcement layer which enhances slope stability
- [Local Topsoil](#) or select material is typically used at the slope to support sustainable vegetative growth
- [Rolled Erosion Control Product \(RECP\) Netting](#) is placed inside the confinement system to prevent release of topsoil through the face
- Welded Wire Confinement System is also known as Embankment Confinement System

- Fill or reconstructed cut slopes that are between 1.5:1 (H:V) and 0.5:1 (H:V).
- Coordinate the use of this treatment with the [Division of Engineering Services \(DES\) Office of Geotechnical Services](#), which may prepare a Geotechnical Design Report for slopes greater than 2:1 (H:V)

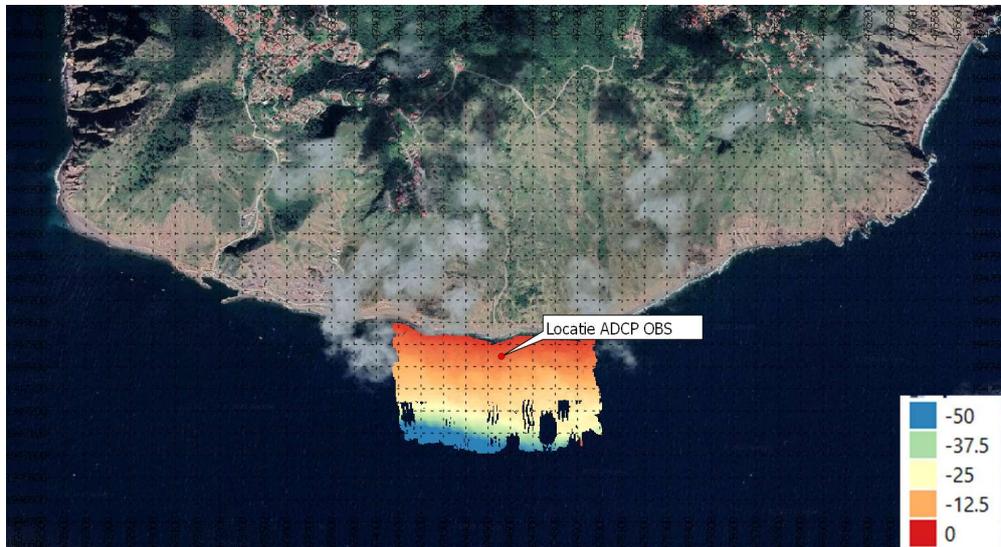
Figure 1 Location of equipment

The instruments were mounted against a rock. The local water depth (from the top of the rock) was 7 m, the surrounding sandy bottom was approximately 8 m deep. The location of the measurements is indicated in figure 1, which is directly south of the planned Black Rocks harbour development.

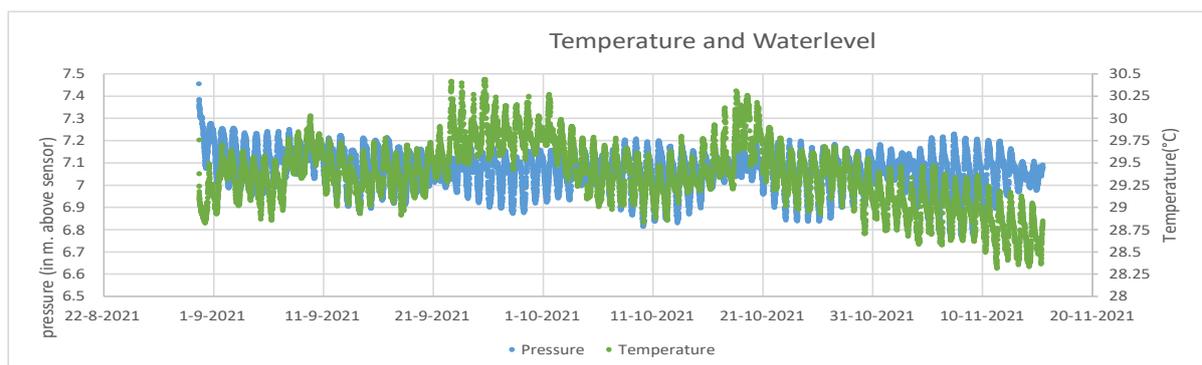
Figure 2 Temperature and water level recording in the period September-November 2021

The measured water levels (or actually: the water column above the sensor of the instrument) and the recorded water temperatures are presented in figure 2 and in the appendix. The pressure and temperature sensors are located approximately 7 m below the water surface. As can be seen in figure 3 the temperatures shows a daily fluctuation which is not related to the tide but to the time only, the temperatures ranges between 28.5 and 30.5 °C, the maximum temperatures are measured between 14:00-15:00 and the lowest temperatures between 5:00 and 7:00.

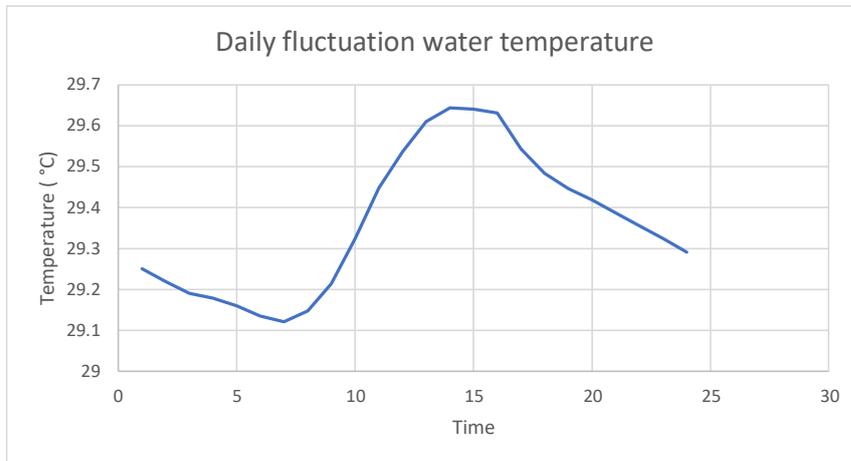
Figure 3 Daily fluctuation of water temperature in the period September- November 2021

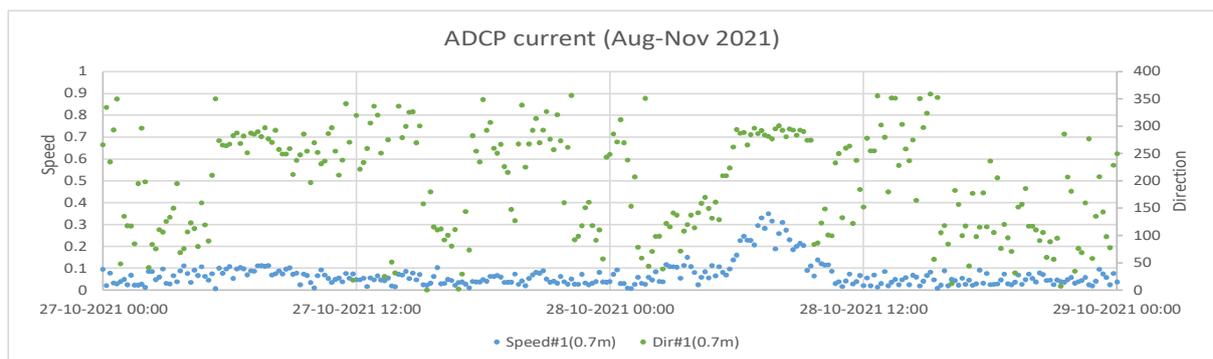
Figure 4 Near bottom current October 27<sup>nd</sup> -29<sup>th</sup> 2021

During the period September -November the current measurements have been obtained. A typical situation in which the current is partly dominated by wind is presented in figure 4, 5 and 6. In these figures the current condition close to the bottom (and instrument), halfway the water depth and near the surface are presented. The full time series of the conditions halfway the water column are presented in the appendix. It can be seen in these figures that the (wind driven) currents near the surface are much larger than the near bottom velocities. The tidal impact on the currents (visible in the change of direction) is more pronounced in the bottom and near bed velocities.

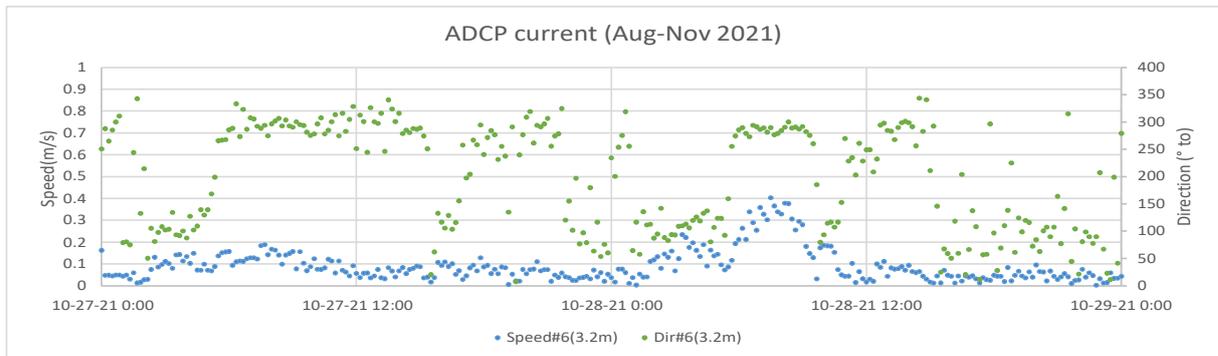
Figure 5 Mid depth current October 27<sup>nd</sup> -29<sup>th</sup> 2021

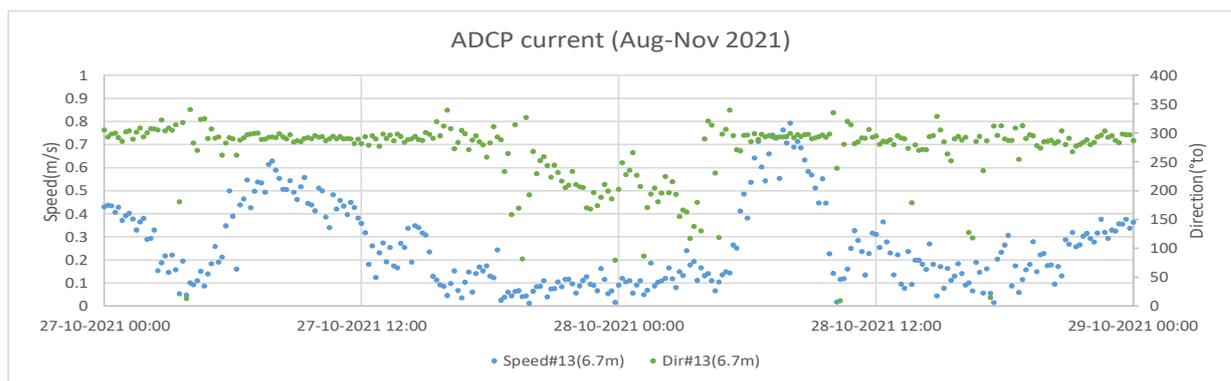
Figure 6 Currents 1 m below the surface October 27<sup>nd</sup> -29<sup>th</sup> 2021

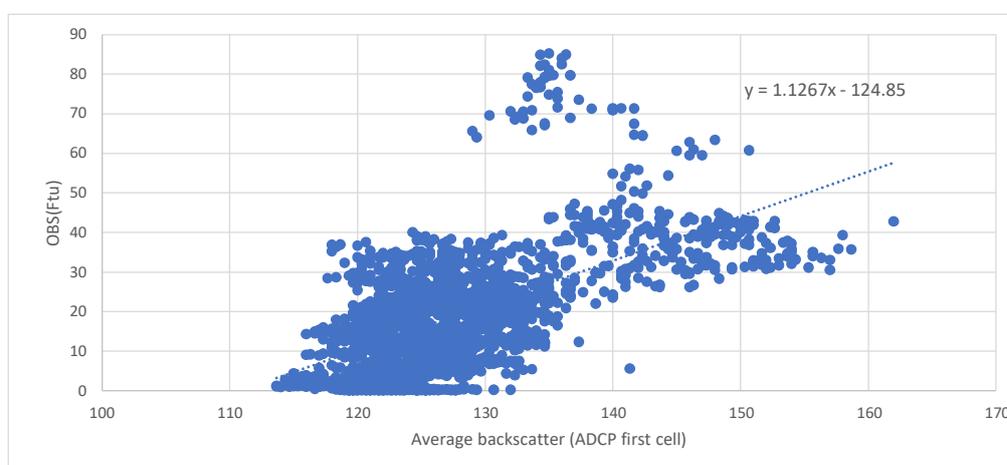
Figuur 7 Relation between recorded OBS values and ADCP backscatter amplitude.

In this case we have an additional sensor that could be used to indicate the variations in optical backscatter during the full period. For this purpose the acoustic backscatter of the ADCP has been correlated with the recorded data from the OBS during the first 10 days. This correlation is presented in figure 7

Based on this relation the full period FTU values and the FTU based on the ADCP data has been presented in the appendix.

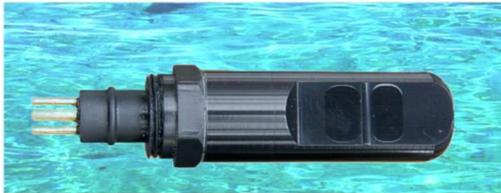
The **Seapoint Turbidity Meter** detects light scattered by particles suspended in water, generating an output voltage proportional to turbidity or suspended solids. The low power requirements make it ideal for applications where battery drain is a concern. Range is selected by two digital lines which can be hard wired or microprocessor controlled, thereby choosing the appropriate range and resolution for measurement of extremely clean to very turbid waters. The offset voltage is within 1 mV of zero and requires no adjustment across gains. The unique optical design confines the sensing volume to within 5 cm of the sensor allowing near-bottom measurements and minimizing errant reflections in restricted spaces. The sensor is easily interfaced with data acquisition packages; a 5 ft pigtail is supplied. Custom configurations are available.
